- Preliminary Report -

AAIS Case N° AIFN/0007/2019

Loss of Control on Approach during Runway Lighting Calibration Flight

Make and Model: Diamond DA62

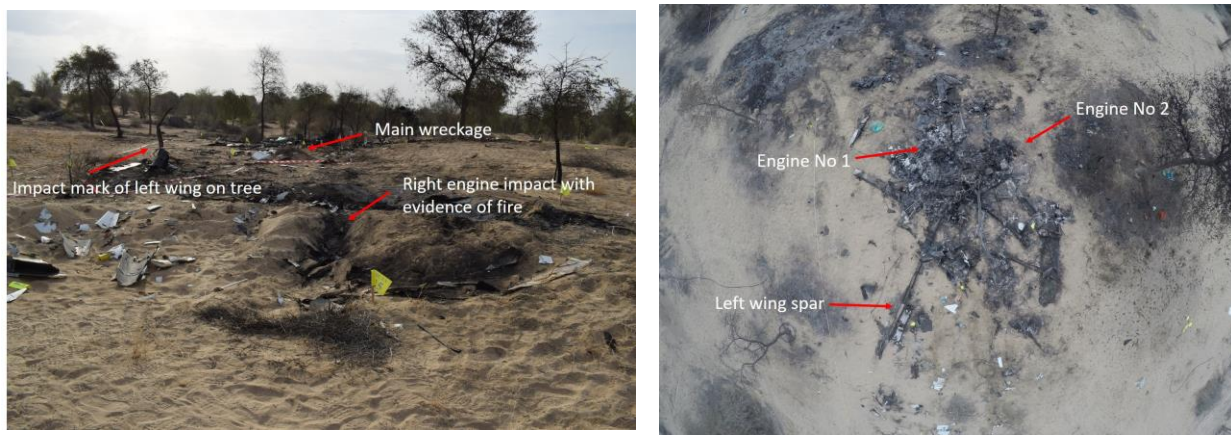
Figure 3. The initial impact crater and the main wreckage at the second impact point

The initial impact site, to the right and 4.2 meters beyond the damaged tree, consisted of two large double craters, each about 600 mm deep and the same widths as the engines. A smaller tree beyond the first impact site showed contact marks with the left wing. The metal wing wiring conduit was found attached to the tree. Unburnt aircraft wreckage, mainly from the underside of the fuselage and the tail, was found in and around the two craters. Evidence of initial fire spreading was evident from the right engine impact crater onwards.

The second impact was located approximately 20 meters from the initial impact point and contained the main wreckage. The Aircraft was completely destroyed by impact forces and the post impact fire. GFRP and CFRP manufactured components of the fuselage structure and the wings were completely destroyed, with only a few metal parts unaffected by the fire. The engines, landing gear, fuel tanks, the nose bay avionics rack and some unrecognizable parts were found in the main wreckage. The left center fuel tank had an impact dent near the leading edge which matched the trunk diameter of the small tree near the first impact site.

The cockpit instrument panel came to rest inverted approximately 25 meters beyond the main wreckage. Both propeller governors were found 37 meters beyond the main wreckage and the Aircraft seats were located 50 to 68 meters beyond the main wreckage.
