# SERVICE BULLETIN

**TB AIRCRAFT**

<b>SB 10–128</b>	<b>30</b> <small>ATA No.</small>
------------------	-------------------------------------

**SUBJECT** : DRAINING OF AIRFRAME DEICING FILLING HOLE  
**EFFECTIVITY** : TB 20 and TB 21 aircraft up to S/N 2143 equipped with OPT10 C687 00M, C687 05M, C687 10M, C687 15M "Airframe deicing" optional equipment.

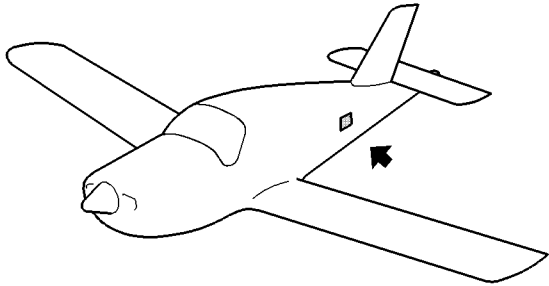
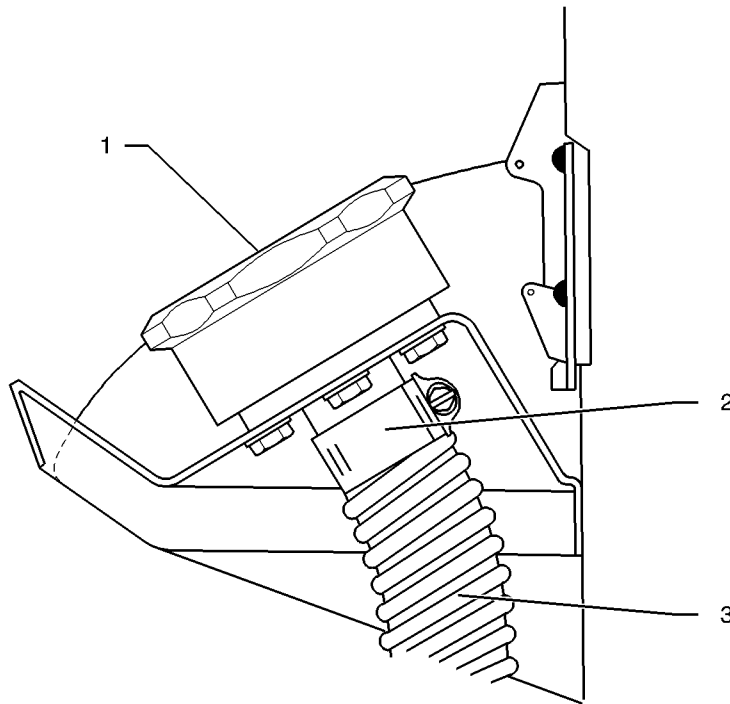
Figure 1 – Filling hole draining – Preparation

- A. PROBLEM  
Glycol projection at the rear part of the fuselage.
- B. REASON  
Leak of glycol through air vent located on filling plug.
- C. SOLUTION  
Installation of a drain.

- 1) Open baggage compartment door 219.
- 2) Remove baggage compartment bottom door 242.

- 1) Untighten clamp (2), remove filling flexible (3) and install a blanking cap.
- 2) Remove door 224.
- 3) According to Detail B, mark attaching dimensions of angle (17), P/N TB20 9608110300 and of flange end (21), P/N TB20 9608110100.
- 4) Position angle (17), make sure there is a gap of about 0.20 in (5 mm) at plug (11) location.
- 5) Counterdrill to diameter 0.13 in (3.2 mm). Deburr.
- 6) Apply a coat of PR 1422 A2 on angle bearing surfaces.
- 7) Install rivet washers (19), P/N Z00.N5734041120, rivets (18), P/N Z00.N5536342406.
- 8) Drill central hole of flange end (21) on tube (22) then counterdrill to diameter 0.39 in (10 mm). Deburr.
- 9) Position flange end (21), counterdrill attaching holes to diameter 0.13 in (3.2 mm). Deburr.
