SERIOUS INCIDENT

Aircraft Type and Registration:	Airbus A330-243, G-TCCF
No & Type of Engines:	2 Rolls-Royce Trent 772B-60 turbofan engines
Year of Manufacture:	1998 (Serial no: 248)
Date & Time (UTC):	6 February 2019 at 1720 hrs
Location:	In flight over North Atlantic Ocean, west of the Republic of Ireland
Type of Flight:	Commercial Air Transport (Passenger)
Persons on Board:	Crew - 11 Passengers - 326
Injuries:	Crew - None Passengers - None
Nature of Damage:	VHF radio unit damaged
Commander's Licence:	Airline Transport Pilot's Licence
Commander's Age:	49 years
Commander's Flying Experience:	13,135 hours (of which 1,050 were on type) Last 90 days - 98 hours Last 28 days - 45 hours
Information Source:	Aircraft Accident Report Form submitted by the pilot and operator investigation

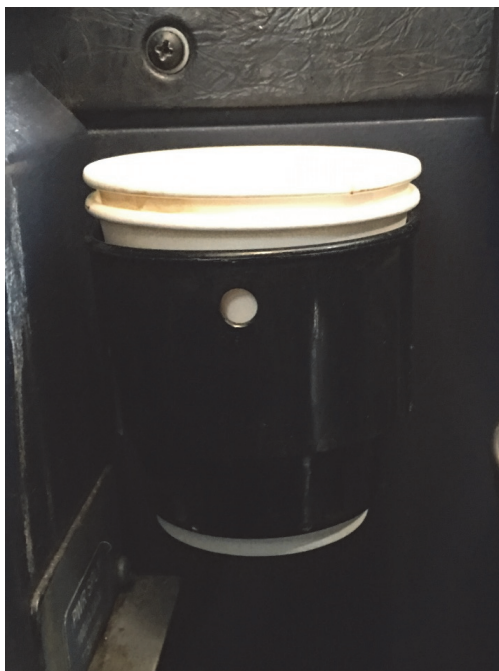
Figure 1

The flight departed from Frankfurt airport in Germany and was scheduled to fly to Cancun in Mexico. Approaching position N5500.0 W02000.0 the flight crew were served coffee in cups without lids (Figure 1). This was normal for this operator and route.

Example of cup used in the aircraft cup holder

The aircraft manufacturer recommends using the cup holder. The size of cups used by this operator on this route made it more difficult to take cups in and out of the cup holder than larger cups that have a bigger area at the top of the cup holder to grasp. This incompatibility generally discouraged use of the cup holder, despite the policy. In the A330, flight crew were provided with a table in front of them, and it was a natural place to put a drink momentarily. However, objects here are vulnerable to being knocked over because it is a fold out table in a small space. It is also a convenient place to put other things that are likely to be moved during flight, such as the pilot's log. A lid properly secured on the top of the cup may have reduced the amount of liquid spilled on the centre console.

The operator changed their procedure to ensure that cup lids are provided for flights on all routes and reminded cabin crew of the requirement to use them. The operator also issued a flight crew notice reminding pilots to be careful with liquids. The operator raised an action to source and supply appropriately sized cups for the aircraft's cup holders.

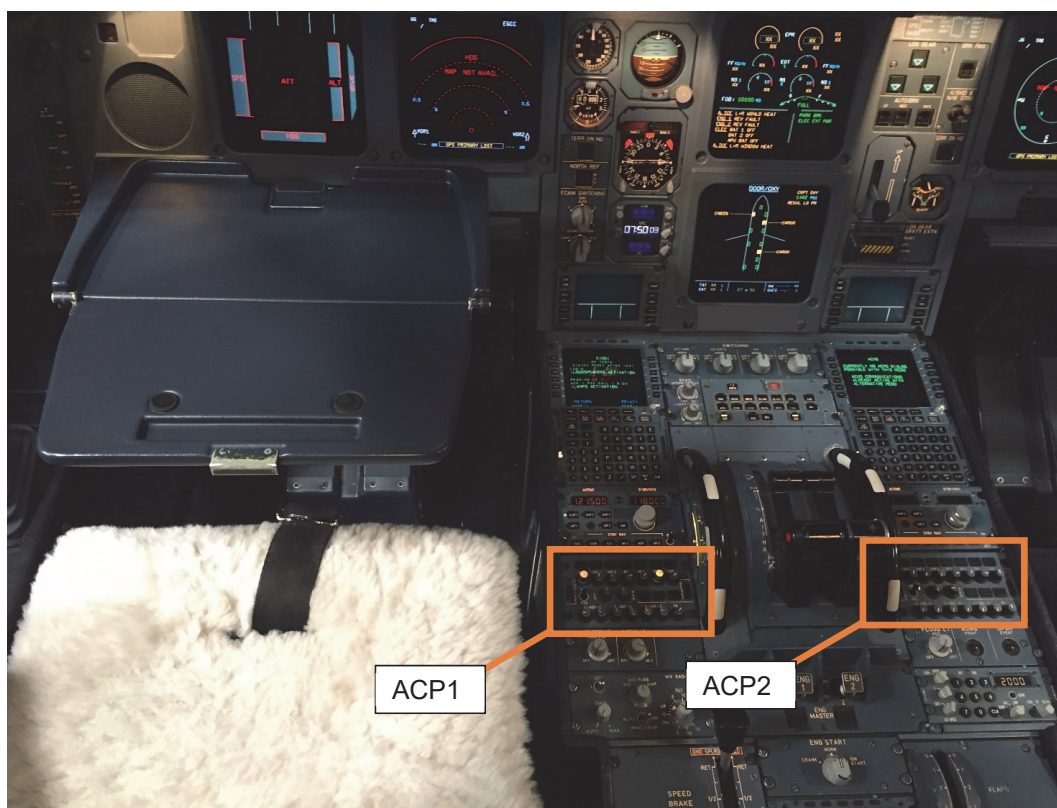
Figure 2

The commander was pilot monitoring. He put the coffee on his tray table while he completed tasks required due to approaching a waypoint. At approximately 1620 hrs, the cup was knocked over. Most of the liquid fell onto the commander's lap and a small amount spilled onto the commander's ACP (ACP1, see Figure 2).

Location of the ACP1 and ACP2 boxes

The coffee on the centre console was dried quickly but resulted in immediate malfunction of ACP1 that affected VHF transmissions and public address announcements from this unit. The crew attempted to isolate ACP1 but it was not possible to do this from the flight deck. Subsequently, at approximately 1700, the ACP1 unit became very hot and failed and there was an electrical burning smell in the cockpit.

At approximately 1720 hrs, approaching N5600.0 W03000.0, the audio control panel on the co-pilot's side (ACP2) became hot enough to start melting one of its buttons, and failed. A small amount of smoke was observed coming from the ACP1. The commander decided to divert to Shannon, Republic of Ireland. During the diversion, the flight crew alternately used supplementary oxygen, with one pilot on oxygen at all times.

ACPs 1 and 2 were removed and stripped by the vendor. The strip report for ACP1 confirmed component failures attributed to liquid contamination. The strip report for ACP2 listed the failed components but did not offer potential causes these failures. The area below the centre console was inspected and no further areas were found that had been affected by liquid contamination.

The strip report indicated that the failure of ACP1 and the smoke and fumes were the result of electrical shorting caused by liquid contamination. The reason for the failure of ACP2 was unclear from the strip report.
