Final Report No. 2053 by the Aircraft Accident Investigation Bureau

to the Eurostar EV-97 model 2000 version R ultralight aircraft

registration 9-249 (DK)

on 24 June 2006

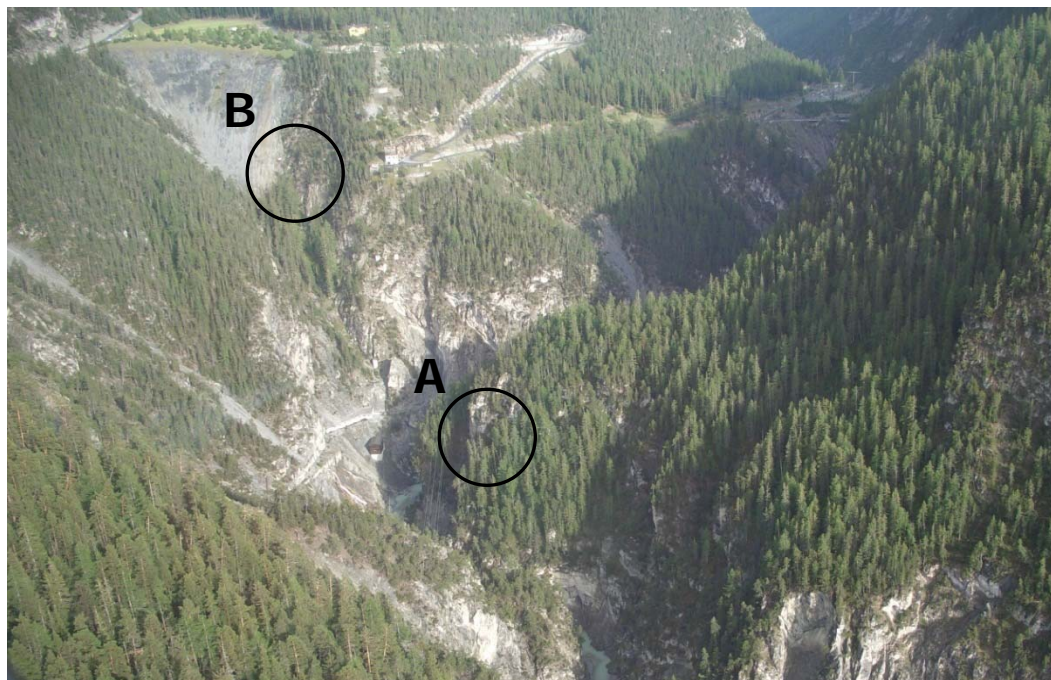
The main wreckage was on a rock outcrop, 50 metres above the bed of the Spöl, on the steep wooded slope west of the course of the river (see figure below, reference A). Large debris items were held by harnesses and control cables which became entangled in the trees. The main impact point was at 1600 m AMSL directly below a high-voltage line of the Engadine power station. The bodies of the two occupants and smaller parts of the wreckage were below the rock outcrop in the river bed and in the area of the Spöl's banks.

A debris field with parts of the cockpit canopy, canopy frame and loose items extended in an east-south-east direction over a distance of approximately 900 metres. The left wing was located along this debris field 470 m from the main wreckage, in steep scree, at 1720 m AMSL (see figure below, reference B).

Figure 1 – General view of the site of the accident, looking east

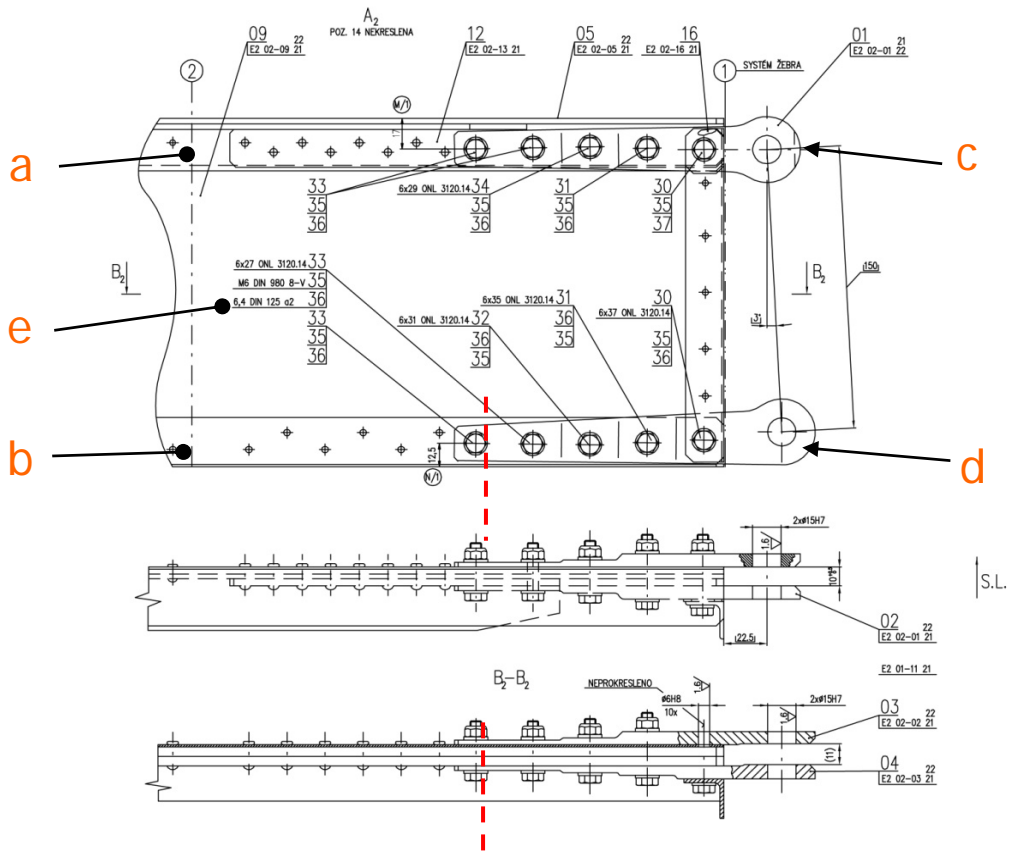
The wing-side attachment parts of the lower spar cap had been torn off from the wing. The lower spar cap – consisting of two flat aluminium profiles – as well as a piece of the wing spar web and the wing skin were torn apart. The fracture in the wing spar cap was in the area of the outermost close-tolerance bolt (cf. figure 2).

From the findings above it is apparent that the lower wing spar cap of the left wing fractured in flight in the vicinity of the fuselage and the left wing was subsequently torn off.

Figure 2 – Wing joint structure with fracture plane shown in red

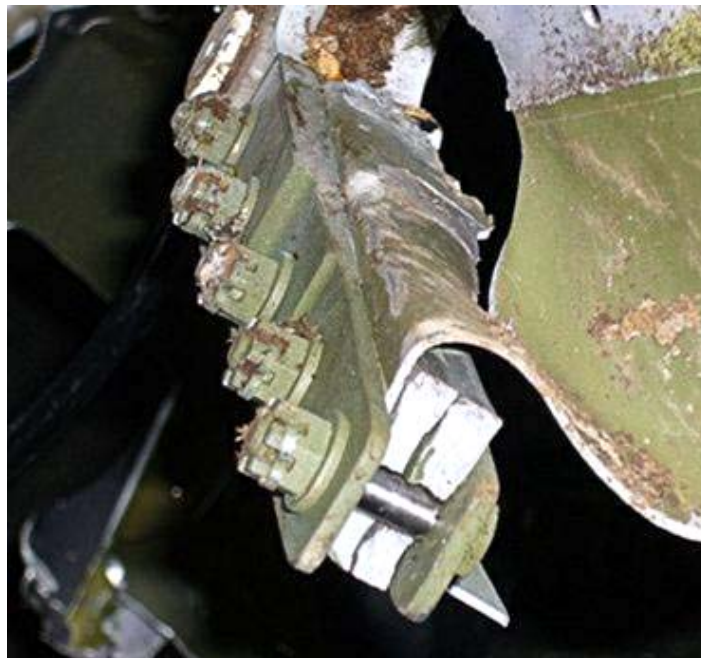
Figure 3 – Location of fracture of the lower spar cap of the left wing with visible outermost close-tolerance bolt

The lower spar cap of the left wing ruptured at a point with high stress concentration and a significant notch effect. This weak point in the structure was neither detected nor recognised by the static wing load test carried out by the manufacturer. At points with a notch effect and high stress concentration, therefore, a static load test is not sufficient to provide proof of adequate structural strength. Furthermore this approach does not take into account any fatigue aspects.

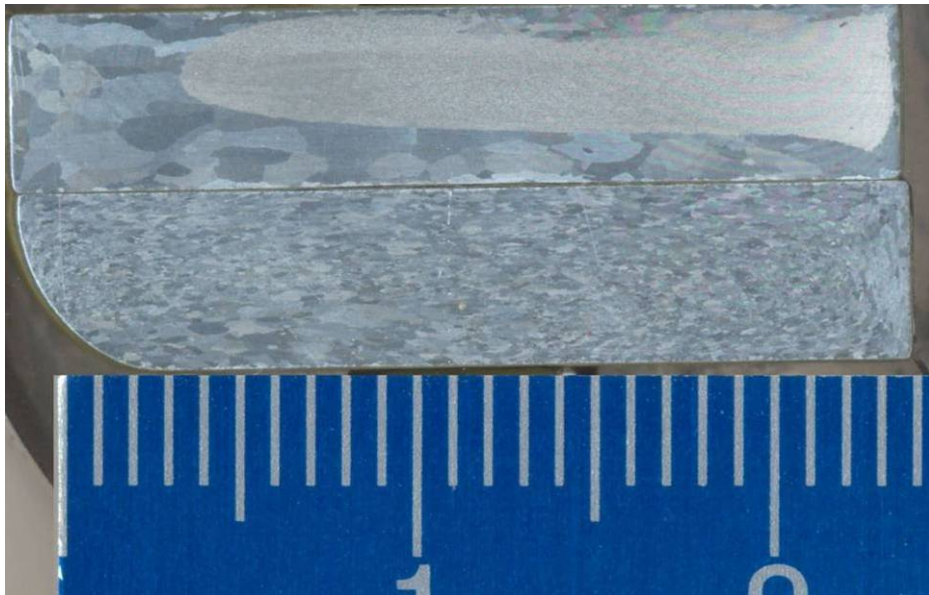
Figure 4 – Left wing, lower spar cap, looking from fuselage outwards
Overall view of the matrix of the two lower spar caps. 1A without radius; 1B with radius

On all the metallographic sections examined, profile B (with radius) exhibited a homogeneous – though rather coarse-grained – matrix.

In the case of profile A (without radius), all sections exhibited the typical indications of an extrusion weld; the inner part of the cross-section is relatively fine-grained and is surrounded by extremely coarse-grained material. This is a case of gross inhomogeneity in the profile. This defect in the material occurs in the fabrication of aluminium profiles in the block on block pressing technique: when the next press block is pressed, the new material flows in a tongue shape into the remaining material of the preceding press block. In this method – termed co-extrusion – this extrusion weld occurs in the transition between the individual blocks. Since it is of relatively lesser quality, the area of the profile exhibiting the extrusion weld must be cut out of the pressed strand and discarded.

In comparison with fine-grained material, coarse-grained material exhibits considerably lower notch impact strength. Elongation at rupture is also lower. Materials with low notch impact strength react very sensitively to shock loading.
