Final Report no. 2175 of the Swiss Accident Investigation Board SAIB

concerning the accident involving the
Piper PA-28-140 aircraft,
registration G-BBEF

on 14 October 2011

Petit-Beauregard, municipality of
Fontaines-sur-Grandson/VD

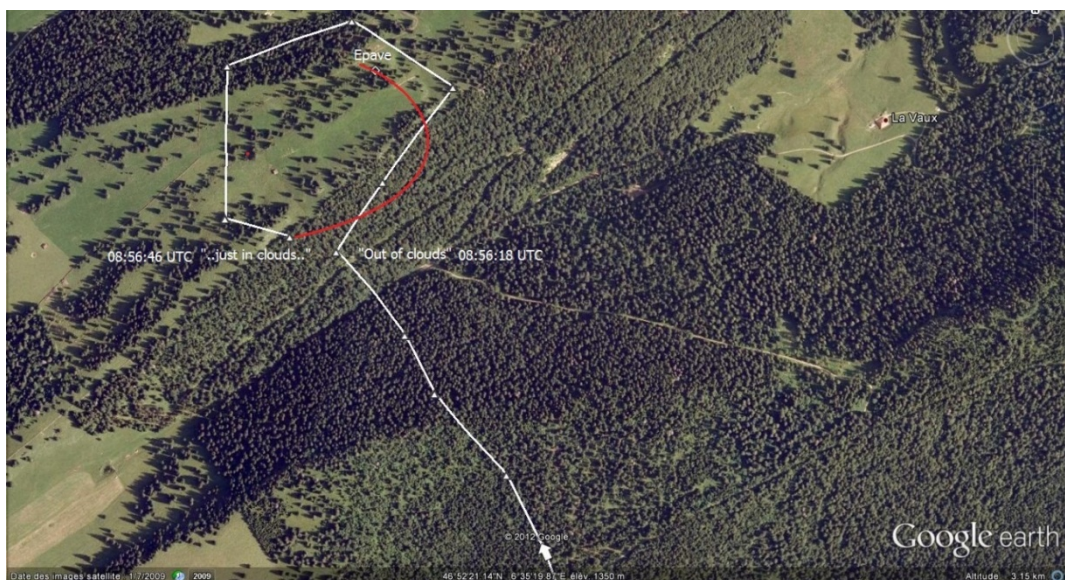
The radar data shows that at this time the aircraft made a right turn followed by a tight left turn of approximately 290°; it was completed in approximately 20 seconds. The elevation of the overflown terrain is approximately 4800 ft AMSL.

Fig. 2: Final turns of the aircraft. The section of the route in red is an extrapolation.

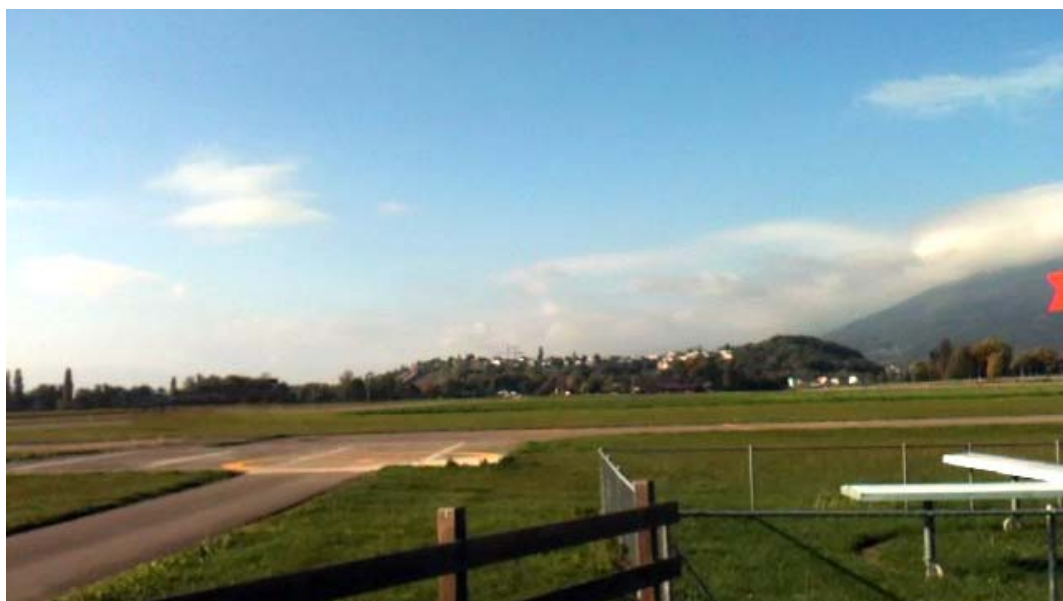
Fig. 3: Meteorological situation at the time of take-off , view towards southwest.

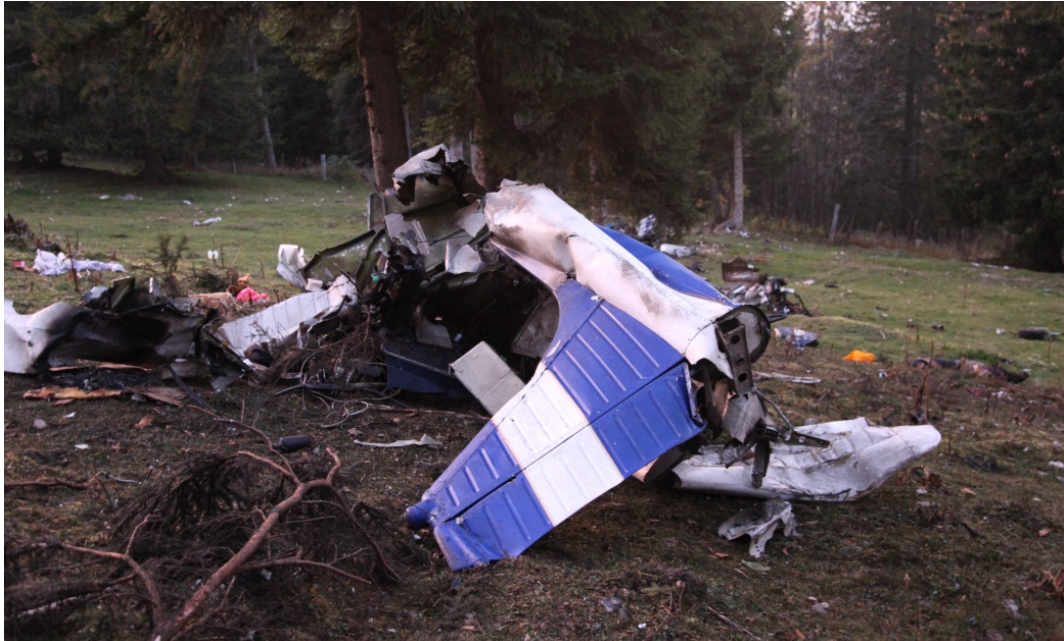
The fuselage broke into several sections, the largest of which was the tail. The three wheels of the landing gear were propelled in different directions beyond the main impact point.

Fig. 4: Rear section of the fuselage.

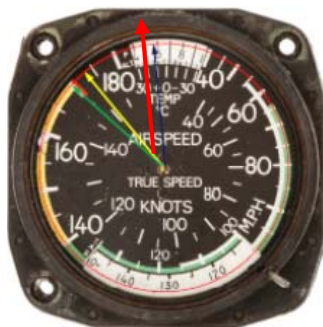
Fig. 5: Airspeed Indicator. The yellow arrow indicates 173 mph, the green arrow 170 mph and the red arrow indicates 188 mph, the maximum airspeed reached.

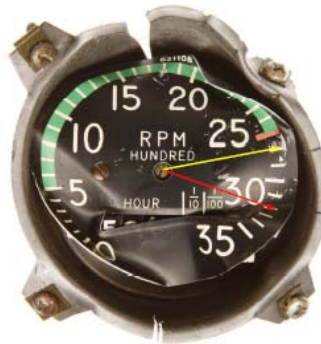
Fig. 6: Rpm Indicator. Needle impacts were detected from 2800 rpm, yellow arrow. The red arrow indicates 3200 rpm, the maximum rpm reached.

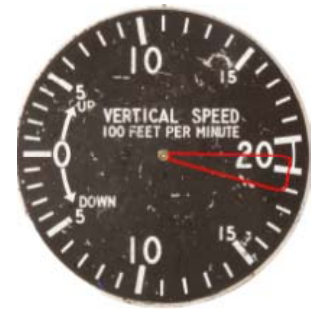
- Vertical speed (Fig. 7): needle impact indicators were detected in the DOWN sector at values between 1900 and 2000 ft/min.

The limit values indicated on the instrument are 2000 ft/min UP and DOWN.

Fig. 7: Vertical Speed. The red triangle indicates 1900 to 2000 ft/min DOWN, the sector where impacts were registered on the instrument.
