Air transportation safety investigation report A19A0025

Controlled flight into terrain

Piper PA-46-350P, N757NY

Makkovik Airport, Newfoundland and Labrador, 35 NM SE

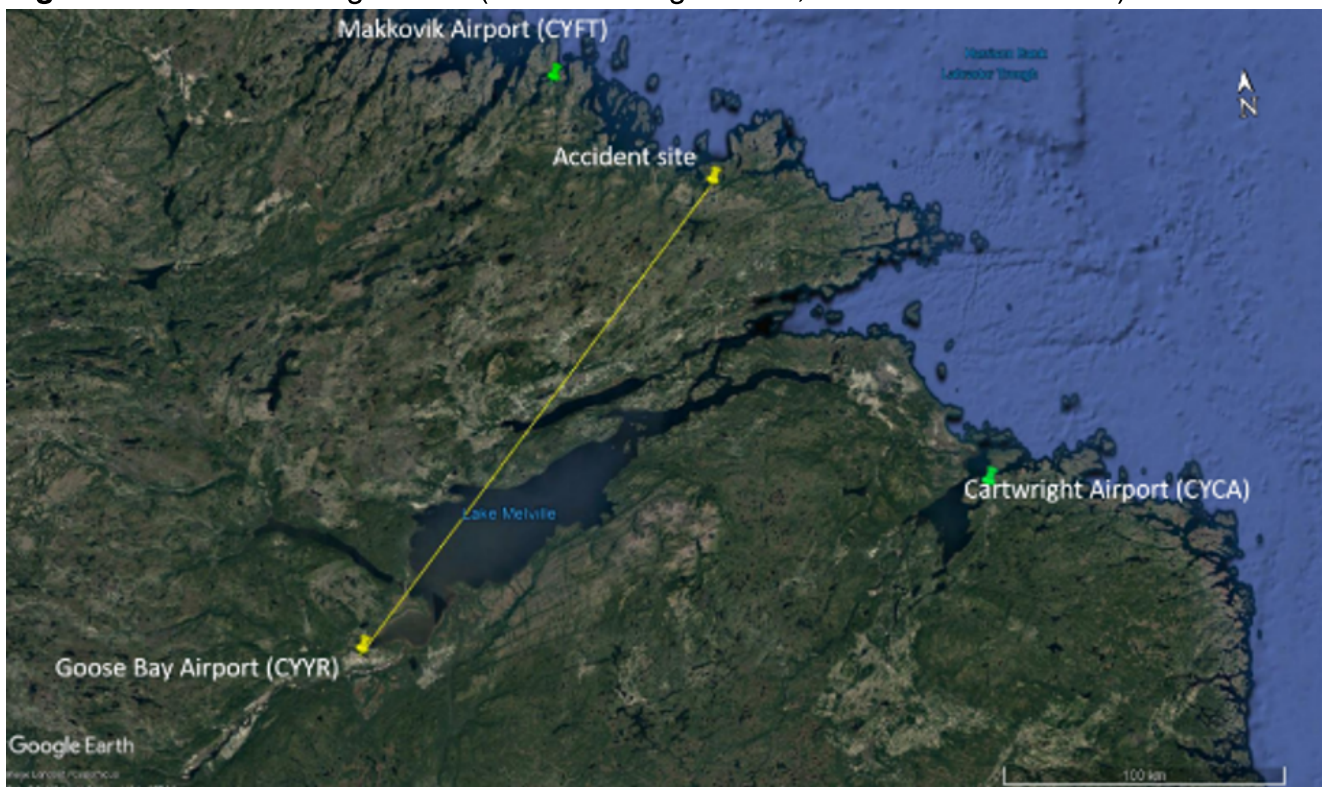
Figure 1. Occurrence flight track (Source: Google Earth, with TSB annotations)

On 01 May 2019 at 0723, ³ the aircraft departed CYYR on a VFR flight plan direct to BGBW. The ferry pilot, who was the pilot-in-command, occupied the left seat while the co-owner occupied the right seat. The aircraft climbed to 2000 feet ASL and proceeded on a direct track to destination. The altitude and heading did not change significantly along the route, therefore it is likely that the autopilot was engaged. At 0816, the aircraft collided with a snow-covered hill 2250 feet in elevation, located 35 nautical miles (NM) southeast of Makkovik Airport (CYFT), Newfoundland and Labrador (Figure 1).

The impact happened approximately 200 feet below the top of the hill. The aircraft came to rest in deep snow on steep sloping terrain. The aircraft sustained significant damage to the propeller, nose gear, both wings, and fuselage. Although the cabin was crush-damaged, occupiable space
