PRELIMINARY REPORT

ACCIDENT

**aircraft Jodel D.140E registration marks F-PMGV
and aircraft AS350 B3 registration marks I-EDIC,
Rutor glacier (AO),
24th January 2019**

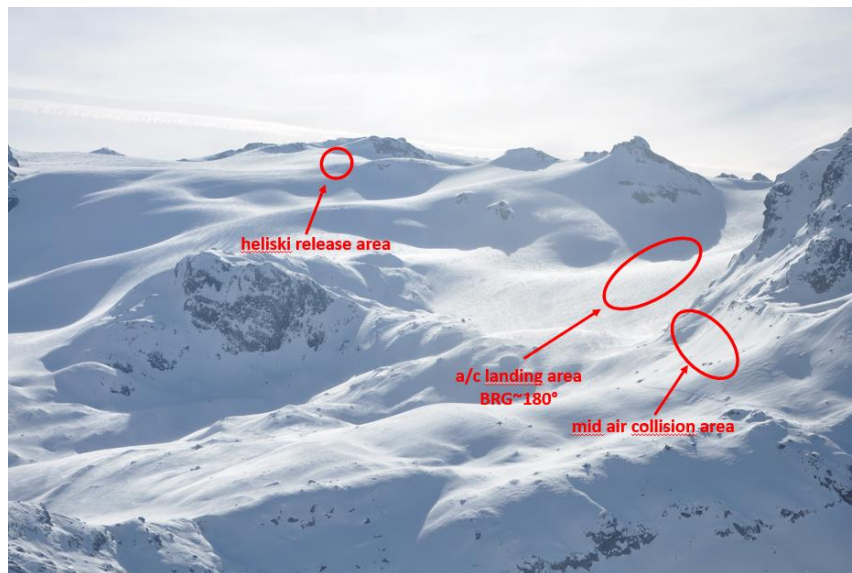
The I-EDIC helicopter and the F-PMGV airplane experienced a mid-air collision in an area close to the Rutor glacier, at an altitude of about 2700 m, around 13.30' UTC (photo 1).

- the mid-air collision between the two aircraft occurred with the airplane higher than the helicopter;
- the first contact occurred between the airplane lower right side and the helicopter main rotor;
- after the first contact between the two aircraft, the airplane broke up in flight, separating in at least 4 sections: the engine, the wings, the canopy and the tail; all these elements were found on the ground separated from each other (photos 2, 4, 5 and 6);
- after the first contact, the helicopter suffered serious damages to the main rotor blades, which likely prevented the helicopter from maintaining control in flight, with subsequent crash to the ground (photo 9);
- the collision between aircraft occurred with both of them having a ground track substantially headed south, consistent with the hypothesis they were flying toward the glacier landing areas (photo 1).

Photo 1: mid-air collision area, glacier landing area, heliski release area.

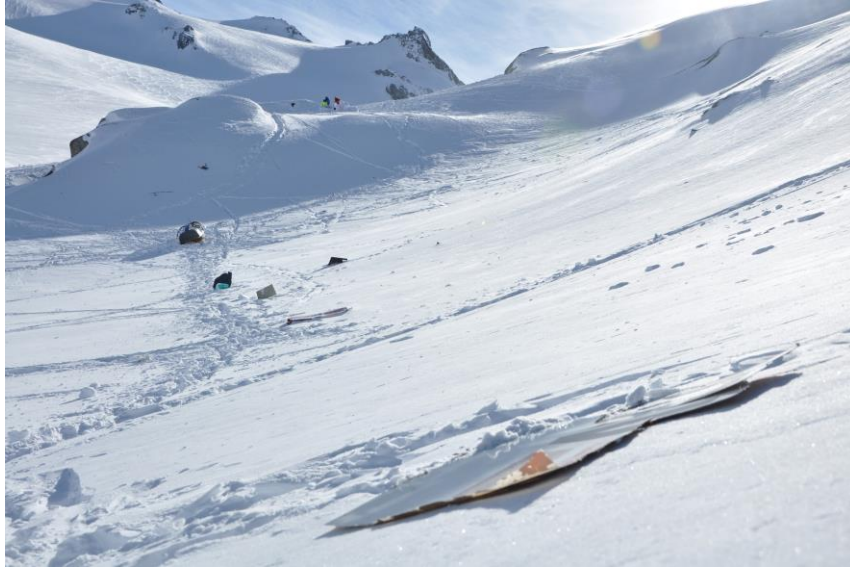
Photo 2: area of dispersed wreckages and parts.

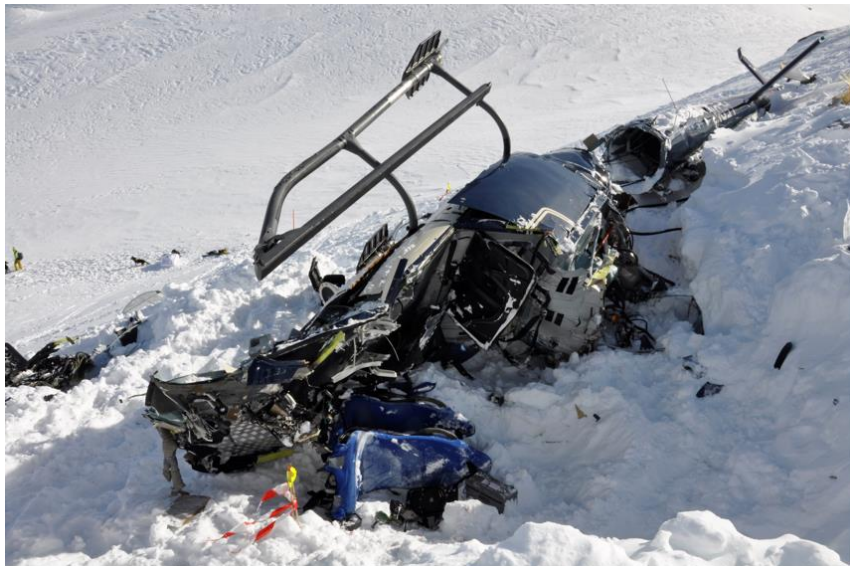
Photo 3: helicopter main wreckage.

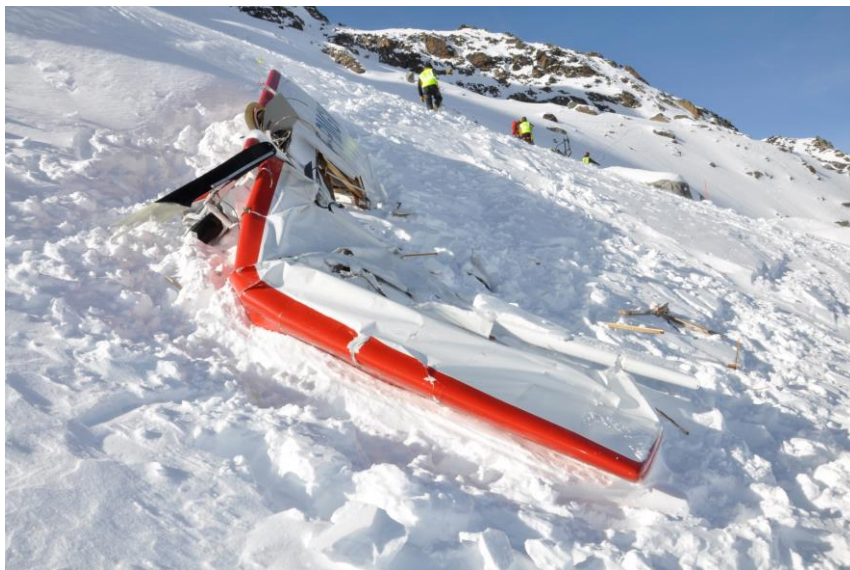
Photo 4: aircraft wing.

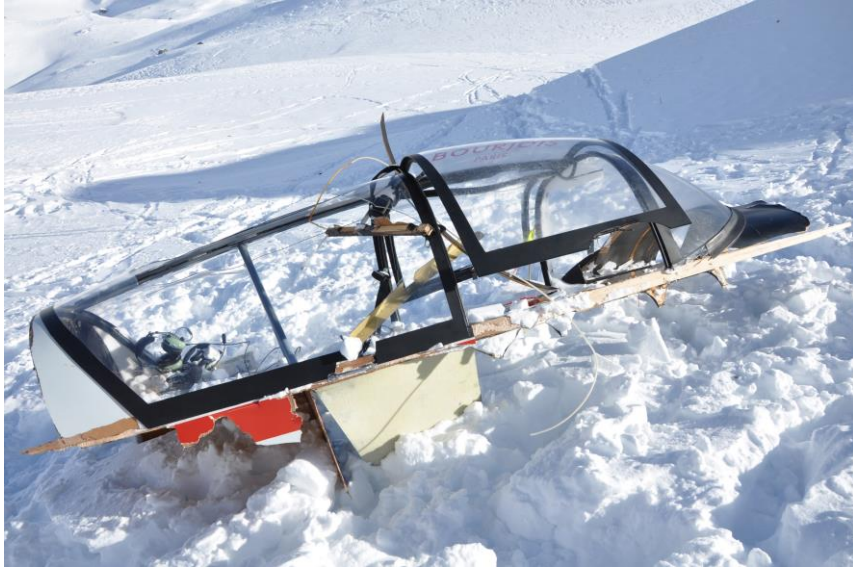
Photo 5: aircraft canopy.

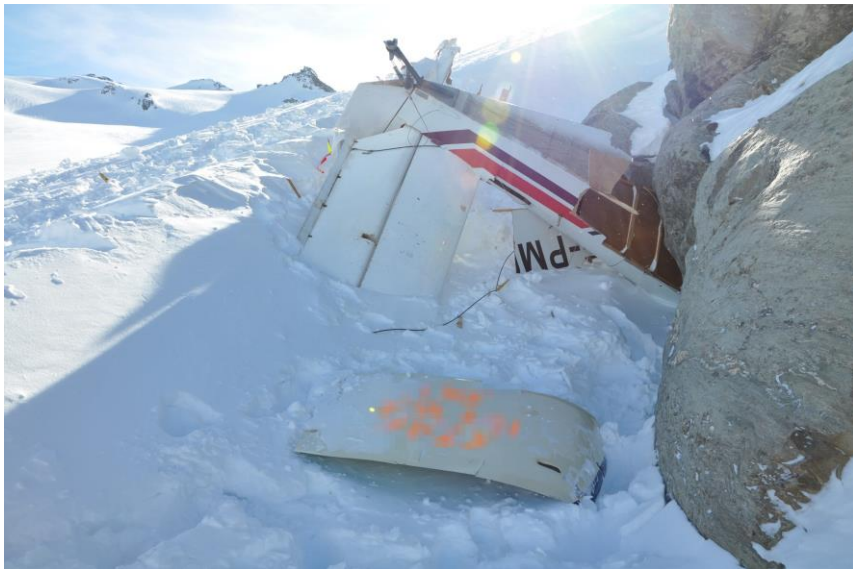
Photo 6: aircraft tail.

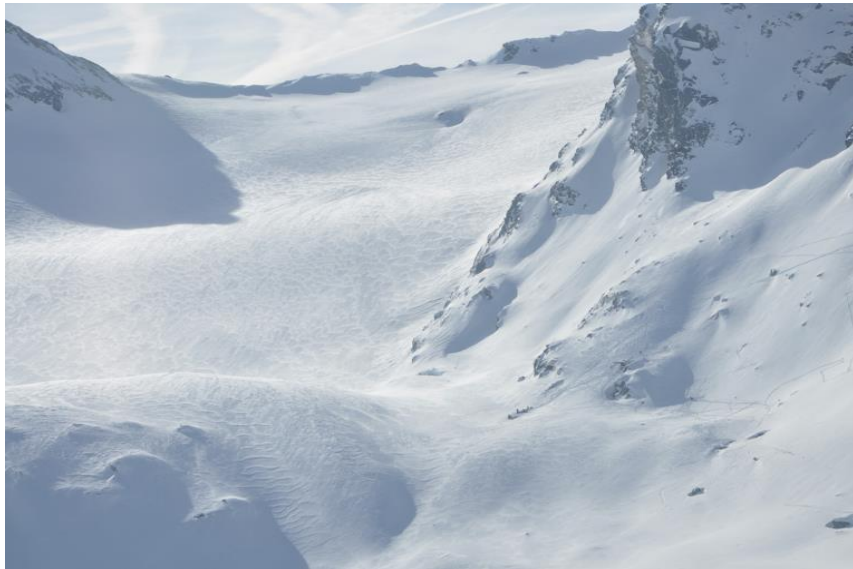
On the Rutor glacier, several ski tracks were found, most likely left by aircraft take-offs and landings (photos 7 and 8).

Photo 7: glacier aircraft landing area.

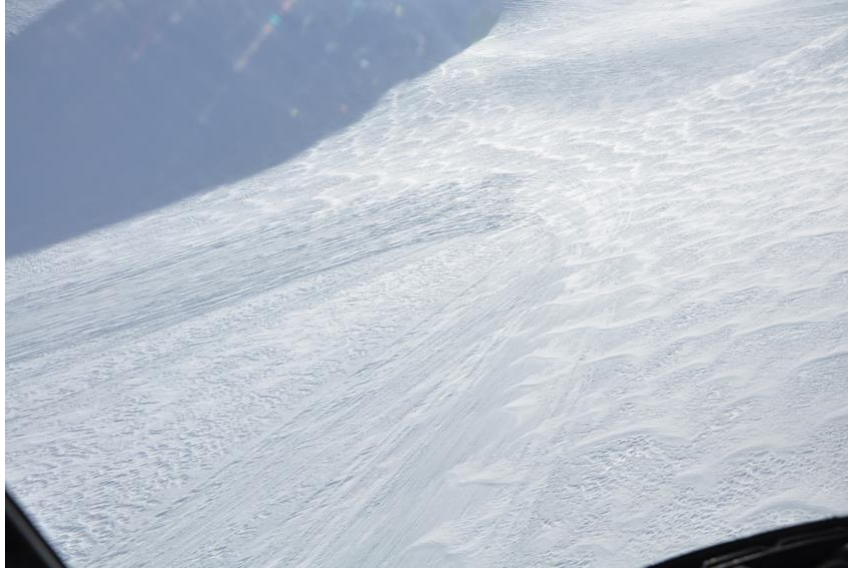
Photo 8: aircraft ski take-off and landing markings.

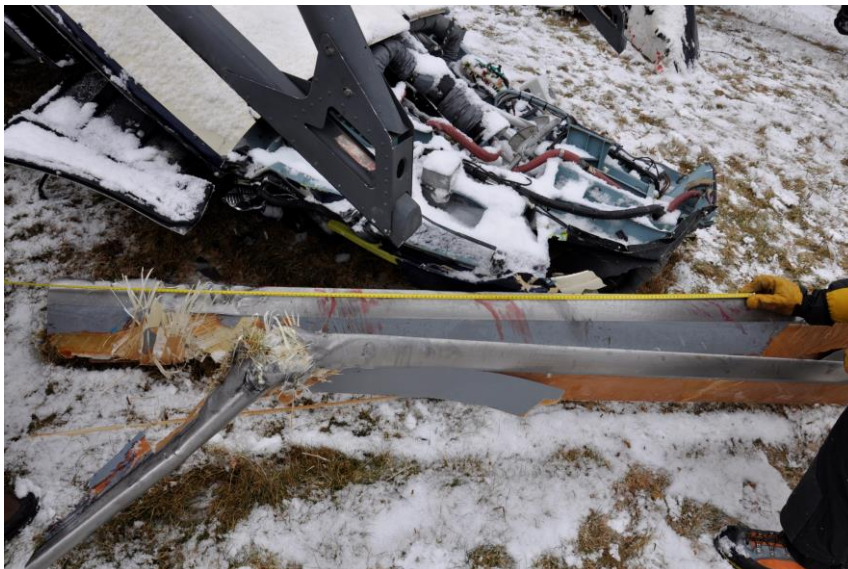
Photo 9: helicopter main rotor blades damages.

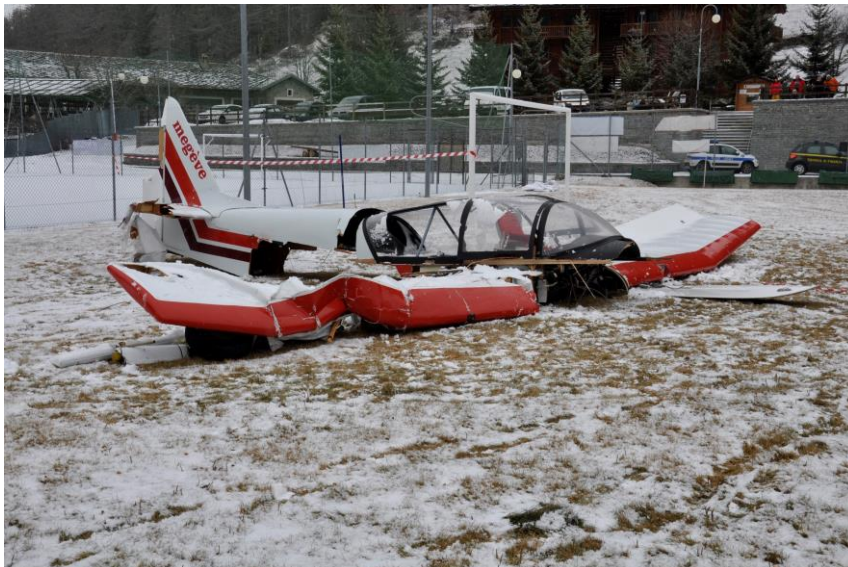
Photo 10: aircraft wreckage reconstruction.
