Final Report No. 2289

concerning the accident involving the
SIAI Marchetti S.205-18/R aircraft,
registration N108MW,

on 19 October 2014

Speck-Fehraltorf Aerodrome (LSZK),
Fehraltorf/ZH

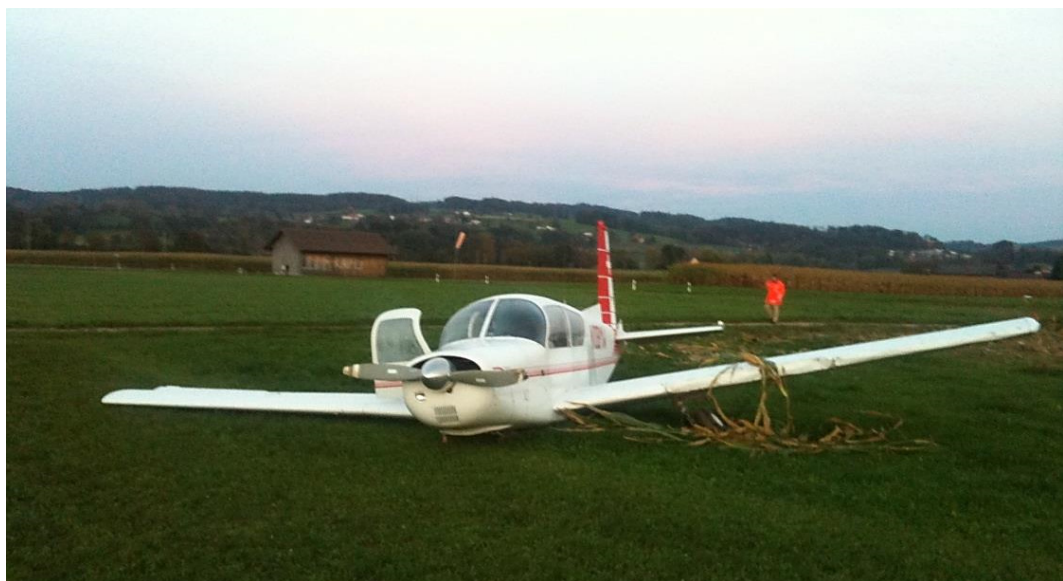
After 64 m, the aircraft crossed the local road between Fehraltorf and Wermatswil, rolled through a cornfield and finally came to rest 67 m past the road, or 188 m past the end of the runway, with torn-off landing gear and lying on its belly.

- The aircraft was lying on its belly on grassland. The nose wheel and the right-hand landing gear were bent backwards; the left-hand main landing gear was bent outwards.

Illustration 1: Final position of the N108MW

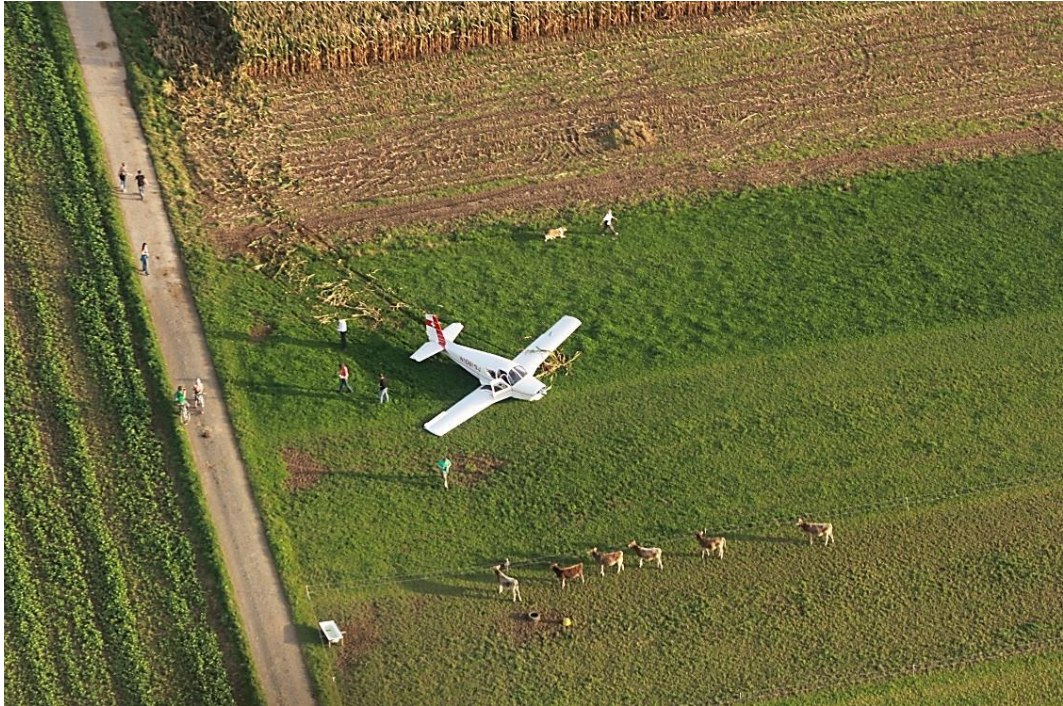
The pilot concluded that the aircraft would not continue to fly and pulled the throttle back. The aircraft touched down in a nose-up attitude on adjacent grassland about 57 m beyond the end of the runway and 18 m to the left of the runway centerline.

The right-hand main landing gear made the initial contact with the ground. The mark left by the left-hand main landing gear started at about 9 m, and the marks left by the nose wheel started at about 20 m past the touchdown point of the right-hand main landing gear. The marks made by the landing gear ran at an angle of approx. 12° left of the runway axis.

Illustration 2: Aerial view of the accident site

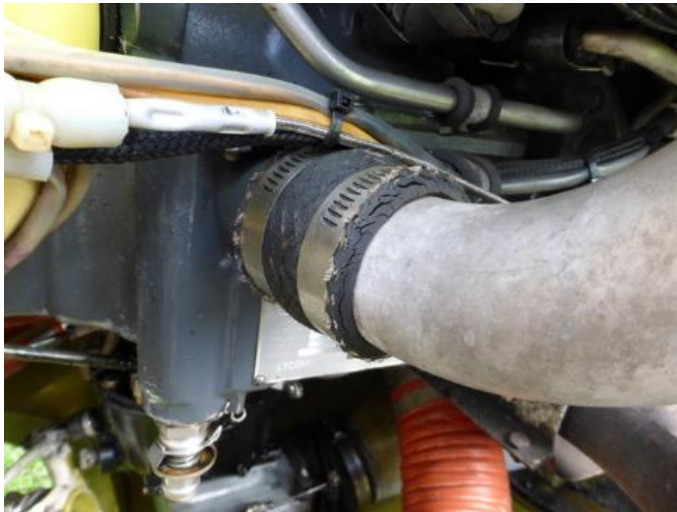
The general technical condition of N108MW was poor. Examples include the following:

- The exhaust pipe flange on cylinder no. 3 was defective.
- The baffles inside the exhaust muffler were damaged.
- The rubber engine mounts were severely cracked.
- The flexible oil return tubes were severely cracked.
- The rubber sleeves of the manifold pipes to the individual cylinders were cracked.

Illustration 3: Cracked rubber sleeves on the manifold pipes to the cylinders

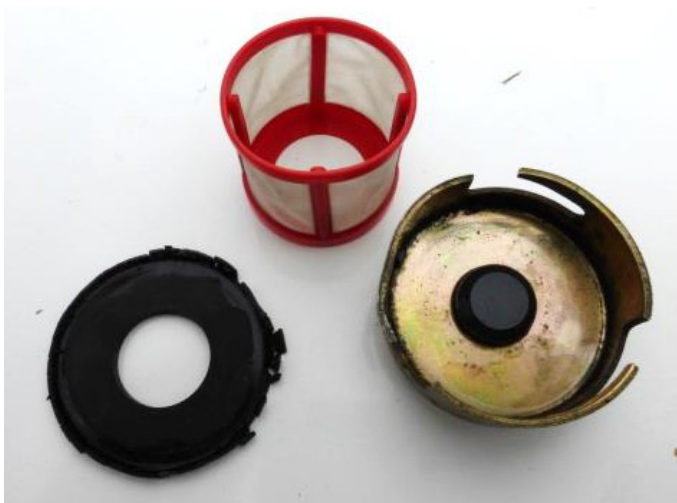
- When the electric fuel pump was disassembled, fuel was found inside the pump and the strainer was clean. The seal on this strainer was cracked and some pieces were missing.

Illustration 4: Strainer of the electric fuel pump with cracked seal

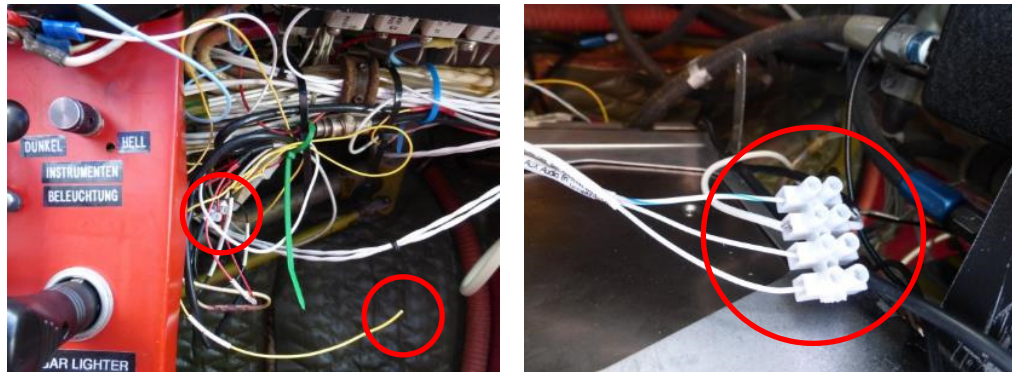
- Upon further examination of the wreckage, it was found that behind the instrument panel, the vacuum filter for the instruments air could chafe on the flight control rods.
- Some of the electrical wiring was improperly installed. There were several loose wires that could chafe on the control rods. Quite a few wires without insulated ends were also found. In addition, lustre terminals were used which are not permitted in aircraft applications.

Illustration 5: Electrical wiring behind the instrument panel

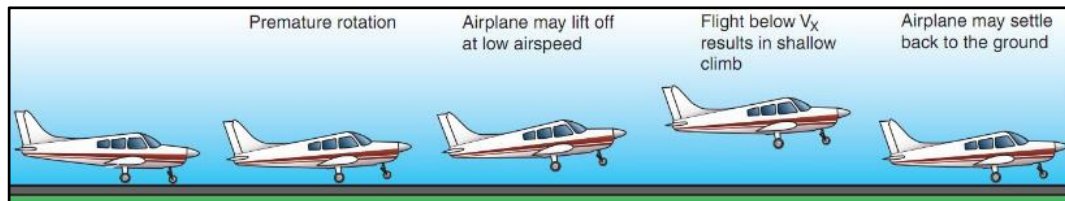
If an aircraft that lifts-off with a deficiency of speed is immediately transitioned into a climb then this may result in the aircraft settling down again. Even if it remains airborne, the initial climb will be shallow and climb performance will remain severely limited until the speed for the best angle of climb is reached.

Illustration 3: Take-off at low speed in the ground effect (source: Airplane Flying Handbook FAA-H-8083-3A)
