## ACCIDENT

<b>Aircraft Type and Registration:</b>	Piper PA-28-140 Cherokee, G-AVRP	
<b>No &amp; Type of Engines:</b>	1 Lycoming O-320-E2A piston engine	
<b>Year of Manufacture:</b>	1967	
<b>Date &amp; Time (UTC):</b>	5 August 2007 at 1100 hrs	
<b>Location:</b>	0.5 nm south-west of Isle of Wight/Sandown Airport	
<b>Type of Flight:</b>	Private	
<b>Persons on Board:</b>	Crew - 1	Passengers - 3
<b>Injuries:</b>	Crew - 1 (Fatal)	Passengers - 3 (Fatal)
<b>Nature of Damage:</b>	Aircraft destroyed	
<b>Commander's Licence:</b>	Private Pilot's Licence	
<b>Commander's Age:</b>	48 years	
<b>Commander's Flying Experience:</b>	687 hours (of which 143 were on type) Last 90 days - 12 hours Last 28 days - 6 hours	
<b>Information Source:</b>	AAIB Field Investigation

## Synopsis

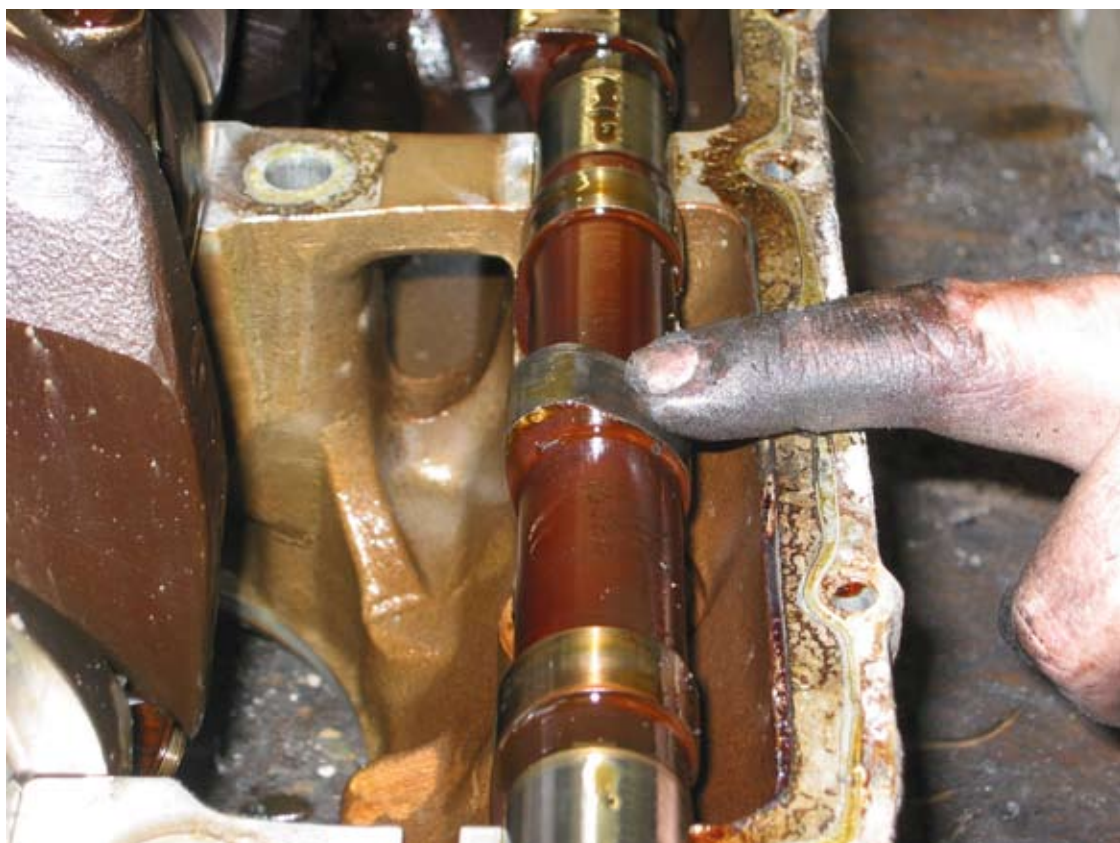
**Figure 1**

On removing the camshaft it was noted that the surface of one of the cam lobes exhibited evidence of severe spalling<sup>1</sup>, with the valve-lifting portion of the profile having been worn down to a significant extent. In addition the surfaces of the cylinder Nos 1 and 2 cam followers had suffered considerable pitting where they had been in contact with the damaged cam lobe.

Photographs of the camshaft, the damaged lobe and the associated cam followers are shown at Figures 1 and 2. Also shown is a sketch indicating the principle of cam/valve operation, although in the subject engine, the cam followers contain hydraulic tappets, which become charged with oil when the engine is running, causing them to expand so that they take up clearances between the various components in the valve operating system. It should be noted that although there is a total of eight valves in the engine, the camshaft has only six lobes because the second and fifth lobes (counting from the front of the engine) each operate the inlet valves of opposing cylinders, Nos 1/2 and 3/4 respectively. Each exhaust valve is operated by a dedicated cam lobe. The effect of the wear was to remove approximately 0.138 in from the cylinder Nos 1/2 inlet valves cam 'peak', which would have resulted in a corresponding loss of inlet valve lift for both cylinders.

Worn cam lobe, as found during engine strip

A metallurgical examination of the camshaft included micro hardness tests on the cam lobe wearing surfaces. During manufacture, the camshafts are subjected to a carburising process, in which carbon is diffused into the surface of the material, resulting in a hardened layer. According to the engine manufacturer, the hardness depth should be around 0.030 to 0.045 in. In fact the micro hardness tests revealed that there was no significant reduction in hardness values until approximately 0.050 in below the surface. The amount of wear on the affected cam lobe was considerably more than this: the wear rate would have increased rapidly once the hardened layer had been removed.

No major mechanical failure had occurred in the engine, although the cam lobe that operated the inlet valves of cylinders 1 and 2, had suffered a considerable amount of wear. This had resulted in a reduction of approximately 40% of the cam follower range of movement, which in turn would have caused a similar reduction in valve opening. A consequence of this could be that a reduced amount of fuel/air mixture would be drawn into the affected cylinders during the induction stroke, with a

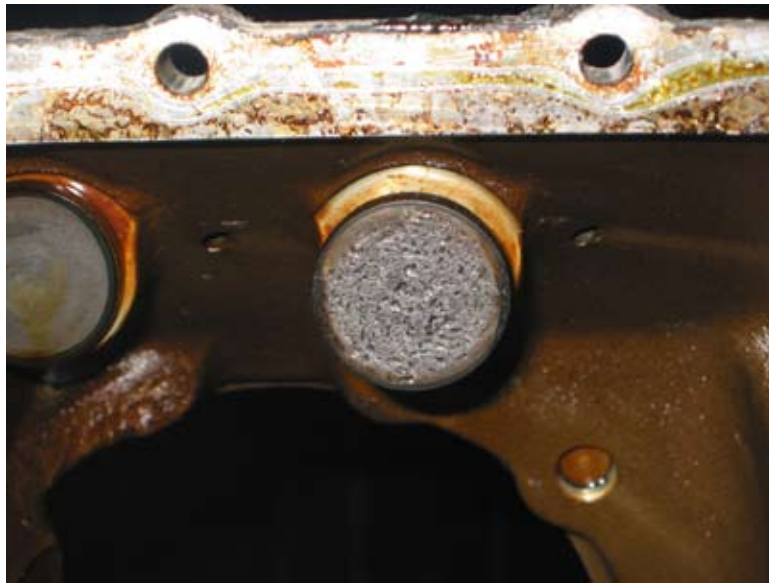
**Figure 2**

View of spalling on one of the cam followers

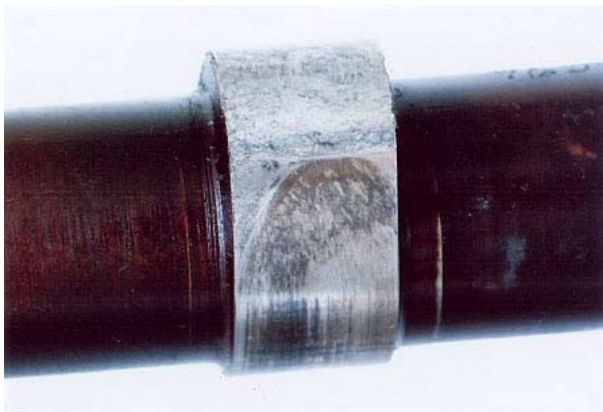
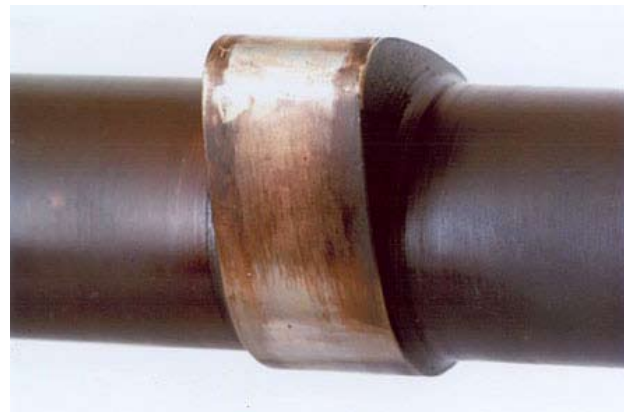
Comparison of worn and normal cam lobes

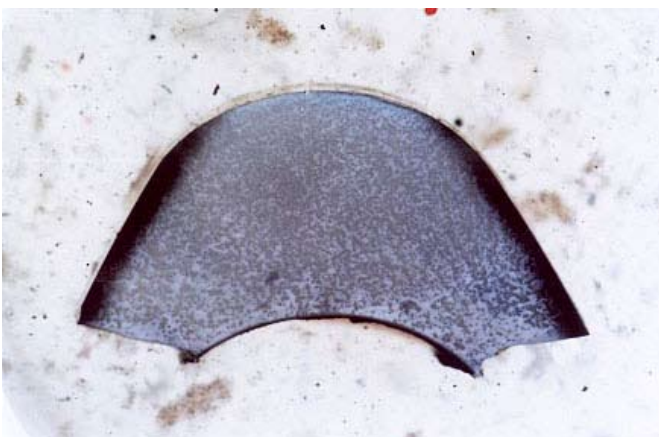
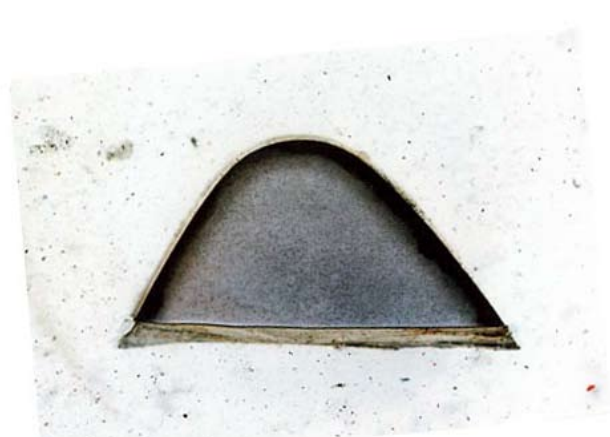
Section through worn and normal cam lobes. Note hardened layer showing as dark areas

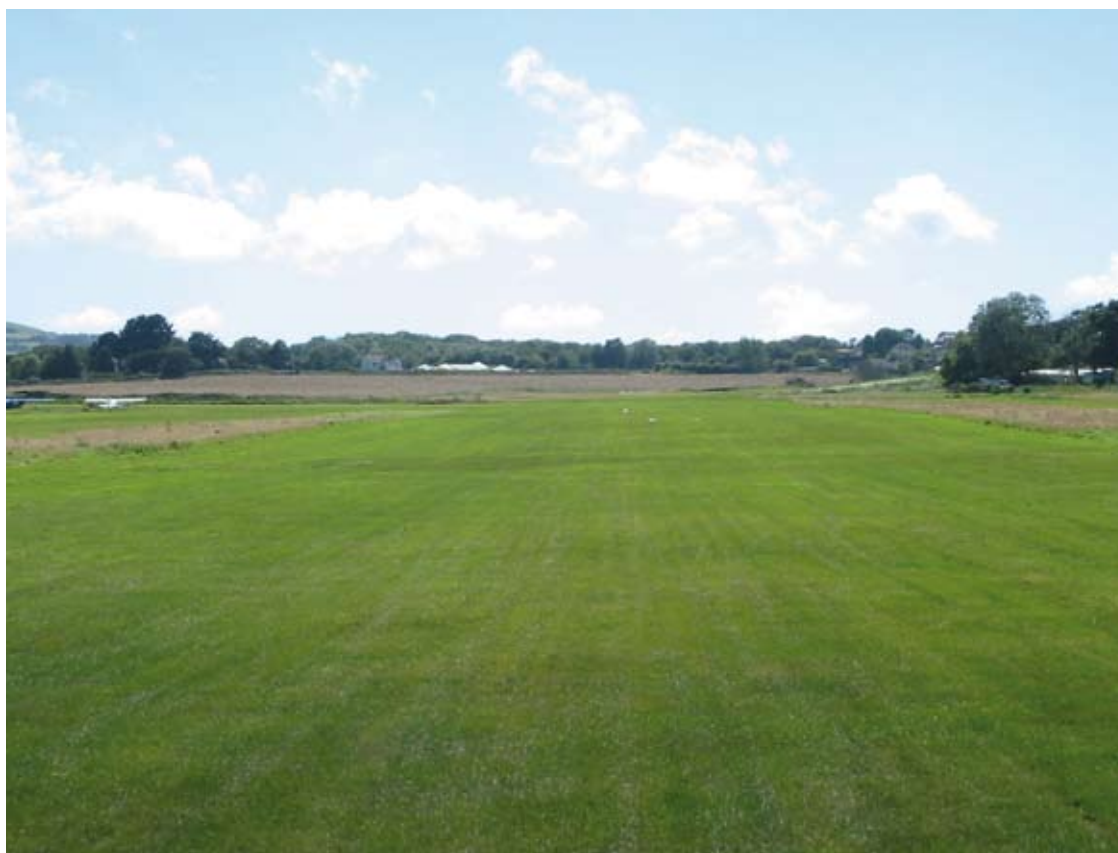
**Figure 4**

Photographs of Runway 23 looking south-west

It is recommended that the Isle of Wight/Sandown Airport aerodrome licence holder installs an additional, suitably located wind sleeve within the appropriate distance from the threshold of Runway 23, in accordance with the advice contained in CAP 168.
