ACCIDENT

| Aircraft Type and Registration: | HK36 TC Super Dimona, G-FMKA | |
| Location: | Near Brimslade Farm, Wiltshire | |

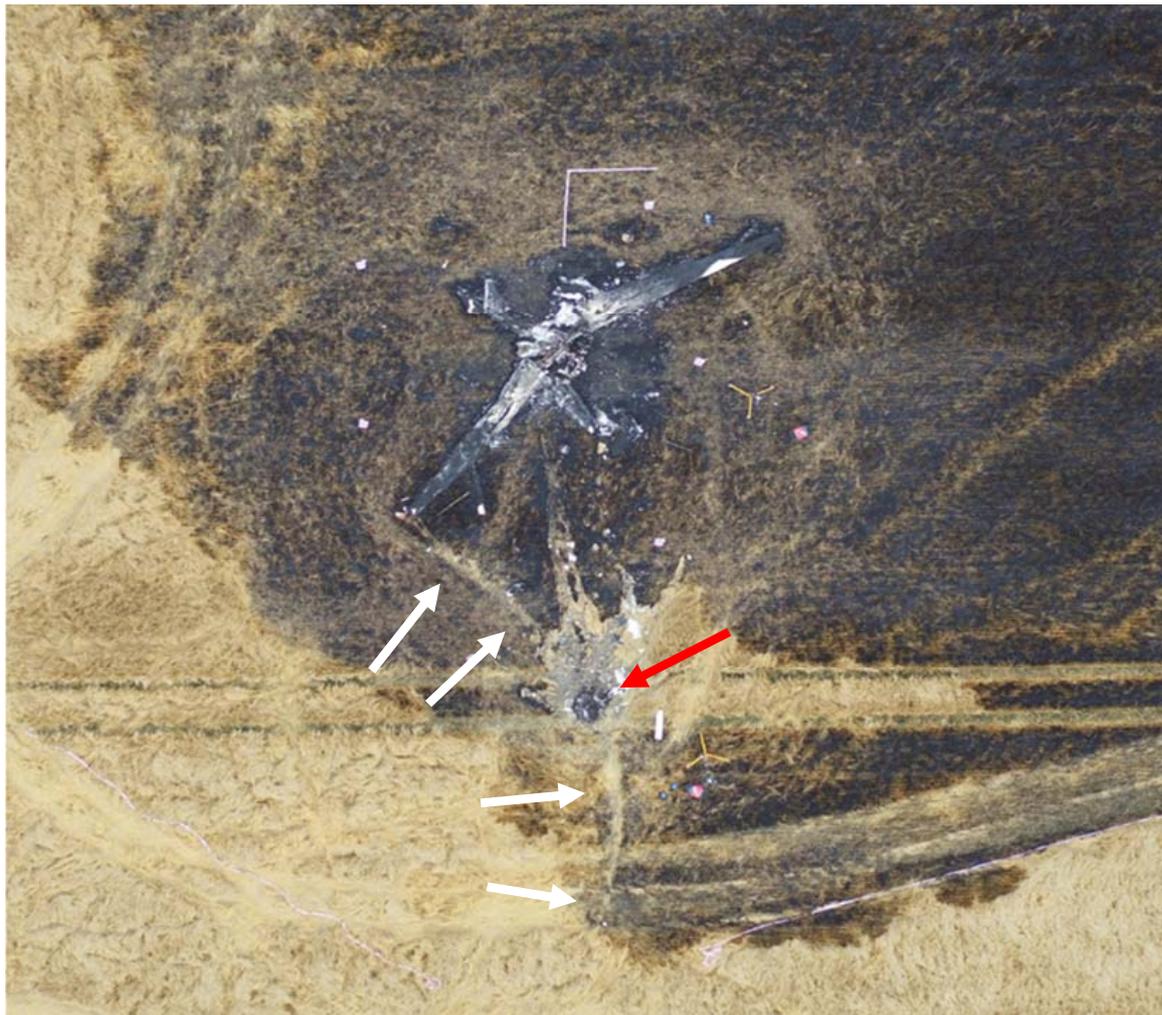
Figure 2

An aerial survey of the accident site (Figure 2) was carried out using the AAIB's camera-equipped drone. This revealed impact markings created by the leading edges of the wings which formed symmetrical arcs centred at the point where the engine was buried. The pronounced curvature of the arcs indicated that the wings were experiencing considerable upwards bending at the point of impact. Measurements of the wing deflection were supplied to the aircraft manufacturer for analysis.

According to the analysis by the aircraft manufacturer, to produce the degree of upwards wing bending indicated by the ground impact marks, the aircraft would have to have been subjected to a positive acceleration approaching 9 g.

It was the aircraft manufacturer's opinion that such loads could not be achieved without an elevator control input.

Aerial photo of accident site
(white arrows indicated curved impact marks from wing leading edges;
red arrow indicates engine impact location)

The vertical nature of the flight path of the aircraft at impact, coupled with the elevator input required to create the 9 g impression in the ground, is consistent with the aircraft having been beyond the vertical shortly before ground contact.
