Air Accident Investigation Sector

- Final Report -

AAIS Case N° AIFN/0007/2019

Wake Turbulence Induced Loss of Control on Approach during Runway Lighting Calibration Flight

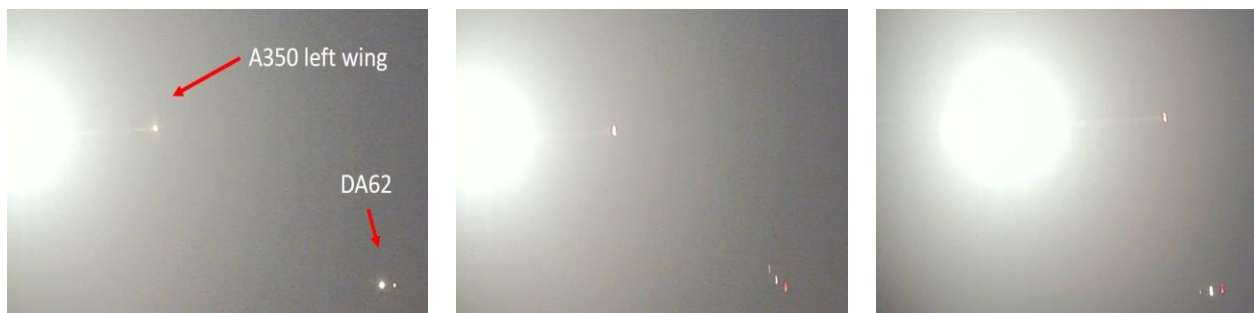
When the DA62 turned onto the approach, it levelled off at an altitude of 1,300 feet (ft) above mean sea level (AMSL) and an airspeed of 120 knots (kt). The airport runway approach camera captured the DA62 rolling dynamically to the left shortly after completing the turn. The DA62 lost approximately 100 ft in altitude, but was recovered after nine seconds (figure 1).

Figure 1. First upset and recovery as captured by the runway approach camera

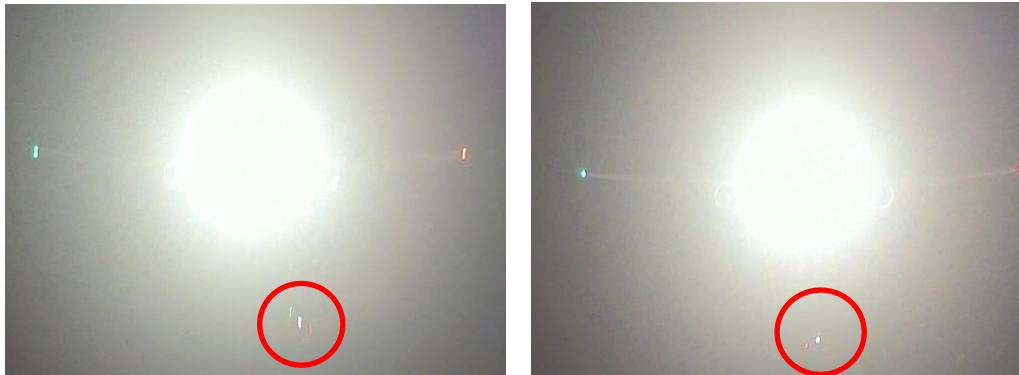
Seven seconds later, the DA62 rolled abruptly to the left until it became inverted and then entered into a steep dive (figure 2). The DA62 impacted the ground approximately 3.5 nm inbound from the threshold of runway 30L. The impact was not visible to the runway approach camera.

Figure 2. Second DA62 upset and roll into an inverted position following the A350

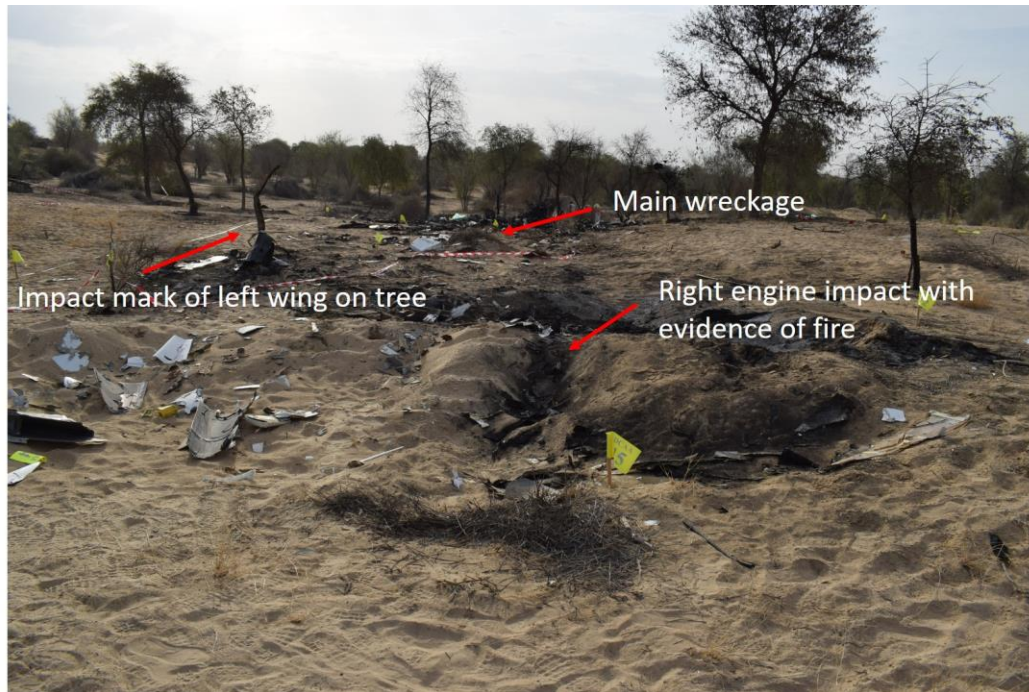
Ground scars and damage to a nearby tree indicated that the Aircraft impacted the terrain at high speed, 24 degrees nose down, 30 degrees right wing down, and on a heading of approximately 100 degrees.

A small tree, located beyond the first impact point, exhibited marks of contact with the left wing. The left wing wiring conduit was found attached to the tree and provided an estimated wing impact location (figure 6).

Figure 6. The initial impact point ground scars

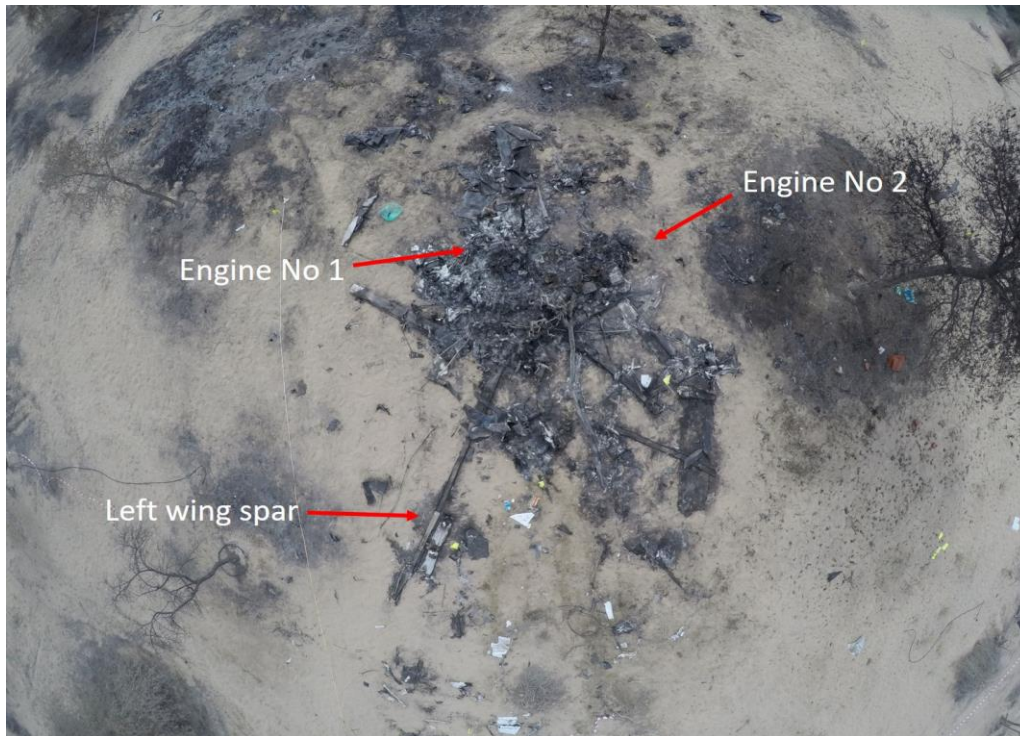
The Aircraft was totally destroyed by impact forces and the post-impact fire. The GFRP and CFRP fuselage and wing structures were consumed by fire. The engines, landing gear, fuel tanks, nose bay avionics rack, and some other unidentified pieces were found in the main wreckage (figure 7).

Figure 7. The main wreckage at the second impact point

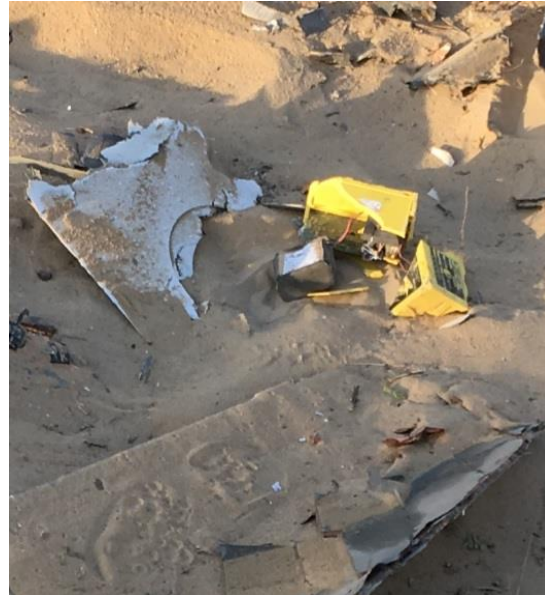
The Investigation found that the ELT had been destroyed by the impact forces, and that the antenna and electrical cables were severed from the unit (figure 8b).

Figure 8b. ELT as found at the Accident site

The AAIS finally recommended that Transport Canada, as the state of certification and design, review the emergency locator transmitter system installation on the DA62 to improve the crashworthiness of the system, and consequently, the survivability of the occupants in the case of an accident.

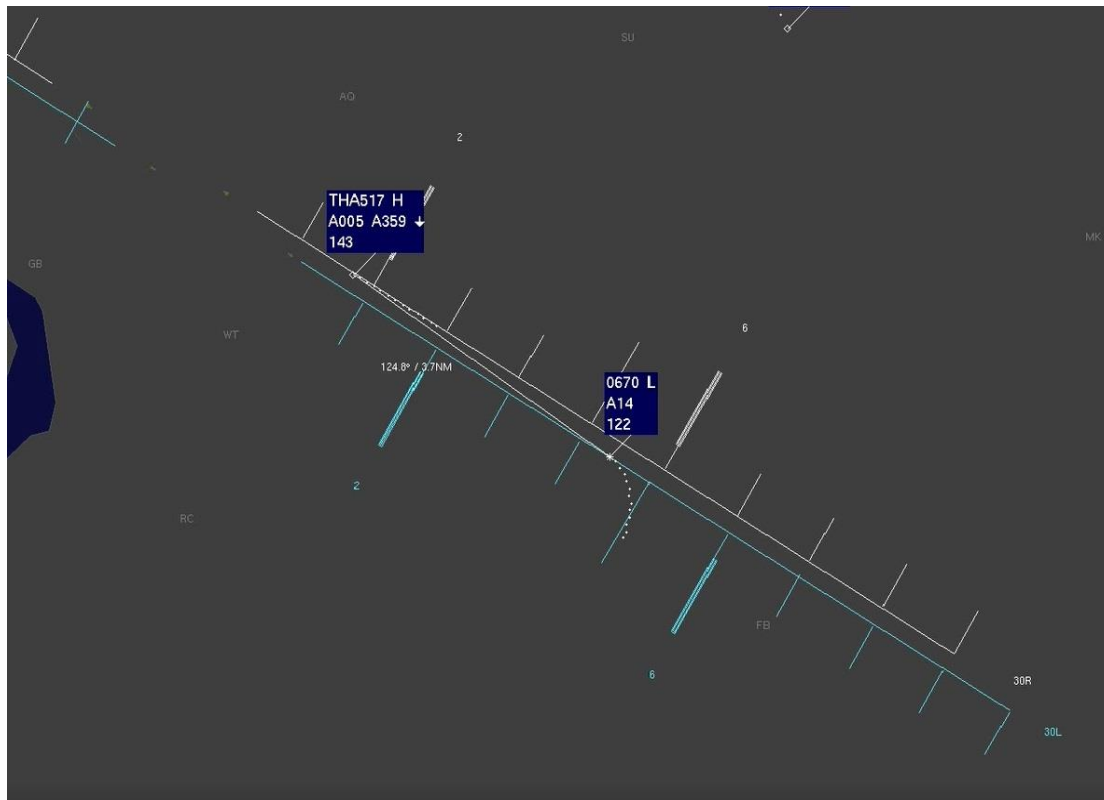
On the approach during which the Accident occurred, a preceding A350 was on Final to runway 30R. The DA62 followed the A350 at a distance of 3.7 nm, approximately 5.5 nm inbound to runway 30L, and entered the approach at an altitude of 1,300 to 1,400 ft AMSL. The A350 had passed through this location on the parallel approach path at an altitude of 1,500 to 1,600 ft AMSL, 90 seconds earlier (figure 11).

Figure 11. Aircraft approach to runway 30L following Airbus A350-900

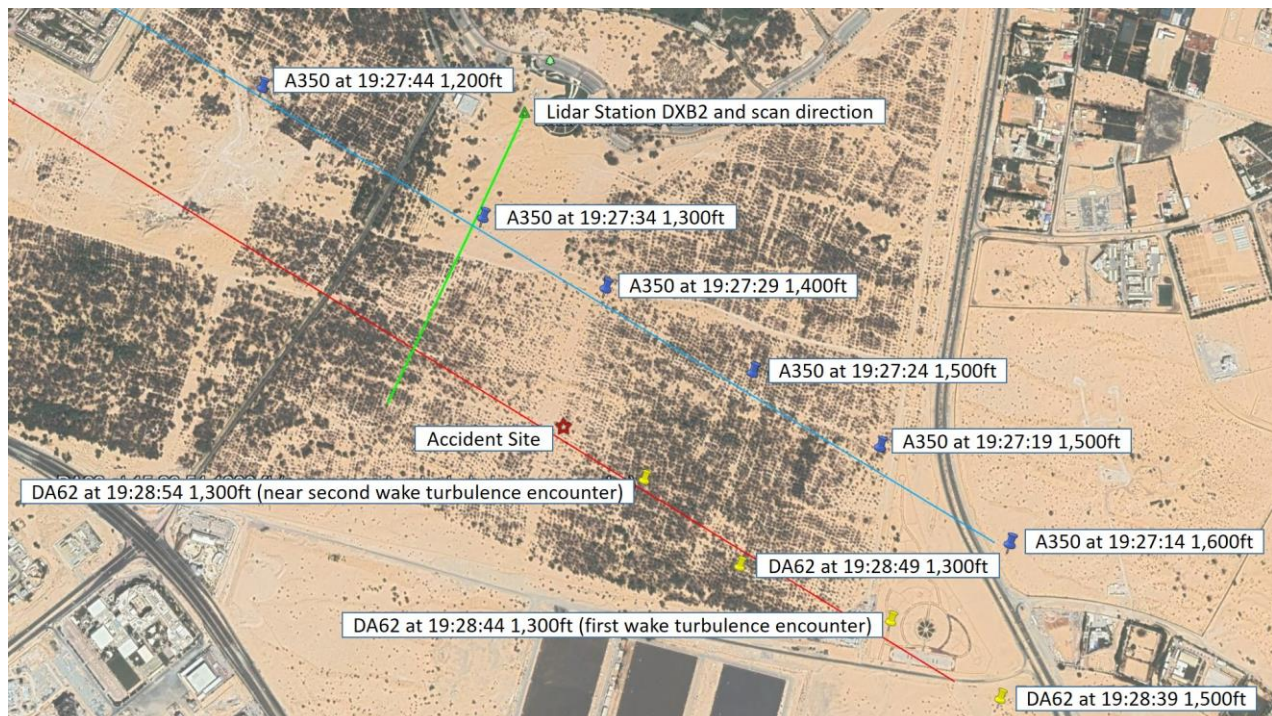
The A350 was recorded by DXB2 at approximately 1927:24 at an altitude of 1,500 ft AMSL on the approach path to runway 30R, perpendicular to the location of the abrupt roll and steep dive of the DA62 at approximately 1928:54 at 1,300 ft AMSL, as shown in figure 17.

Figure 17. LIDAR station DXB2 scan range and aircraft locations

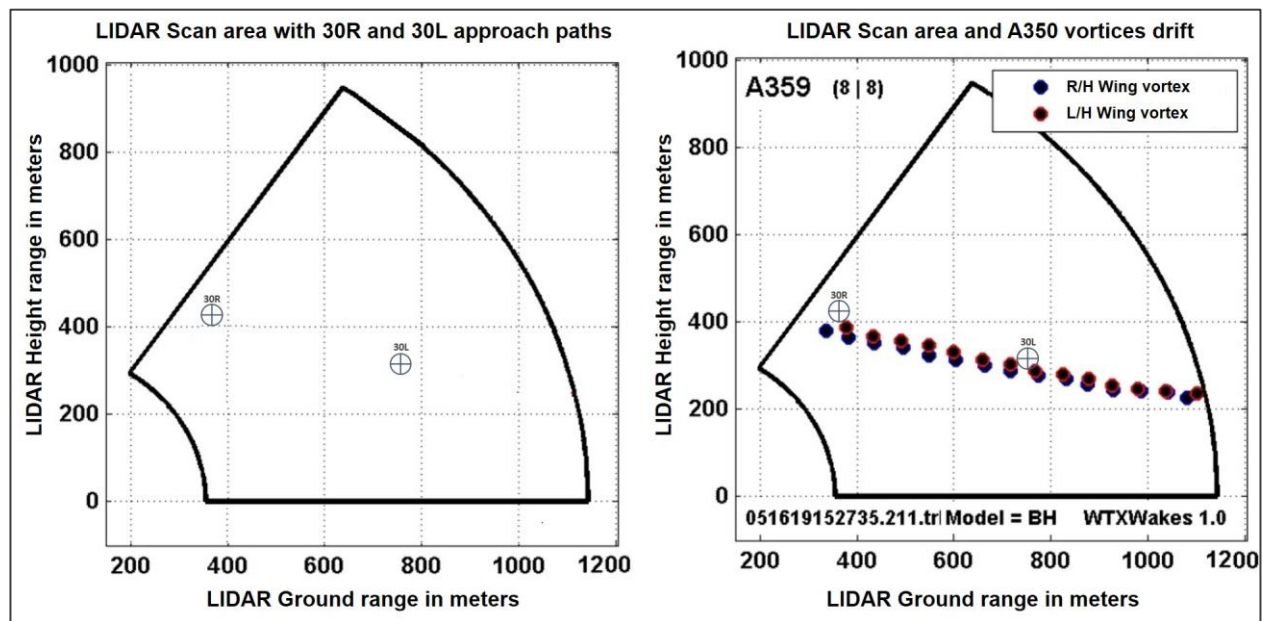
of the A350. The figure illustrates the drift rates of the vortices towards the runway 30L approach path and the vortices locations at the time of the second sudden roll upset of the DA62.

The Investigation determined that the core of the left wing vortex had passed through the approach path of the DA62 at a height of approximately 289 m (948 ft). The right wing vortex followed at a height of 287 m (942 ft).

Figure 18. LIDAR ground range and A350 generated vortices [Source: dans]

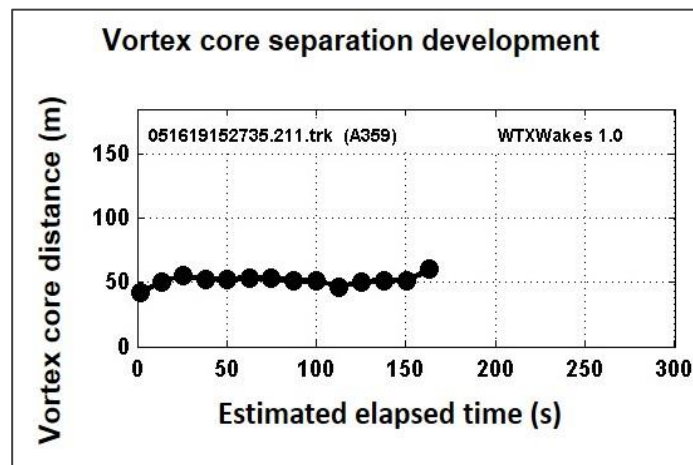
Figure 19 identifies that the vortices remained at a similar parallel distance of approximately 50 m apart for 150 seconds.

Figure 19. A350 wake vortices drift [Source: dans]

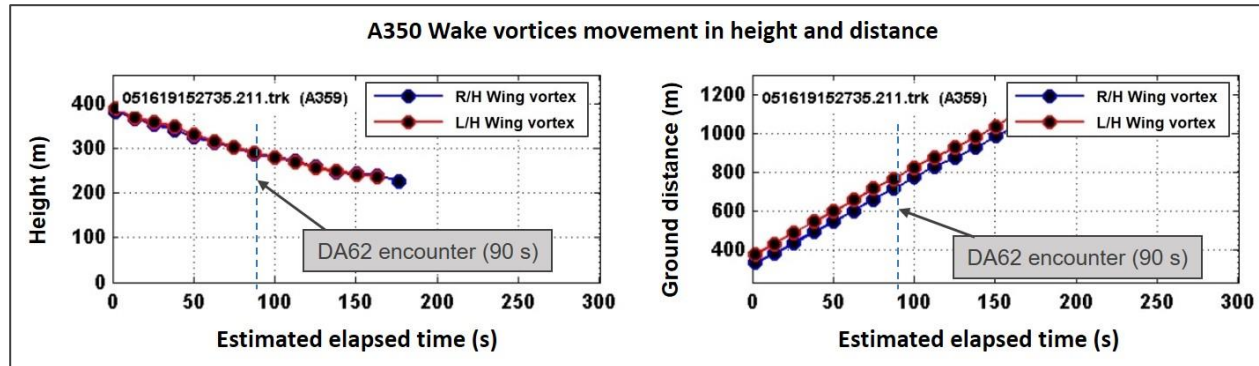
Figure 20 illustrates the wake vortices and the vertical and horizontal drift. The left and right wing vortices drifted to the left with a speed of 4.6 m/s and 4.4 m/s respectively, and reached the runway 30L approach path after approximately 74 and 87 seconds.

The left wing vortex descended at a rate of 1.08 m/s and moved into the approach path to runway 30L with a speed of 4.56 m/s. The right wing vortex reached a sink rate of 1.16 m/s and a drift speed of 4.44 m/s to the left.

Figure 20. A350 wake vortices drift [Source: dans]

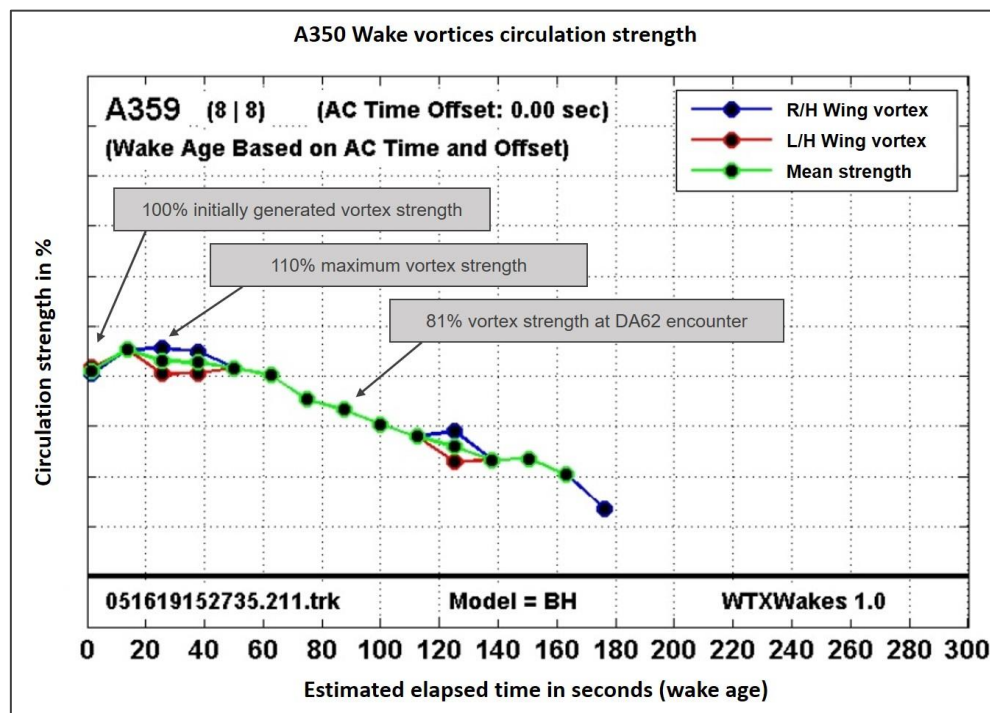
Figure 21 represents the wake vortex circulation strength and progress. It illustrates that both vortices were generated with the same vortex circulation strength. However, the strength of the left vortex increased to a maximum of 108% after approximately 13 seconds, while the right vortex strength increased to a maximum of 110% after approximately 26 seconds.

Both vortices degraded to 81% after 90 seconds when the DA62 followed at an altitude of 1,300 ft AMSL on the runway 30L approach path.

Figure 21. A350 Generated vortices and at time of DA62 encounter [Source: dans]

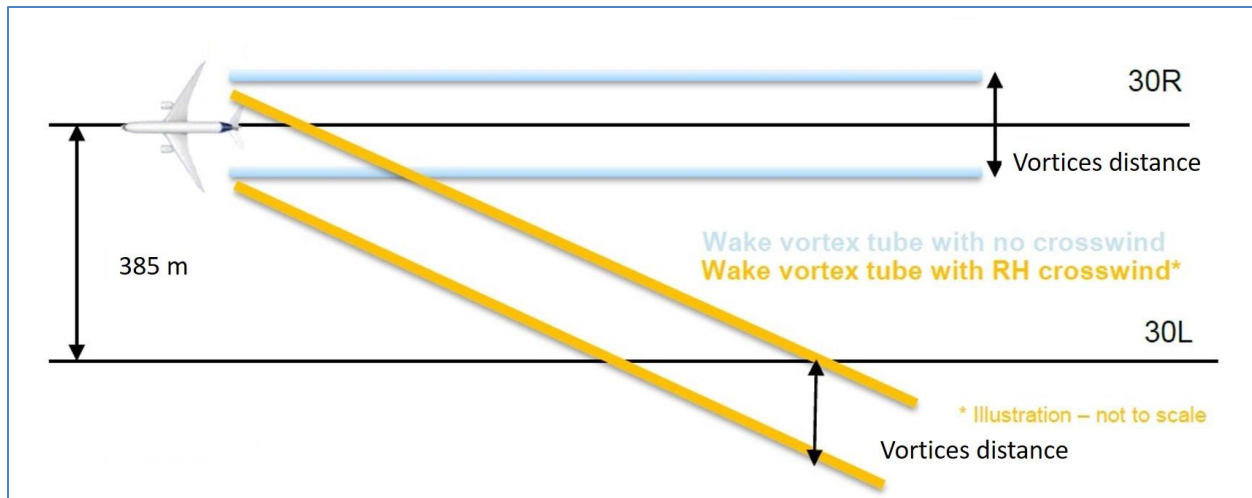
The Airbus report confirmed that “the estimated characteristic of wake vortex generated by [the preceding] A350 are consistent with a rate of decent enabling wake vortex to descent [descend] to the vicinity of the RWY 30L 3° glideslope height taking into account the parallel approaches configuration, the 4D trajectories (time, latitude, longitude, altitude) of both aircraft”, and the on-board wind computation from A350 navigation system. (Figure 23)

Figure 23. Representation of A350 generated vortices and drift [Source: Airbus Industries]
