ACCIDENT

Aircraft Type and Registration:	Pitts S-2A Pitts Special, G-ODDS	
No & Type of Engines:	1 Lycoming AEIO-360-A1E piston engine	
Year of Manufacture:	1980 (Serial no: 2225)	
Date & Time (UTC):	24 August 2019 at 1304 hrs	
Location:	Stonor, Oxfordshire	
Type of Flight:	Training	
Persons on Board:	Crew - 2	Passengers - None
Injuries:	Crew - 2 (Fatal)	Passengers - N/A
Nature of Damage:	Aircraft destroyed	
Commander's Licence:	Private Pilot's Licence (Class Rating Instructor)	
Commander's Age:	35 years	
Commander's Flying Experience:	Approximately 710 hours (of which about 172 hours were on type) Last 90 days - 35 hours Last 28 days - 12 hours	
Student's Flying Experience:	197 hours (of which 1 hour 25 minutes were on type) Last 90 days - 34 hours Last 28 days - 8 hours	
Information Source:	AAIB Field Investigation

Synopsis

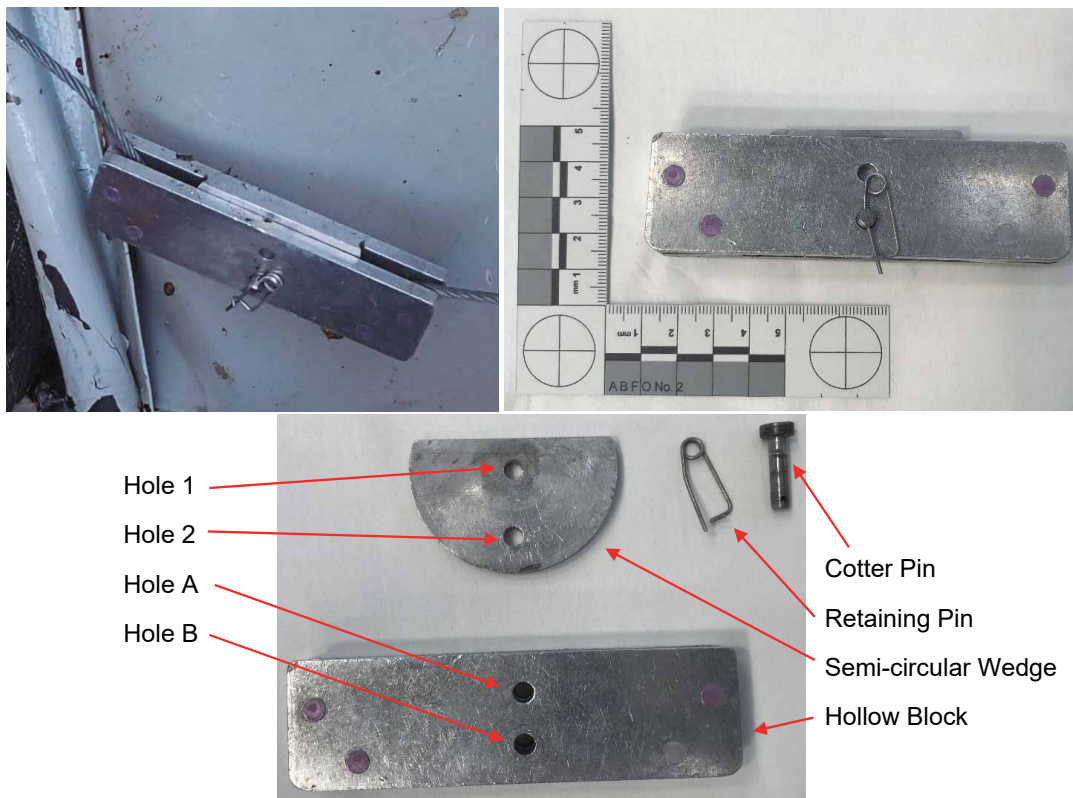
Figure 7

During the initial examination of the aircraft at the accident site it was noted that there were four unidentified devices fitted onto the rudder cables. They were left in place for further examination at the AAIB facilities. A device was fitted on each of the cables between the forward and rear rudder pedals and on the cables aft of the rear rudder pedals. After removal, it could be seen that each device constituted an aluminium block, aluminium semi-circular wedge, steel cotter pin and steel retaining pin (Figure 7) with the forward devices a matching pair and the aft pair matching. Each pair was similar in construction and design however there were some minor dimensional differences.

Rudder cable device shown in situ, removed for examination and constituent parts

When fitted, they effectively shorten the cable by diverting it around the semi-circular wedge. In the block and the wedge, are two cotter pin holes (Figure 7) that make it possible to install the devices in different configurations. Each configuration will shorten the cable by a different amount. Table 1 shows some of the configurations and the effect they had on the rudder pedal neutral position, in terms of movement towards the seat. The aircraft was in configuration B2+B2 for the accident flight.

The fitting of such devices should be an EASA approved modification so that their operation and effects can be tested and documented. The investigation was unable to locate any approval for a modification to fit these devices. It was noted during a maintenance check that the devices, which were fitted at the time, restricted the rudder travel by 3° (10% of travel).

Unapproved devices, which adjusted the rudder pedal positions, were found on the rudder cables but were unlikely to have impeded the recovery from the spin.

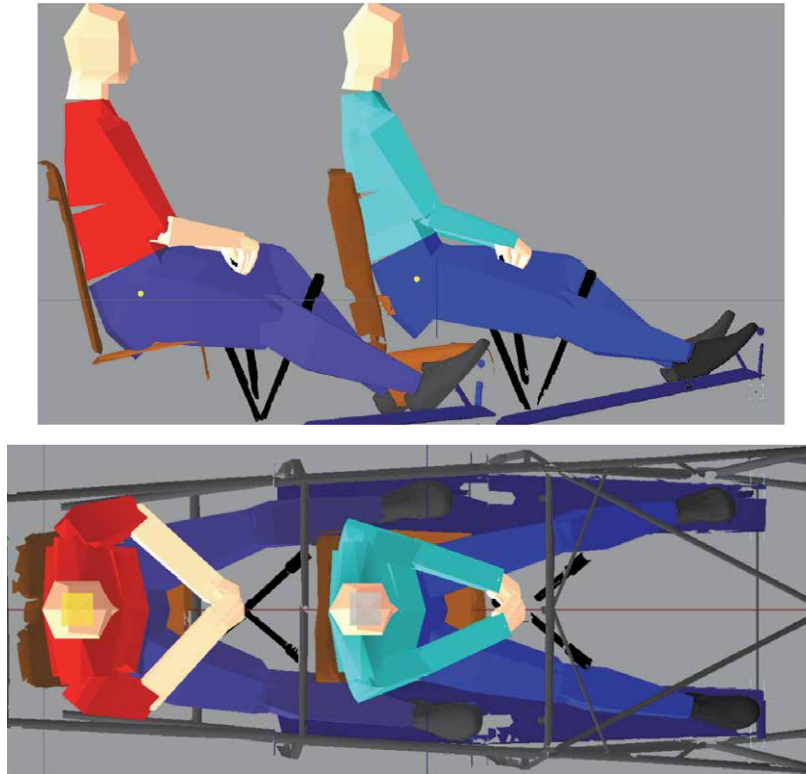
Figure 14

Right rudder pedals full forward without the devices fitted
(brake pedals omitted for clarity)

The assessment showed that the commander was unlikely to have been able to move the pedal to this position because the leg is fully extended with only the tip of the toes in contact with the pedal. The student was likely to have had better foot contact on the pedal and the leg is only slightly bent, but this position may have been uncomfortable due to the additional seat cushions digging into the thigh and the front seat back on the inside of the calves. The assessment showed that the receding pedal position was unlikely to pose a problem for either pilot to exert the force necessary to return the rudder to the neutral position.

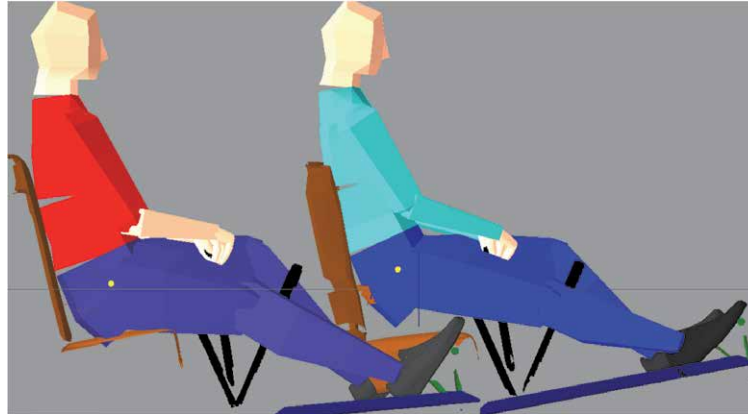
Figure 15

With the devices fitted as they were on the accident flight (Figure 15), the assessment showed that the commander would be able to reach the extreme of pedal travel more easily. Full extension of their leg was still required but instead of the toe, the ball of their foot would likely have been on the pedal affording more control.

Right rudder pedals fully forward with the devices fitted
(brake pedals omitted for clarity)

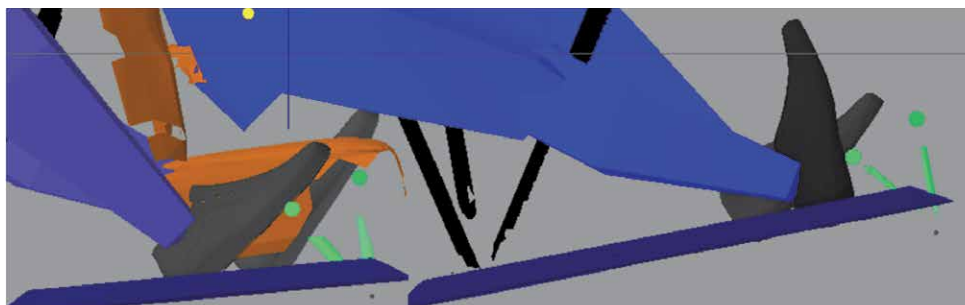
Figure 16

Digital modelling and practical assessment of this scenario was made using the SAMMIE tool and an exemplar aircraft and it was found that it was possible to apply the required rudder input even against a 'locked' straight leg. The commander's joint mobility was explored via digital modelling (Figure 16) and although the ankle is nearing the limits of extreme movement, it is possible for full opposite rudder to be applied. Typically, an external force would be required to extend the ankle to this position but a further 6° of extension is possible in the extreme range.

Commander ankle movement with full opposite rudder
(brake pedals omitted for clarity)
