The latest LAA Engineering topics and investigations. By Malcolm McBride

Safety Spot

Malcolm McBride takes a look at degradation, be it rubber pipes or propellers

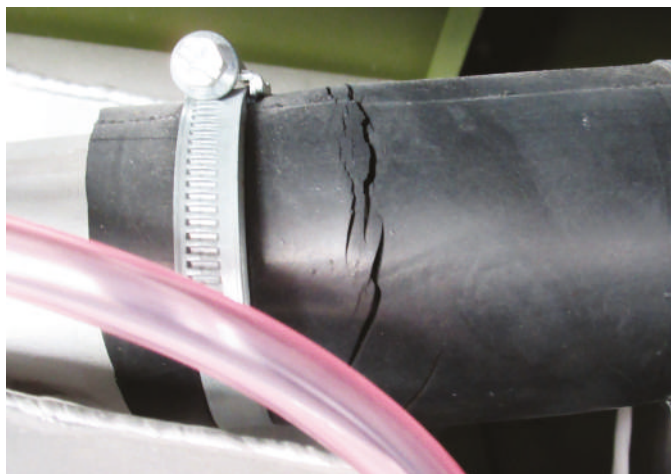
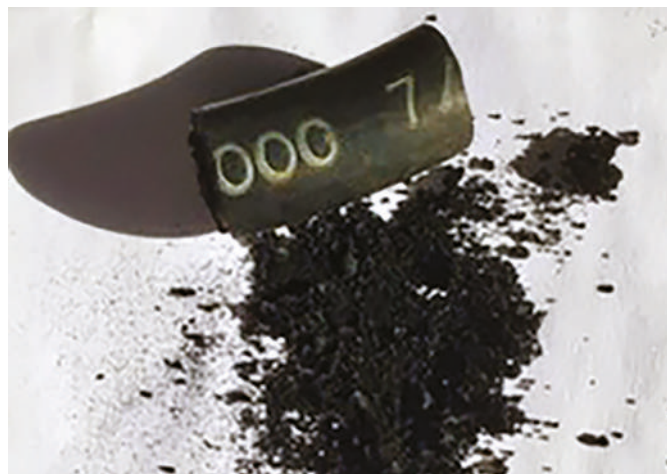
Above Two pictures with similar stories – the passing of time degrades most materials. We showed you the picture of the EV-97 fuel filler pipe (left) last month and there's an update about this issue in the main text. And I've been itching to show you the picture (right) of internal fuel pipe degradation. LAA Inspector Dr. Bill Brooks sent it a while back now – he wasn't sure why he appeared to be getting a poor fuel flow until he disconnected the fuel pipe to find that the inner surface of the pipe had completely disintegrated. **Photos: Martin Child/Bill Brooks**

to check the fuel filler hoses on their aircraft as soon as practicably possible, and then every year at the annual. You'll see from the pictures that at least two members have done this, and both have found that the fuel filler pipes on their aircraft remain in 'mint' condition, despite being pretty old. More importantly, their fuel filler pipes are clearly much higher quality components that are clearly marked-up as fuel pipes.

Looking at the issue with this new viewpoint in mind, we've adjusted the annual check requirements accordingly and re-issued the AIL. You can find the updated version in the 'Alerts' page within the Engineering section of our website.

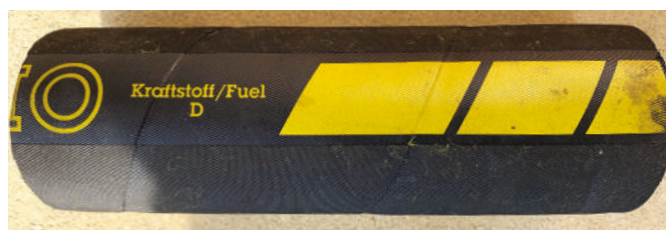
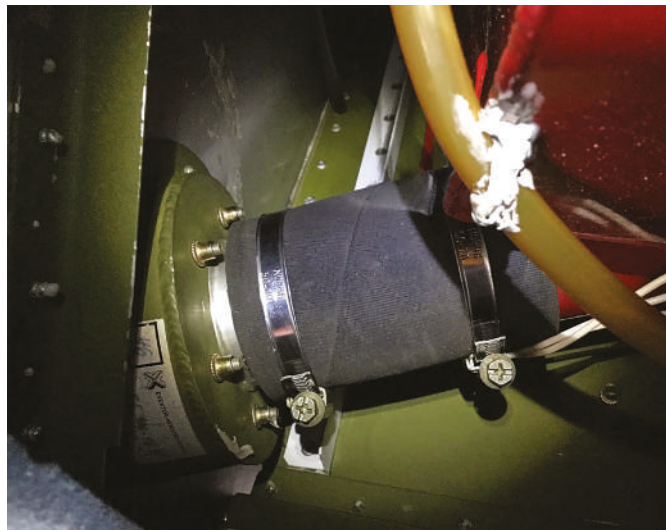
Above Having asked all EV-97 Eurostar owners to take a look at the fuel filler pipes on their aircraft, some owners have now done so, although because of COVID-19 restrictions we're expecting further feedback later in the year. Thus far it's clear that there's a wide variance in the original quality of this part – somebody suggested that the failed part we showed looked more like a component from a washing machine and not something that should have been in an aircraft's fuel system. Because of this variation (and one or two other points) we've 'up-issued' the AIL we published on the matter.

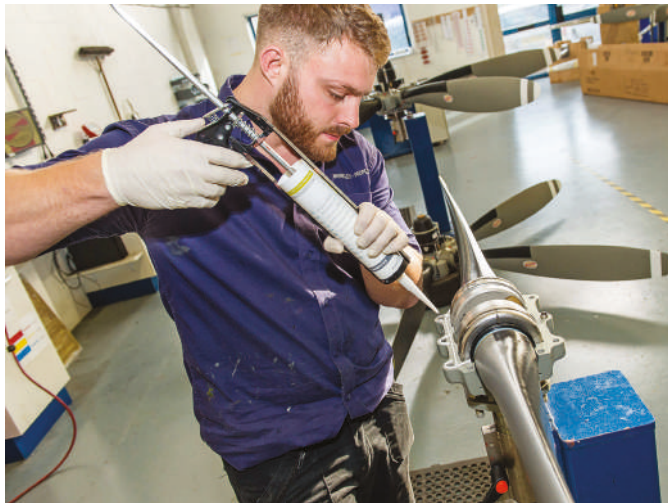
Above An LPIP inspection takes into account that a propeller that hasn't completed many hours will not need specific checks related to wear and fatigue, so there's not a requirement to strip the coatings from blades or carry out expensive non-destructive testing.
Photo: Ed Hicks

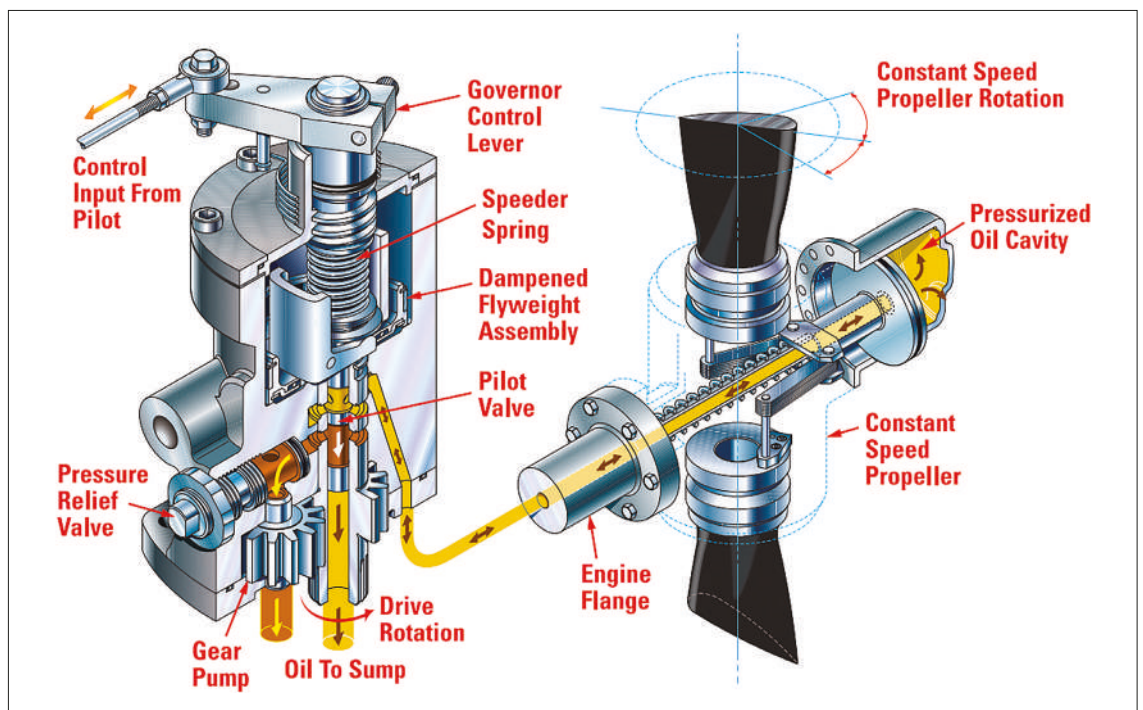
Right LAA Engineering has issued a TL describing more fully the Low-Hours Propeller Inspection Protocol (LPIP). We have been trialling this alternative inspection protocol for a couple of years now, and we're very happy with the feedback that we've received. The picture shows the basic mechanics of a pressurised-oil variable pitch propeller system.
Photo: Hoffman Propellers

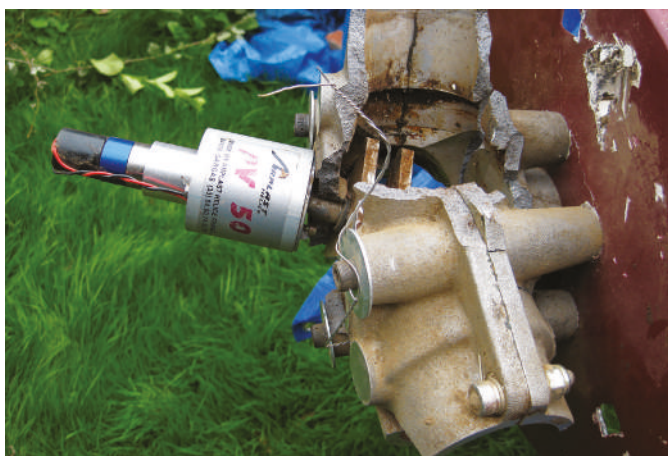
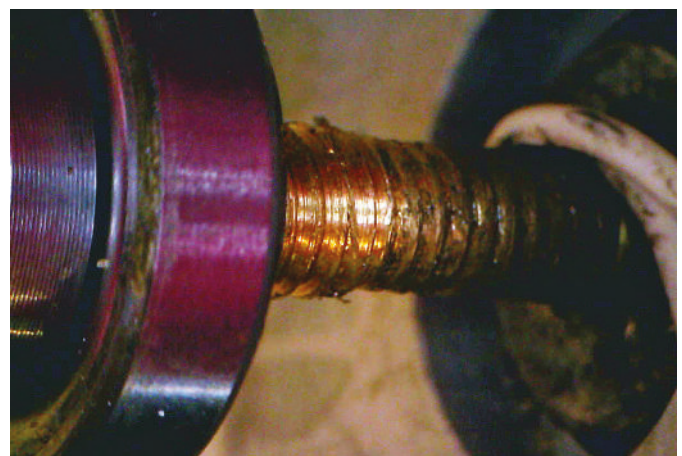
Above In 2007, the pilot of a Europa suffered a loss of propeller thrust shortly after take-off, and in 2018, the pilot of a Kitfox Mk. 7 lost propeller thrust whilst at altitude. Both aircraft were substantially damaged during the following forced landing. In both cases, the initial cause of the propeller pitch mechanism failing was found to be a 'stripped' leadscrew. **Photos: Malcolm McBride/ Alan Bray**

In 2007 the pilot of a Europa suffered a loss of propeller thrust shortly after take-off. The cause was found to be a failed leadscrew (the threaded shaft that drives the pitch change mechanism). The pictures show a more recent example where the lead screw's thread has stripped, most likely through lack of lubrication. Under normal circumstances, the position of an electrical fine pitch stop determines the minimum pitch angle for the propeller, this is normally a microswitch designed to isolate the motor when contacted. In the case of an electrical or mechanical failure, the fully fine position is determined by a back-stop device known as the mechanical fine pitch stop. In this instance thrust was lost because the mechanical fine pitch stop had not been correctly adjusted.

Following this incident, an Airworthiness Information Leaflet (AIL) (MOD/PROP/08-007 Issue 1) was issued requiring that the leadscrew be inspected and lubricated at 25-hour intervals. To be certain that the mechanical fine pitch stop could do its job when required, we asked that the position of this be checked - this initial check was done by measurement against a manufacturer's drawing.

In light of this latest incident, we've reissued the original Airworthiness Information Leaflet, so LAA/MOD/PROP/08-007 has been raised to issue 2. This latest issue reaffirms the importance of the 25-hour lead screw inspection/lubrication requirement and introduces a one-time

check to ensure that when the propeller is operating against the mechanical fine pitch stop with the electrical side of the mechanism disabled. The resulting minimum pitch angle must be sufficient to hold the engine rpm within manufacturer's limits – thus ensuring that a positive climb can be achieved should a lead screw fail during flight.

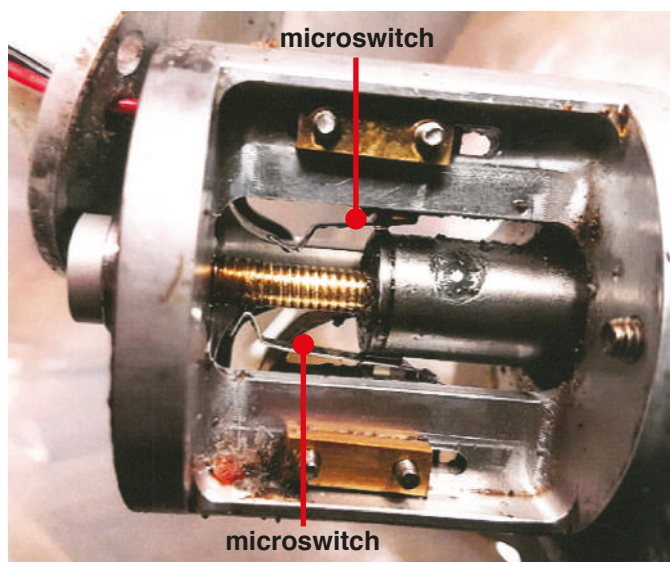
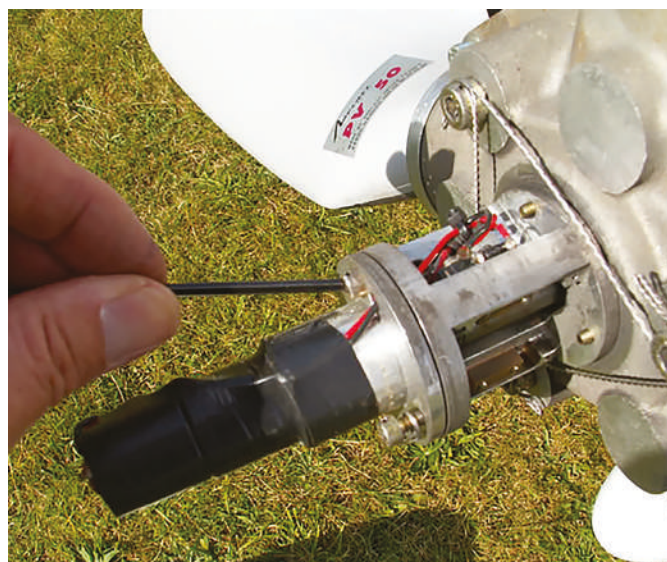
Above Though the initial cause of the propeller returning to fine pitch was the failure of the leadscrew, the reason why a forced landing became necessary was that the mechanical fine pitch stop wasn't correctly set. Under normal circumstances, the position of the electrical fine pitch stop determines the minimum pitch angle for the propeller (see microswitches in the picture on the left). In the case of an electrical or mechanical failure, the fully fine position is determined by the mechanical fine pitch stop. The picture on the right shows that it's easy to temporarily remove the electric motor to gain access to the leadscrew and mechanical fine pitch stop. A recent Airworthiness Information Leaflet requires owners to check that the mechanical fine pitch stop is correctly adjusted. **Photos: Alan Bray/ Arplast Propellers**

important that the mechanical fine pitch stop is correctly adjusted. Experience has shown that this needs to be tested by ground running the engine with the propeller at its minimum pitch angle as defined by the stop. This stop will, naturally, be set just aft of the electrical microswitch which, in normal service, will set the minimum pitch available.

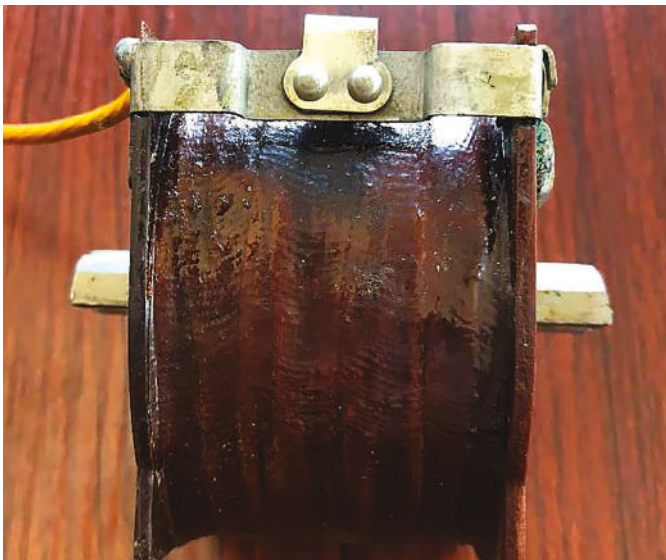
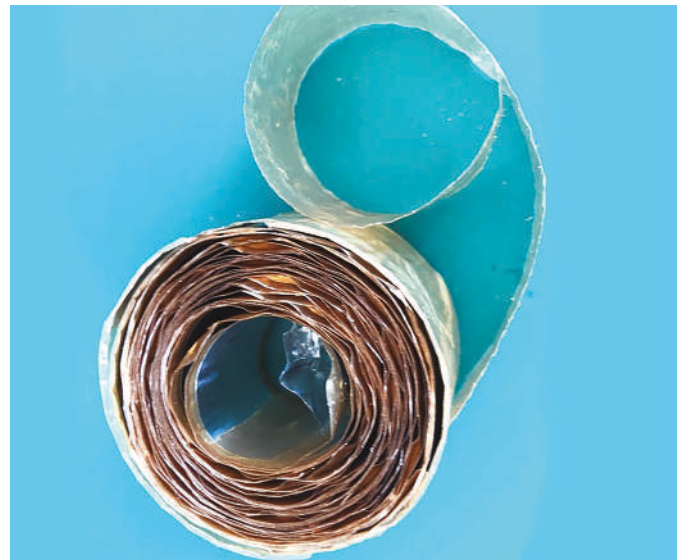
1.3 Whilst investigations are ongoing, there appeared in this particular case to be an issue of magneto coils breaking down during flights of longer duration (in this case ferries, as opposed to short aerobatic sorties). The failure mode that triggered the event that featured in the occurrence report was replicated during bench testing. Given the age and relatively large numbers of this engine type in service, it seems unlikely to have been the first such instance of this problem, but due to the differences in approach to type approval and associated reporting criteria between the originating states and the current EASA/CAA model, reliable data is expected to be difficult to obtain.

Above The picture on the left shows the high-tension coil from a magneto off a Russian-made M14P – one of the most successful small radial aircraft engines built and which is recognised for its reliability and durability. However, its ignition system is particularly susceptible to the influence of aging. The insulation on the coil in the left picture is breaking down when the coil becomes hot – notice the burning due to arcing at the top of the coil. The picture on the right shows the plastic foil-type capacitor, which has also failed. **Photo: AutoYongChen**

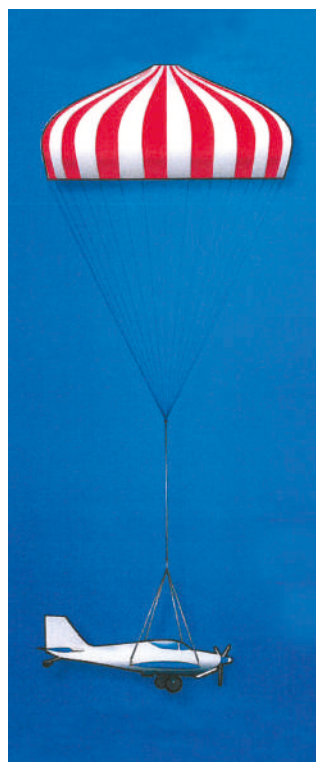
Left Different views abound about the wisdom of fitting explosive safety devices to amateur-built aircraft but I'm sure all pilots would agree that the safety of first responders to an accident or incident, involving an aircraft fitted with BPRS, is of paramount importance. Though many have expressed a view that placarding an aircraft 'spoils' its appearance, it is absolutely vital that aircraft fitted with BPRS equipment are appropriately placarded. In the event of an accident or serious incident, it's only fair that those first on scene are able to take account of the associated risks involved in un-deployed ballistic parachute systems.

LAA Engineers have written a Technical Leaflet, TL 3.27, giving further advice on the fitment of placards to aircraft fitted with ballistic devices. All the TLs can be found in the Data Library in the on-line Engineering section of the LAA's website. And there's a link to this one in the Alerts section of the website.
