Safety Spot  
By Malcolm McBride

# LOW-HOURS PROPELLER INSPECTION PROTOCOL, AEROTECHNIK WHEELS & SPORTCRUISER NOSELEGS

The latest LAA Engineering topics and investigations

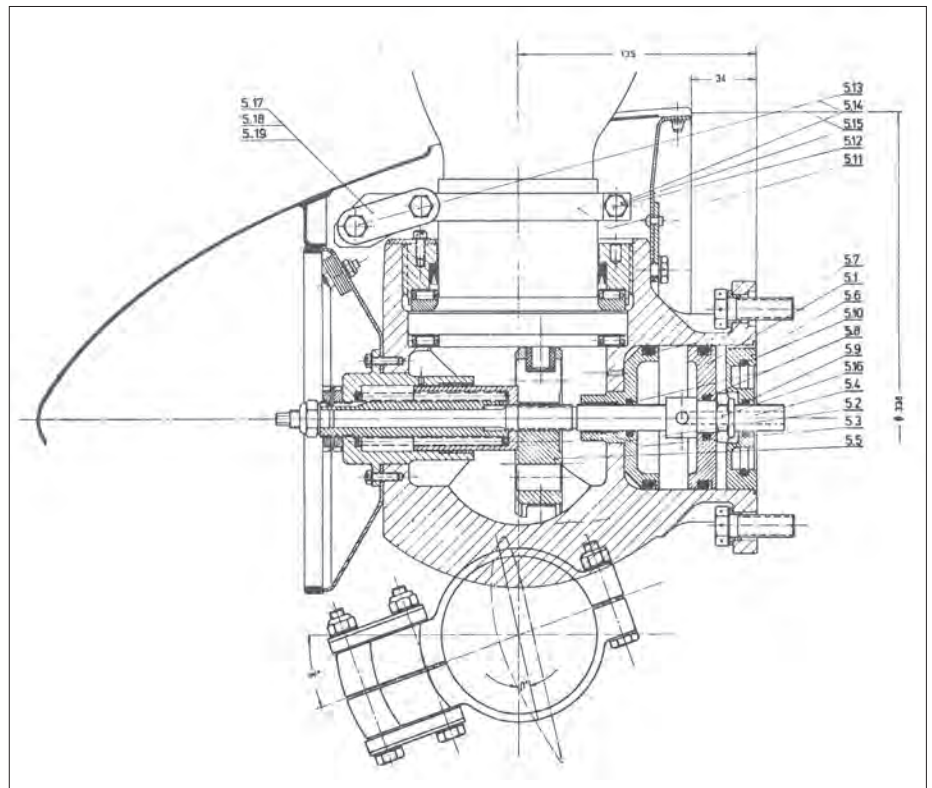
(Above) It's easy to forget that a propeller is one of the hardest-working devices on a sports aircraft. Every time you start the engine almost unimaginable forces travel through the components which go to make up the prop assembly, and that's why it's essential to follow manufacturer's inspection guidelines. Naturally, variable-pitch propellers are complicated devices and most of the working parts are hidden from view so the services of a professional 'prop shop' are needed to inspect it properly.

Manufacturers' overhaul requirements are driven by two basic realities: one, things wear out and, two, they degrade over time. Because LAA aircraft normally fly relatively few hours in the year, wear isn't normally an issue but degradation and the effects of corrosion can be. That's why LAA Engineering, after consultation with manufacturers, the CAA and commercial propeller shops, have introduced the Low-Hour Propeller Inspection Protocol (LPIP). With LPIP there's a limited inspection for wear, so no expensive NDT or blade strip. The focus of the inspection is to ensure that the 'innards' are all working correctly, the seals are replaced and any early signs of corrosion (which are often present) are dealt with before it has the chance to contribute to a hub failure. (Photo: LAA Library)

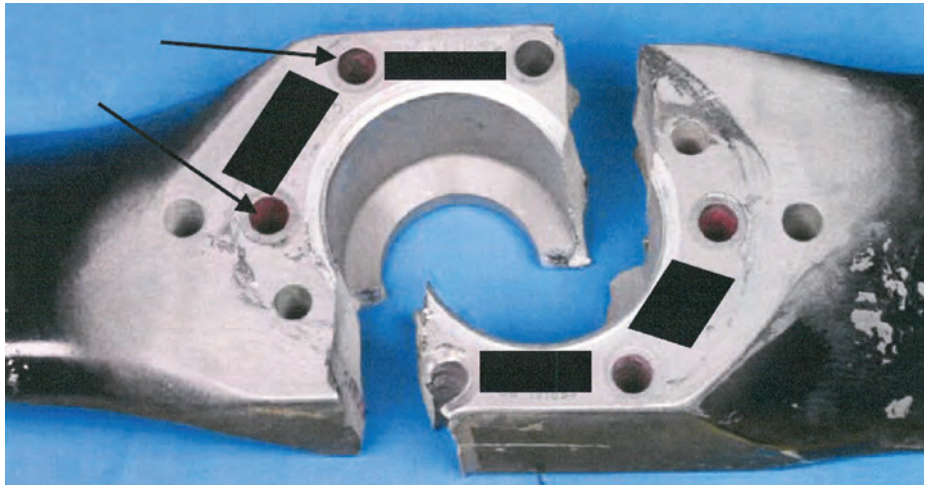
*(Top & above)* Although LPIP doesn't include fixed-pitch propellers, it doesn't mean that regular inspections aren't necessary, though they need to be appropriate for the actual prop type. This failed McCauley 1A170 propeller is a type similar to those fitted to quite a few LAA aircraft and, as you can see, it has suffered a catastrophic failure. Sadly, the failure occurred during a cross-country flight and the pilot and his passenger suffered serious 'life-changing' injuries after hitting trees during the ensuing forced landing.

There's a specific *Airworthiness Directive* requiring regular (every 200 hours) dye penetrant testing of these prop bosses. Though no LAA aircraft operate with this specific type, similar props are in service, so LAA Engineering is recommending that owners of all metal fixed-pitch propellers include a thorough visual inspection at each annual and consider removing the prop, perhaps every three years, to take a very close look at this critical component as part of their Tailored Maintenance Schedule. *(Photos: NTSB/FAA)*

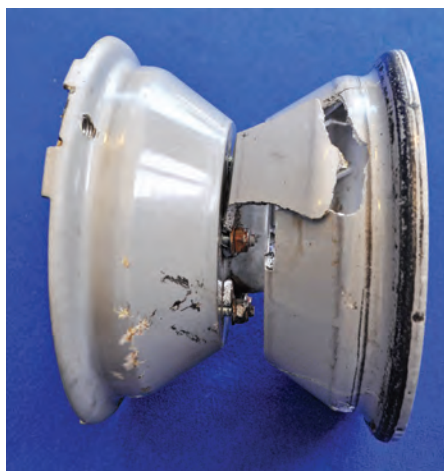
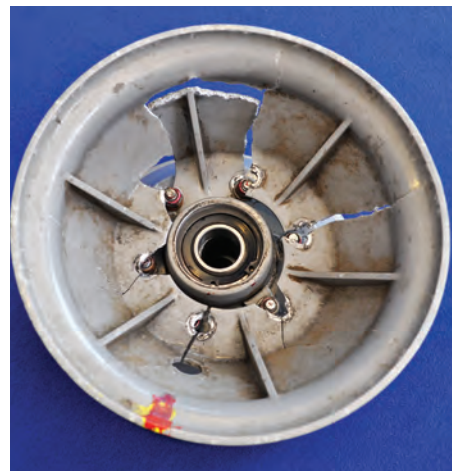
(Above left & right) A full inspection of the undercarriage assembly on an aircraft isn't complete until the wheel has been fully checked. Like the propeller mentioned earlier, these essential components are so reliable that they're often completely ignored during regular maintenance inspections. Again, just like the prop, they're one of the hardest-working components on an aircraft and fully deserve time taken to keep them in tip-top condition.

This wheel, from a EuroFOX tug aircraft, failed during taxi after launching a glider – you can see that the failure sequence has started because of cracks which have originated at the wheel-half bolt attachment holes. (Photos: Malcolm McBride)

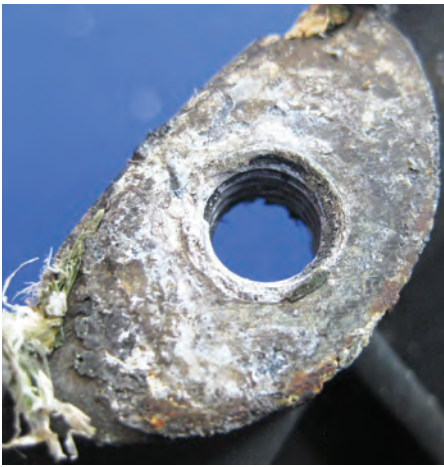
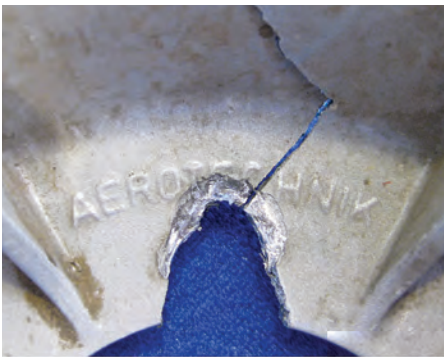
(Top & above) Initially, when we received the failed Aerotechnik wheel from a EuroFOX, I focused my attention on the failure point, the previously mentioned cracks. Then I received an email from LAA'er, Martyn Wilmington, detailing another failure, this time on an Aerotechnik wheel off an EV-97 EuroStar. In this later failure it looked like corrosion around the brake disk supports at the wheels rim, so I looked again at the EuroFOX wheel.

The uppermost picture shows the level of corrosion in this attachment, which was probably caused by dissimilar metals in close proximity. The picture above, meanwhile, shows the manufacturer's casting mark above a failed bolt hole.

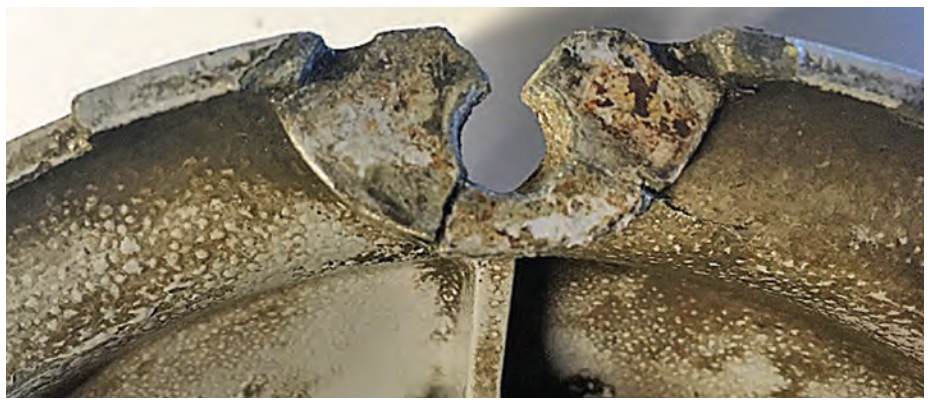
(Above) Here's what Martyn Wilmington found when he dismantled his wheel to fit new tyres. The failure of this attachment was most likely due to the electrolytic action because of the close proximity of steel (the brake disk attachment bolt) against aluminium alloy (the wheel half), aided and abetted no doubt by the various substances in the water splashed up during normal operation.

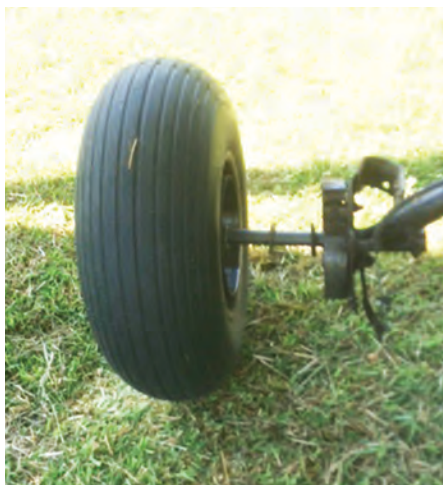
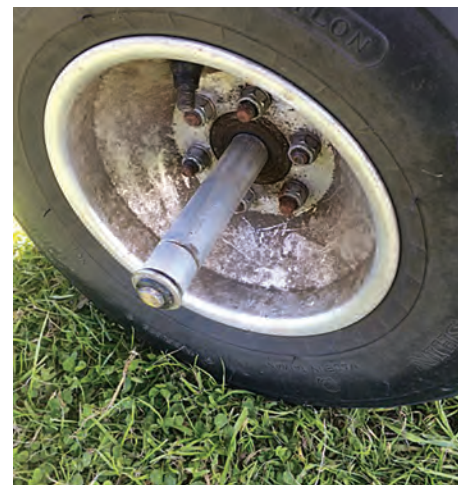
(Right) Just after a practice take-off, a student's instructor noticed that 'something didn't feel right'. After visually checking around the airframe, the student was horrified to see that the right mainwheel was just hanging onto its axle. The picture right shows the wheel after bringing the aircraft to a stop, while the one far right was shot after it'd been refitted, using all the required parts!

'On the left side both of these spacers were missing. On the right, both were still in place and the wheel hadn't moved.

'It appears that, when taking the spats off, a bolt was removed from the end of the axle. What wasn't obvious was that this bolt not only held the spat in place but was also essential for the security of the wheel. As such, it should've been replaced, along with a washer to retain both the wheel and the spacer.

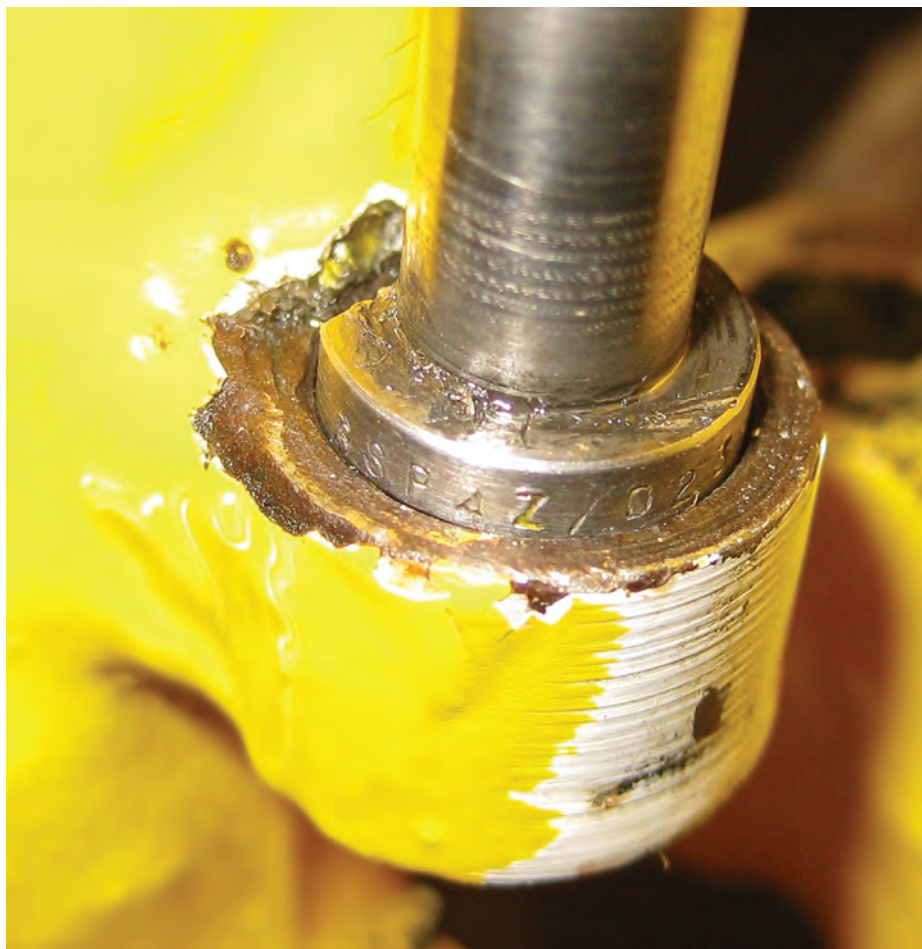
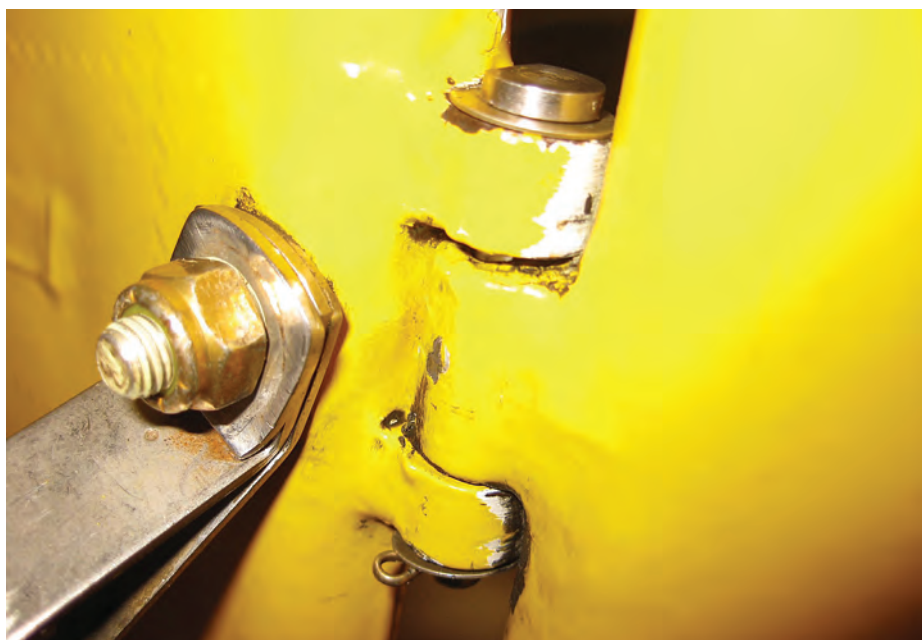
*(Top & above)* These two pictures serve to remind us about the need to recognise potential system failure modes on aircraft. That may sound a bit fanciful, but it's always worth thinking 'what if' when assembling any component part. Regular readers of *Safety Spot* will know that we've been highlighting a hinge failure which recently caused the partial detachment of a rudder on an early Piper Cub. Although this was the first record of an incident like this, it did highlight a previously un-spotted failure mode.

In the picture at top, note that the head of the hinge pin is smaller than the inside diameter of the knuckle, so the only thing holding the hinge assembly together is the friction in the interference fit of the inner bearing. Lose this friction, for any reason, and the hinge will fail. The picture above, meanwhile, shows a simple 'fix' – a thin washer fitted to the top and bottom of the pin – so, even if the bearing does become loose, the hinge pin cannot fall out. *(Photos: Malcolm McBride)*

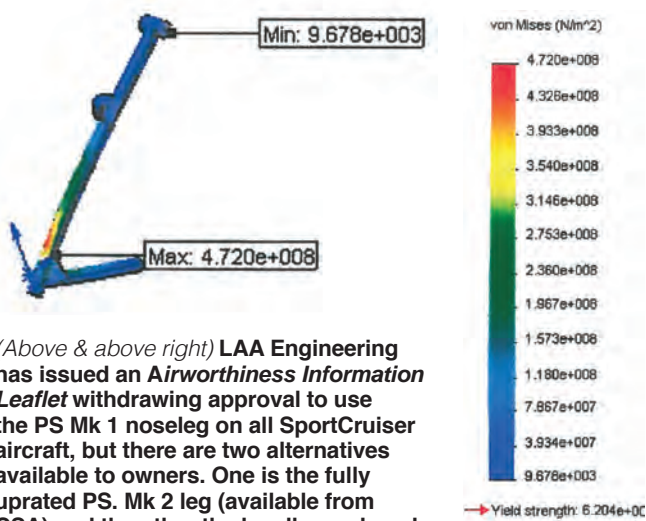
(Above & above right) LAA Engineering has issued an *Airworthiness Information Leaflet* withdrawing approval to use the PS Mk 1 noseleg on all SportCruiser aircraft, but there are two alternatives available to owners. One is the fully updated PS. Mk 2 leg (available from CSA) and the other the locally produced ‘updated’ version of the CZAW version.

These screenshots, submitted by the original designer of the leg strengthening mod, LAA’er, Tony Palmer, shows clearly where the maximum bending load is in this component. (Images: Tony Palmer)

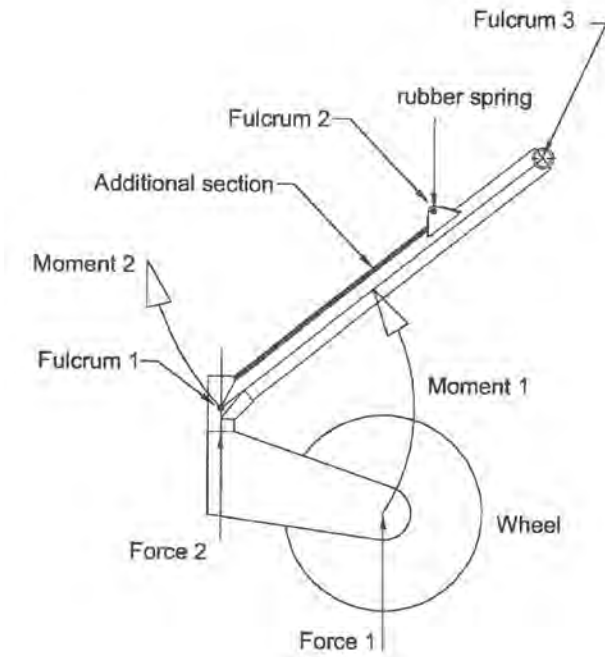
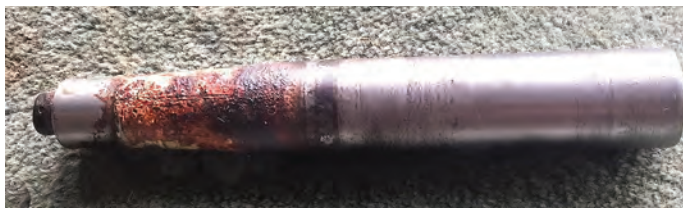
(Above) As part of the recent *Airworthiness Information Leaflet* withdrawing the PS Mk 1 noseleg from use on all UK SportCruisers, the LAA has taken the opportunity to review the maintenance/inspection requirements for them in rather more general terms.

The annual inspection now requires the spindle assembly to be dismantled, inspected, re-lubricated and re-tensioned. Many of these spindles have been in service for the last six years and, as you can see from this picture, some are suffering from the potentially weakening effect of corrosion. (Photo: Martin Ferrid)

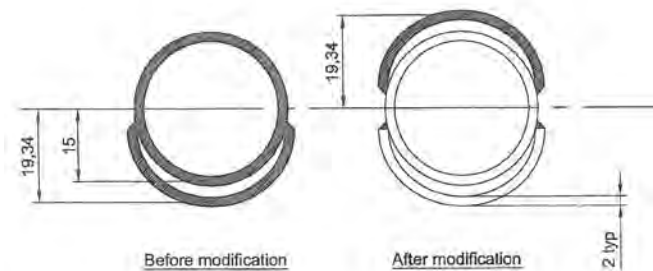
(Top & above) Tony Palmer enlisted the help of LAA Inspector Farry Sayyah to make a strengthened noseleg and quite a few SportCruisers have benefited from this less expensive alternative to the factory replacement part.

This strengthening mod is now a Standard Option for CZAW SportCruiser aircraft (as listed in the TADS) so ‘sign out’ can be done by an LAA Inspector (without reference to HQ). These pictures show how the leg has been strengthened. (Images: Tony Palmer/Farry Sayyah)

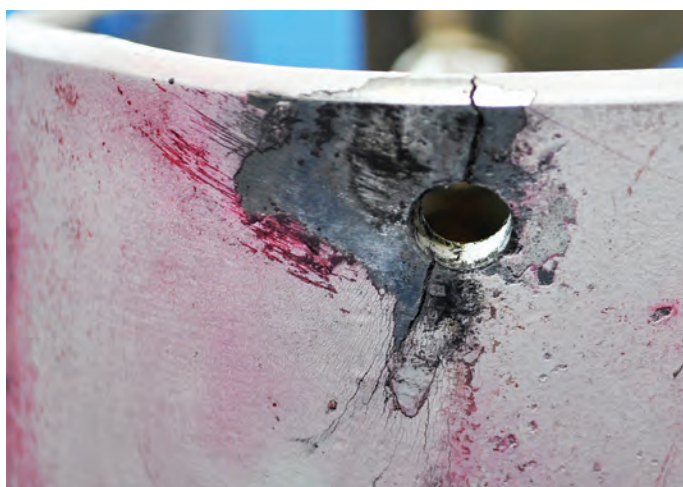
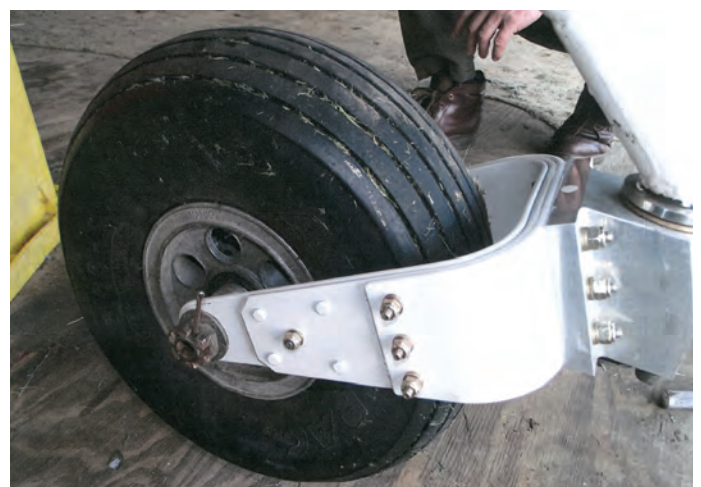
(Above & above right) LAA Inspector, Graham Smith has developed a stronger version of SportCruiser nosewheel fork. Regular readers will know that the original ‘two-leaf’ design has been suffering cracking, originating from the attachment holes, as shown in the the picture above left, which has led to an increased inspection requirement (every fifty hours).

The photo above right, meanwhile, shows the updated noseleg fork – notice that it now has three leaves. This three-leaf fork is available from Graham, and its fitment removes the fifty-hour inspection interval. Many owners have taken advantage of this ‘LAA Home-Grown’ replacement part, for which replacement is covered by a *Standard Modification (SM 13680)* – details on the LAA Website. (Photos: Graham Smith/John Tiley)

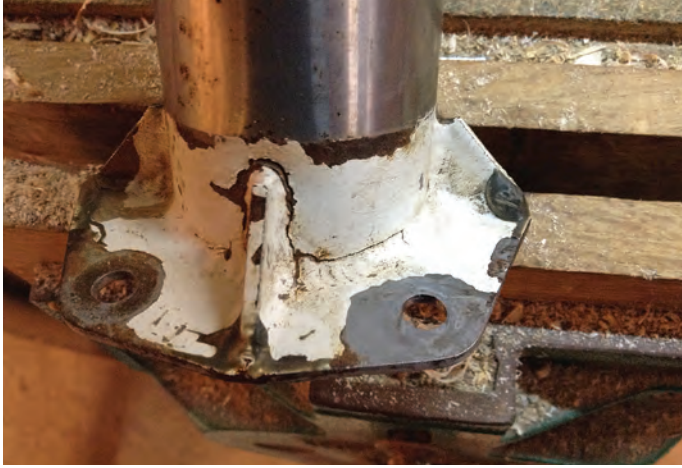
(Left) Although SportCruisers have been grabbing all the headlines when it comes to noseleg issues, it should be noted that all nosewheel types need careful (and regular) detailed inspections. The noselegs on most LAA types aren't designed to take the punishment which some of the other in-service training aircraft (like the PA-28 or the C-150) are able to withstand.

This picture shows a fairly typical overload failure, along the edge of a weld in the support flange of a DynAero MCR-01 Club noseleg. Luckily, this failure was spotted by the diligent owner, Peter Milward, during a pre-flight inspection so it didn't end up as being the cause of a collapse on landing or take-off. (Photo: Peter Milward)

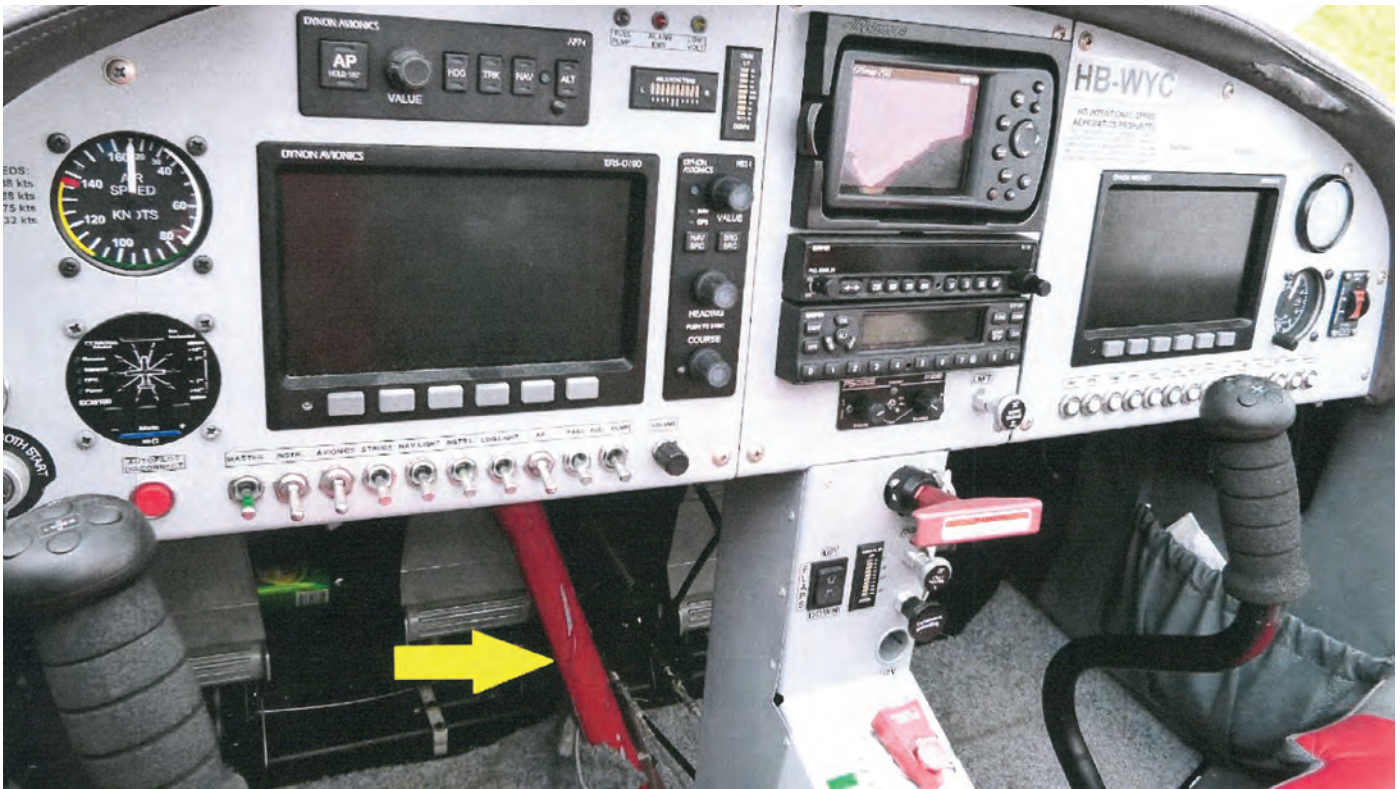
(Above) Whatever aircraft you fly, it's vitally important that its undercarriage is inspected before every flight, and a detailed inspection of the whole assembly is carried out regularly, as part of your Tailored Maintenance Schedule. Noseleg failures almost always involve extremely expensive repairs – firstly, there's the inevitable engine shock load inspection, then there's normally a new propeller, plus, of course, repairs to the lower forward fuselage structure, which, if you're very unlucky can include a firewall replacement.

There's perhaps an even more important reason to keep an eye on things – during this failure, the leg itself has broken through into the cockpit! As you can see, the part has ended up very close to the pilot's feet, which is potentially more life-changing than a dent in the bank balance. (Photo: Swiss TSB)
