**** MANDATORY ****
SERVICE BULLETIN

SUBJECT: GRS 77 AHRS (Attitude and Heading Reference System) Mod 1

SB07-34-06

GARMIN G1000 GRS-77 ATTITUDE AND HEADING REFERENCE SYSTEM (AHRS)
INSPECTION/REPLACEMENT

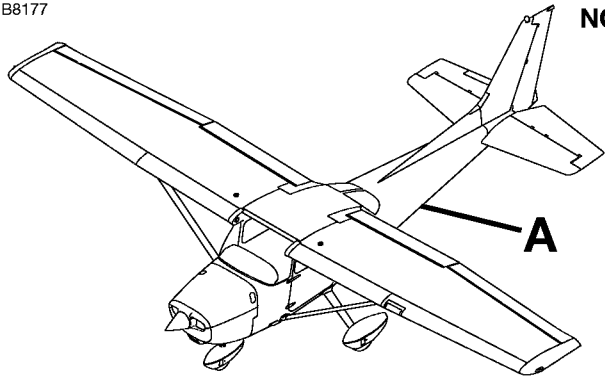
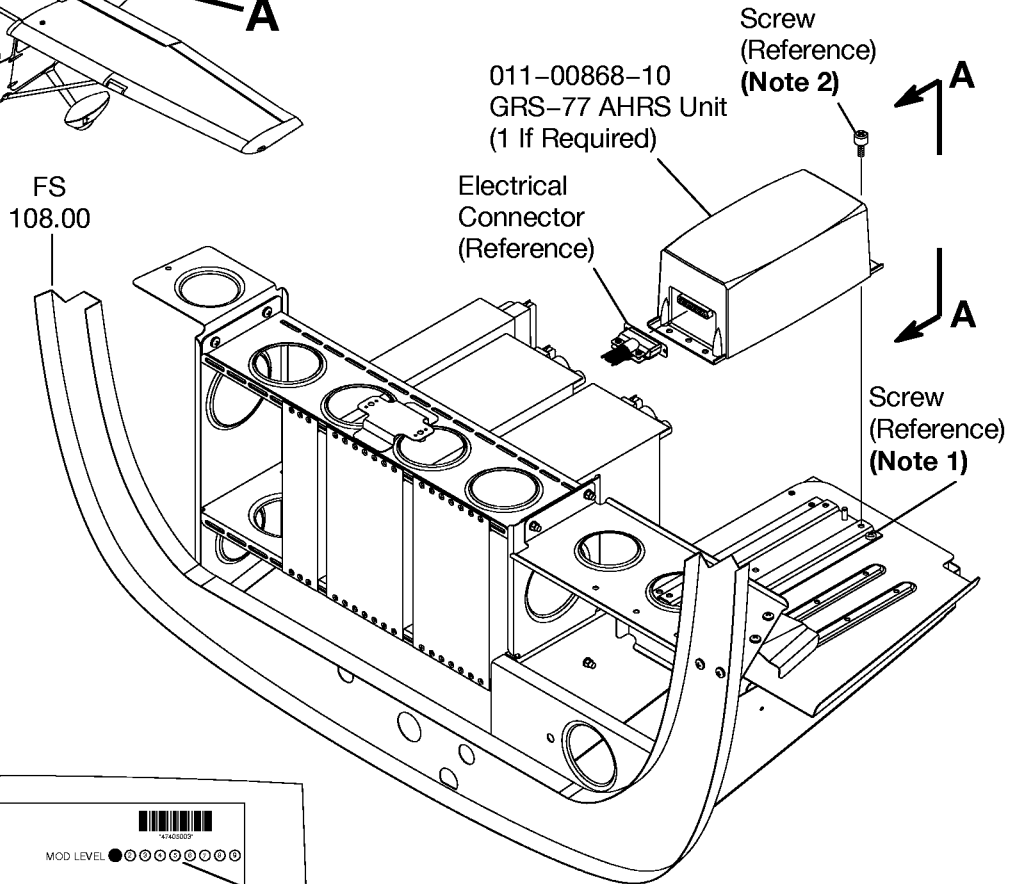
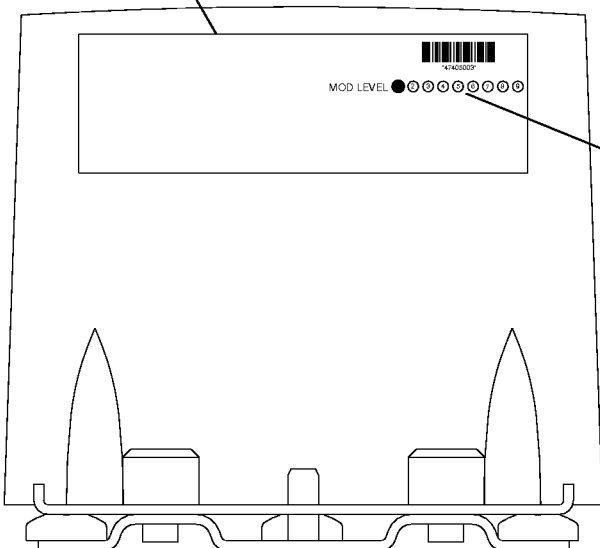
Figure 1. AHRS Inspection/Replacement (Sheet 1)

NOTE 1: Do not loosen or remove the screws that attach the mounting tray to the airplane structure. It is not necessary. If you do loosen or remove these screws, you must do a calibration of the AHRS unit or it will not send correct information to the avionics system.

NOTE 2: Loosen these screws to remove the GRS-77 AHRS unit.

NOTE 3: If the mod level shown on the identification plate is MOD 1 or later, no GRS-77 AHRS unit replacement is necessary.

6. (Refer to Figure 1, Detail A.) Remove the GRS-77 AHRS unit from the airplane. (Refer to the applicable maintenance manual, Chapter 34, Attitude Heading Reference System (AHRS) - Maintenance Practices.)

- C. Remove the GRS-77 AHRS unit from the airplane.
7. (Refer to Figure 1, View A-A.) Identify the mod level of the GRS-77 AHRS unit installed in your airplane:
