ACCIDENT

Aircraft Type and Registration:	Aeroprakt A32 Vixxen, G-ENVV	
No & Type of Engines:	1 Rotax 912ULS piston engine	
Year of Manufacture:	2019 (Serial no: LAA 411-15611)	
Date & Time (UTC):	19 July 2022 at 1920 hrs	
Location:	Newtownards Airfield, County Down	
Type of Flight:	Private	
Persons on Board:	Crew - 2	Passengers - None
Injuries:	Crew - 2 (Fatal)	Passengers - N/A
Nature of Damage:	Extensive	
Commander's Licence:	See pilot information section	
Commander's Age:	See pilot information section	
Commander's Flying Experience:	See pilot information section	
Information Source:	AAIB Field Investigation

Synopsis

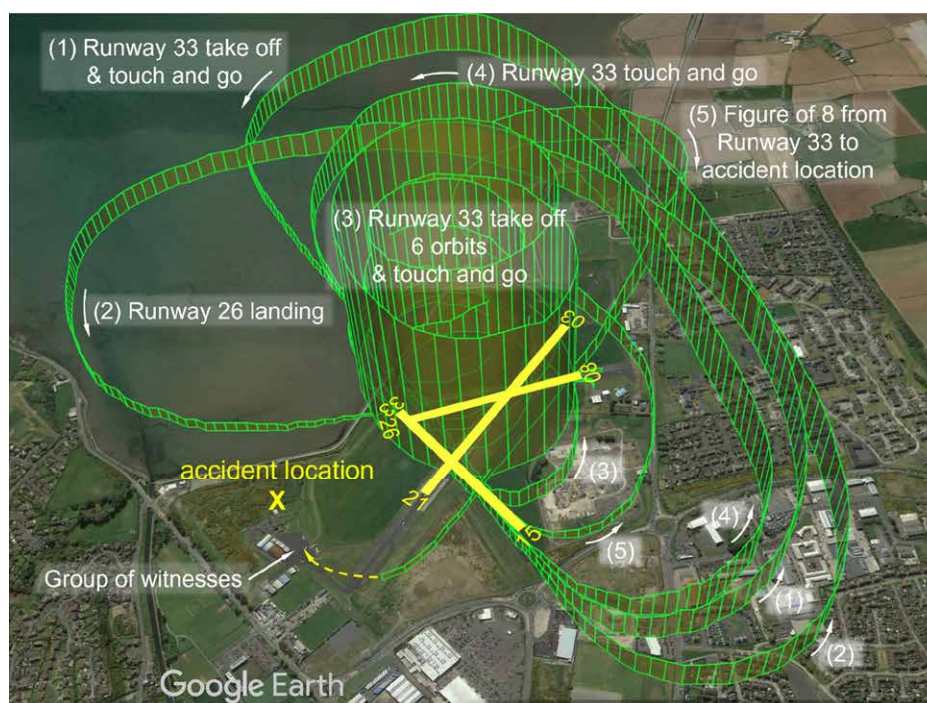
Figure 2
Flight path of accident flight

The aircraft then took off again and flew an 'S' turn to approach Runway 03 (Figure 2 – Point 5). During this turn the angle of bank reached 59° with the aircraft at 370 ft agl. The aircraft then flew a low pass parallel to Runway 03 at approximately 70 ft above the ground. At the end of the runway the aircraft made a right turn passing over the people stood next to the vintage bus. Witnesses estimated the aircraft's bank angle was over 60°. One witness described the aircraft "travelling more in the direction of its belly rather than forward". It was reported that the engine sounded "normal" and was at "full power". The last data point, recorded as the aircraft turned right, showed the aircraft was at 72 ft agl, with 71° angle of bank, travelling at an indicated airspeed of 86 kt and a normal acceleration¹ of 1.91 g.

Seconds after the aircraft passed over the bus it appeared to be out of control and descended rapidly to the ground. Witnesses reported it happened very quickly and accounts of exactly what happened varied. However, witnesses described the aircraft “spiralling”, “turning wing over wing” and “tumbling”. One witness reported that the aircraft “made a steep bank to its right before it pitched up. The aircraft partially turned over on itself, continued along the trajectory of its initial banking turn but it was losing altitude”. Another witness described seeing the aircraft yaw markedly into the turn as it lost control. No one reported any abnormal noises from the aircraft or its engine. Witnesses also confirmed that the aircraft did not collide with any other object.

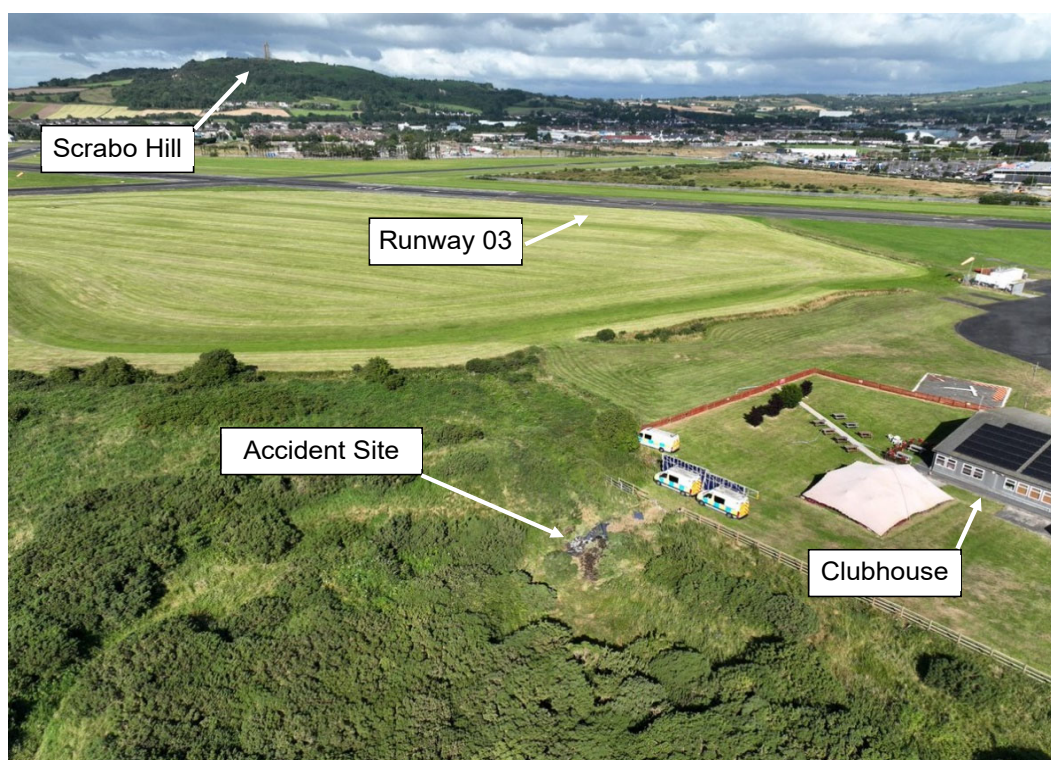
Figure 3

The aircraft struck the ground on the airfield boundary just to the south of the flying club and airport cafe buildings. Witnesses ran to the accident site and airport staff collected the airport fire vehicle. They reached the aircraft within a few seconds but there was no sign of life from the occupants. A fire started on the right side of the fuselage but this was extinguished by the airport fire crew and the local fire service, who arrived shortly after the accident.

Accident site location

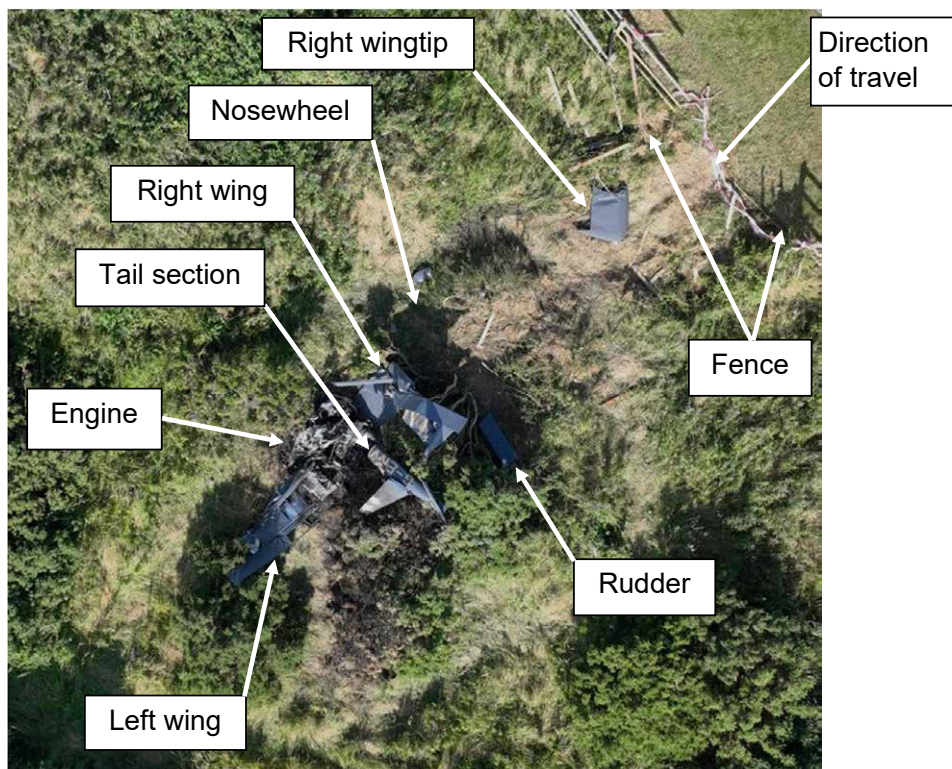
Figure 4
Accident site

G-ENVV struck a wooden fence on the boundary of the airfield close to the clubhouse and its outside eating area, continuing through the fence before coming to rest, inverted, over a gorse bush (Figure 3). There were no apparent ground marks from impact prior to the fence line.

Witness marks matching G-ENVV's paint were found on the fence posts. The right wingtip, some glazing from the windows, and the nosewheel were detached at the point of impact with the fence (Figure 4). The rudder became detached at the point of impact with the gorse bush, and was undamaged by the post-impact fire. The remainder of the right wing, left wing, tail section, fuselage, engine and propeller were all located at the final accident site.
