The Mystique of Autopilot Accidents

BY JACK LIPSCOMB AND PAUL BRAY, JR.

Reprinted from the Jan/Mar 2000 issue of *ISASI Forum* with permission of the International Society of Air Safety Investigators. All rights reserved.

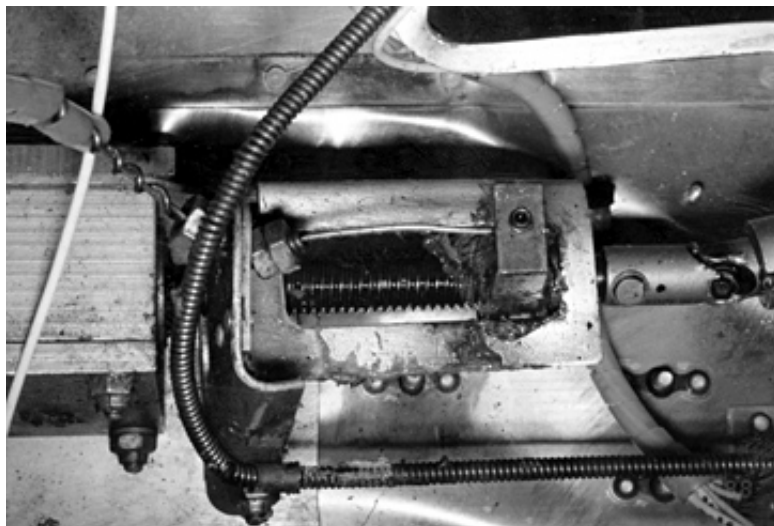
An example of a Mooney pitch trim screw and nut in the full nose-down position.

The unit is located under the pitch trim wheel between the pilot seats in the cabin.

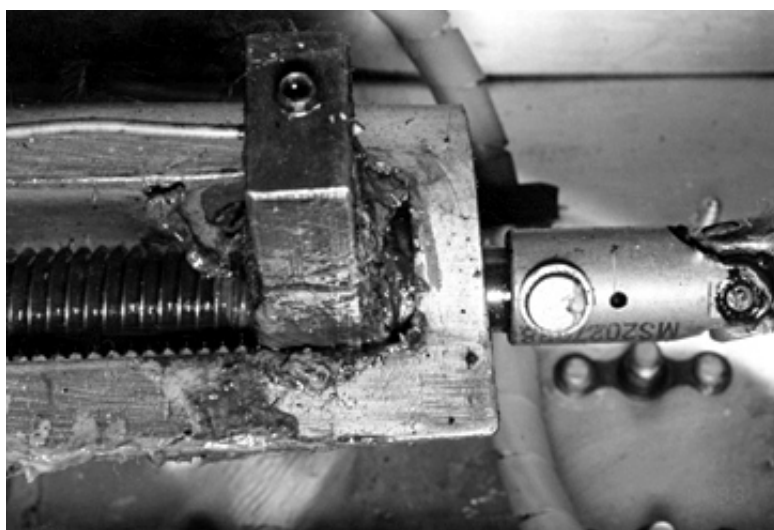
A close-up view of the full nose-down position.

Mooney-type trim actuators, of the worm screw type, will lock and reflect setting at time of impact. Actual autopilot engagement at the time of breakup or impact may be clouded as removal of electrical power from the servo solenoids allows them to relax to the disengaged position.
