MH370 Flaperon Inboard Hinge - Finite Element Analysis (FEA)

by Tom Kenyon
November 25, 2020

The purpose of this analysis is to provide FEA results for two (2) key Flaperon Hinge failure scenarios for the MH370 right-side Flaperon recovered at Reunion Island on July 29, 2015.

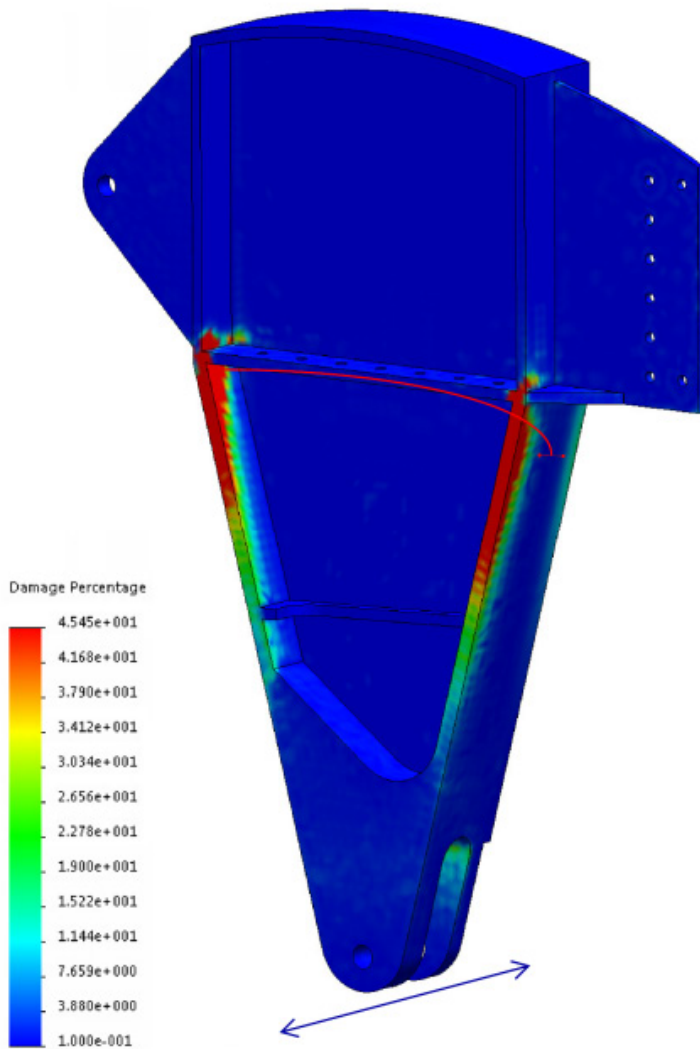
3.0 Torsional Flutter Scenario (CASE 1)

- a. The percent alloy damage, calculated by the SOLIDWORKS torsional flutter simulation, indicates failure of the Inboard hinge's forward and aft flanges near the hinge connection point at the Flaperon's bottom exterior skin. This result is highly consistent with the MH370 photographs of the recovered right Flaperon (*see Exhibit 1*)

- b. An additional detail is observed that further mimics MH370's Flaperon inboard hinge. The aft flange fails at a point lower in elevation compared to the forward flange. The failure points of each flange is identified by the narrowest strip of low damaged flange. The projected high damage areas match the flange and web failures observed on both of MH370's inboard and outboard Flaperon hinges. (*see Exhibit 1*)

- c. Note once the flanges reach a point of fatigue failure, the interstitial web simply fails along a path between the flange's failures. (*depicted by red line*)

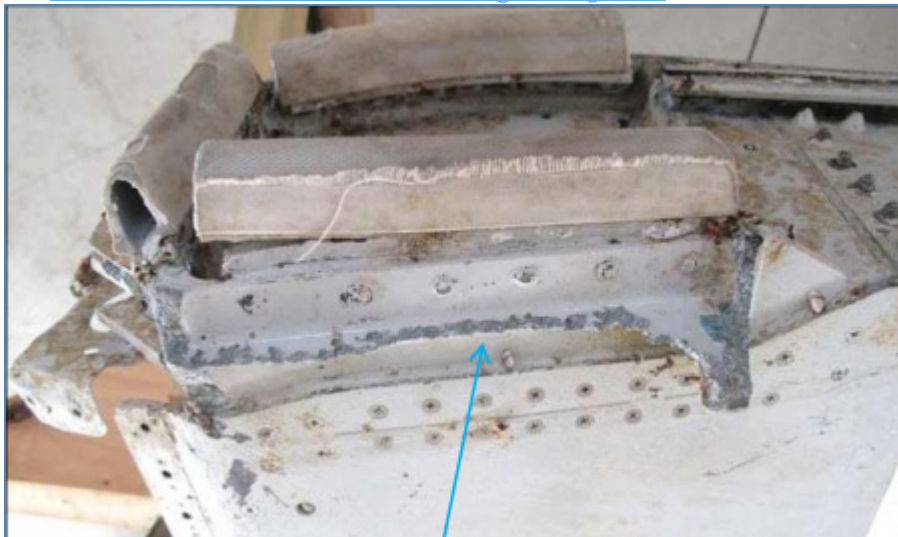
Lower Inboard Side of MH370 Right Flaperon EXHIBIT 1

(Photo inverted for orientation clarity, ignore blue arrow from DGA report)

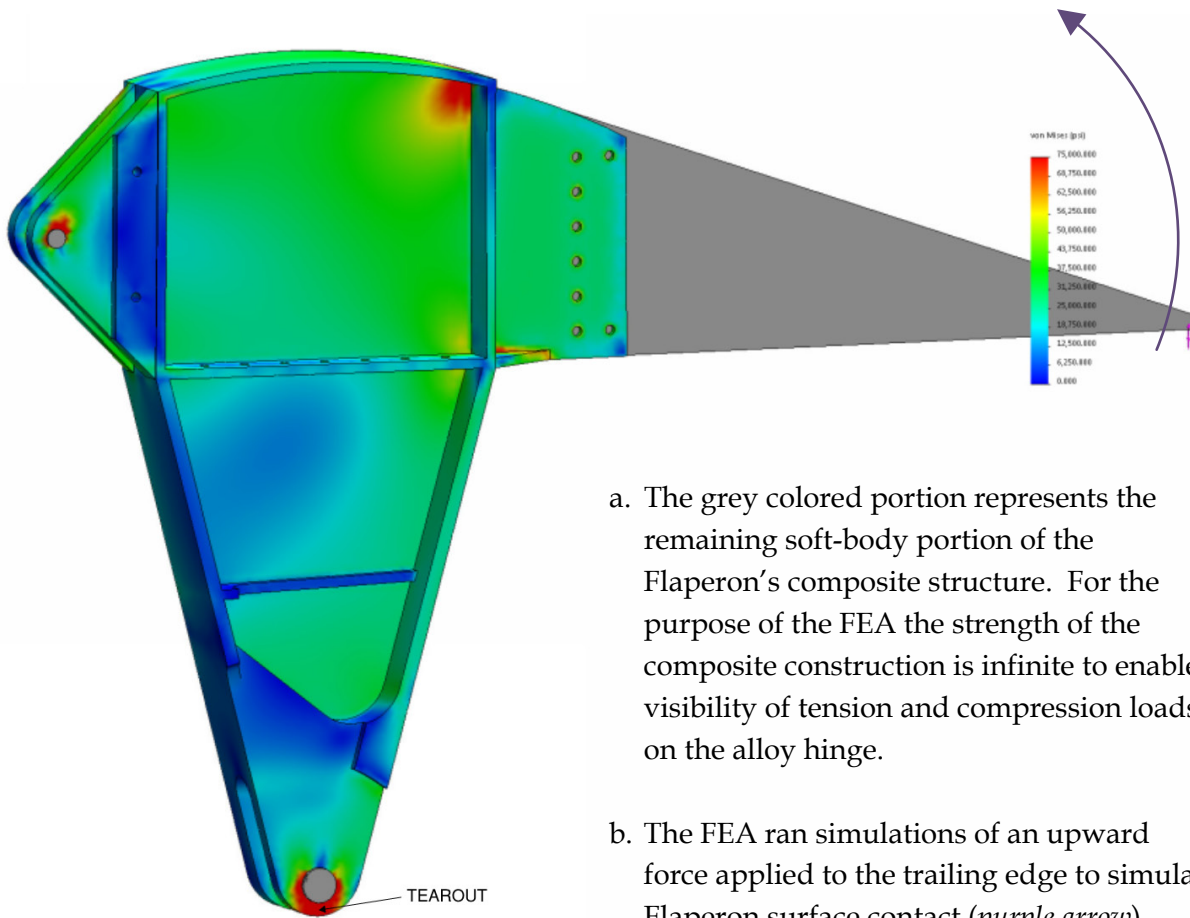
4.0 Surface Impact Scenario (CASE 2)

- a. The grey colored portion represents the remaining soft-body portion of the Flaperon's composite structure. For the purpose of the FEA the strength of the composite construction is infinite to enable visibility of tension and compression loads on the alloy hinge.
- b. The FEA ran simulations of an upward force applied to the trailing edge to simulate Flaperon surface contact (*purple arrow*).
- c. Several FEA runs were made between 10 kips and 15 kips with similar results.
- d. The top of the hinge system exhibits significant compression load in the aft position and a tension load where the aft portion of the hinge meets with the bottom of the Flaperon composite surface.
- e. The bottom hinge connection shows a local tension failure (Tearout) and the PCU attachment exhibits compression damage.

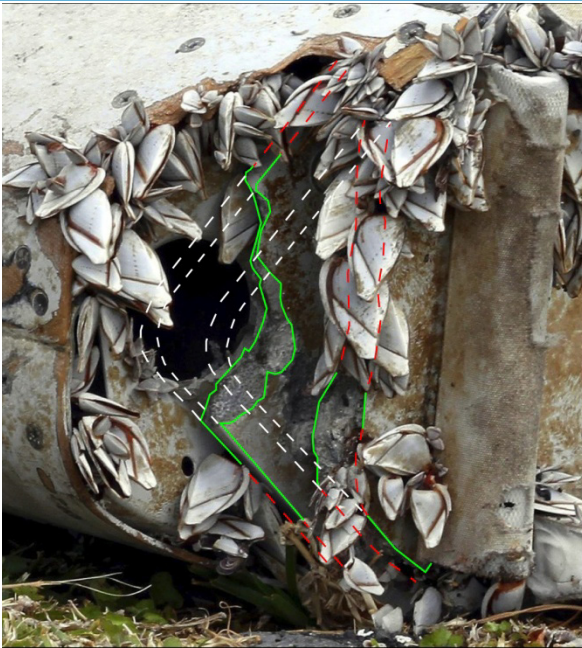
Annotated View of Inboard Side of MH370 Right Flaperon EXHIBIT 2

Further FEA analysis can be performed on the PCU attachment area (*shown below*) to provide further insight. However, general observation of the PCU area damage in the photographs of the recovered right-side Flaperon indicate an additional FEA study would likely support the Torsional Flutter scenario.
