## **EASA Safety Information Bulletin**

SIB No.:	2012-06R2
Issued:	28 October 2013

## Defective Standard Hardware – MS21042, NAS1291 and LN9338 Self-Locking Nuts, and NAS626 Bolts

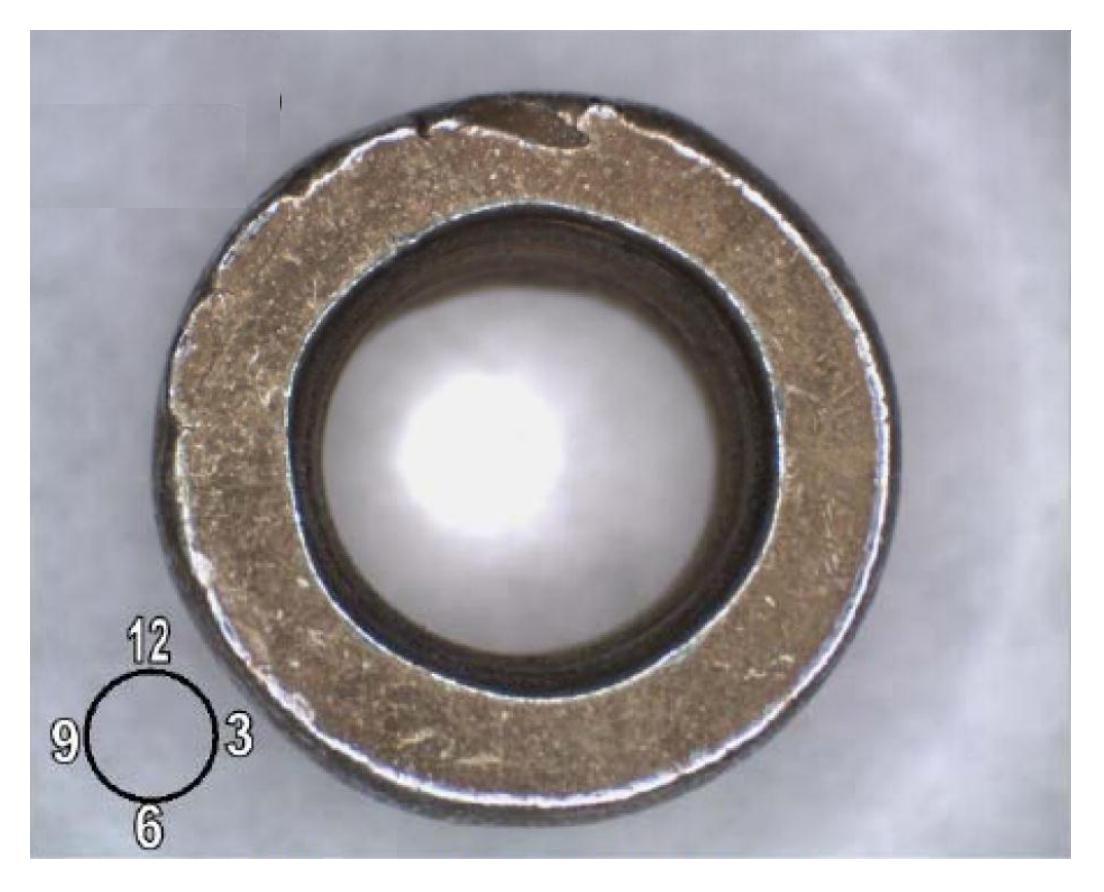
Figure 1: Example of surface irregularities observed on a nut. Overall view.

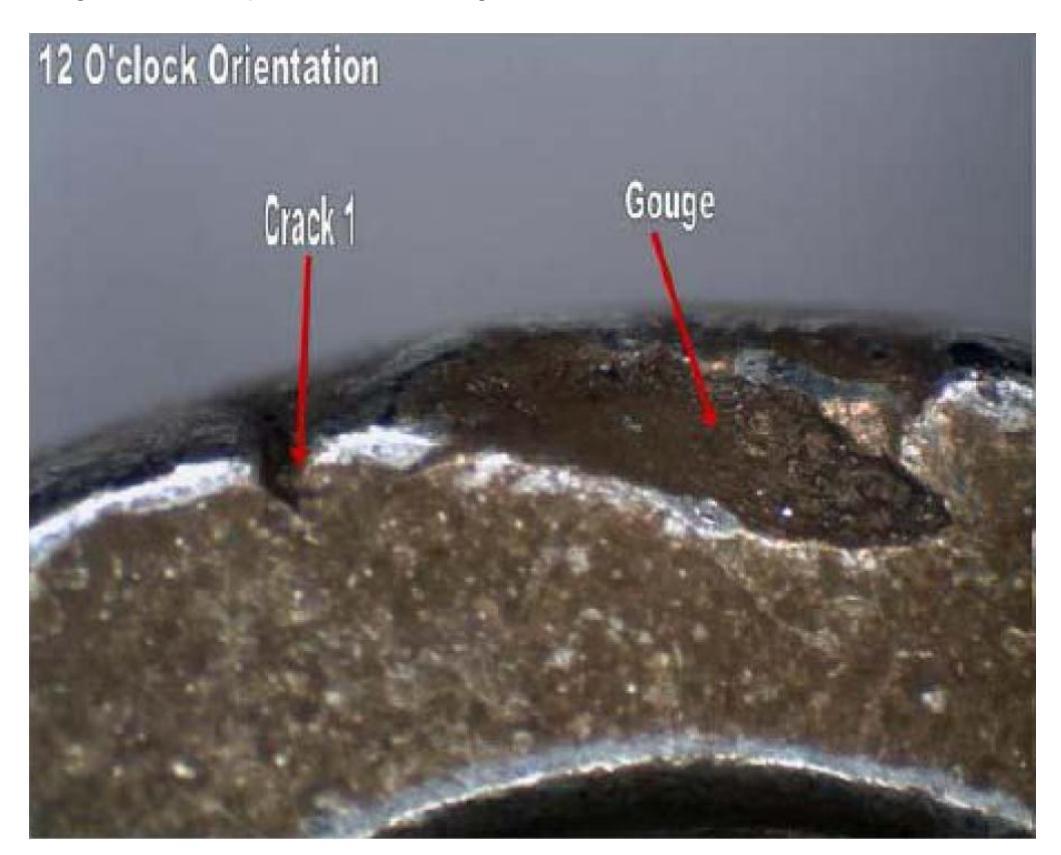
Figure 2: Example of surface irregularities observed on a nut. Detail

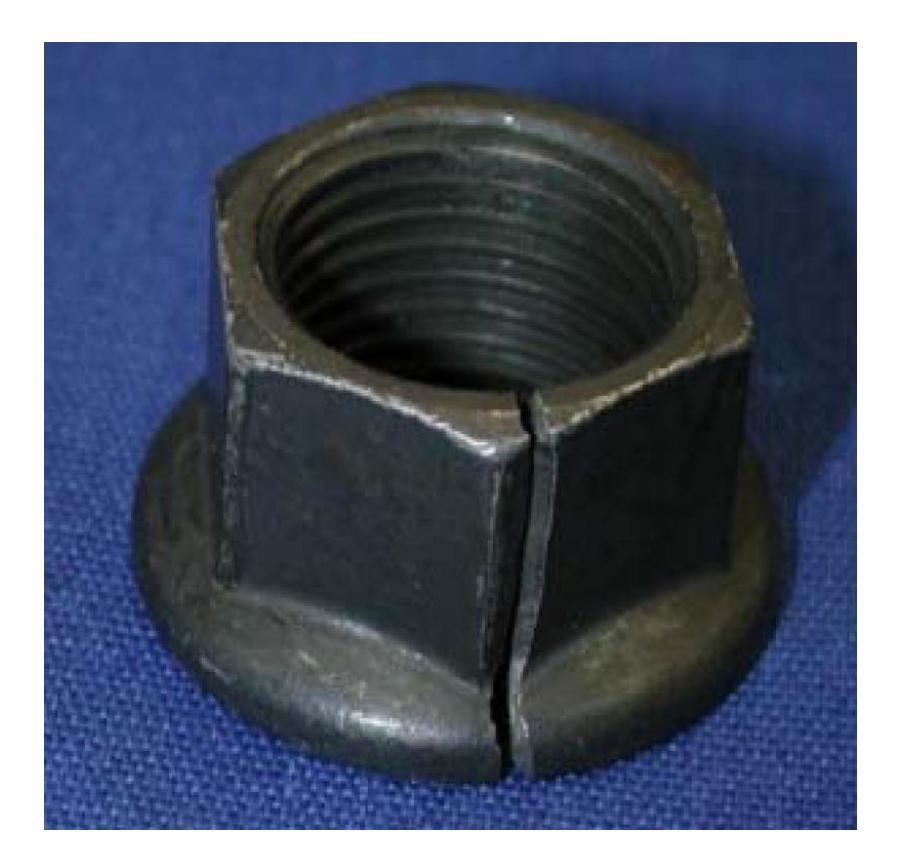
Figure 3: Example of longitudinal crack.
