The NTSB wants the FAA to issue an AD against certain retrofit oil filter adapters.

## NTSB Warns of Engine Failures Caused by STC'd Oil Filter Adapters

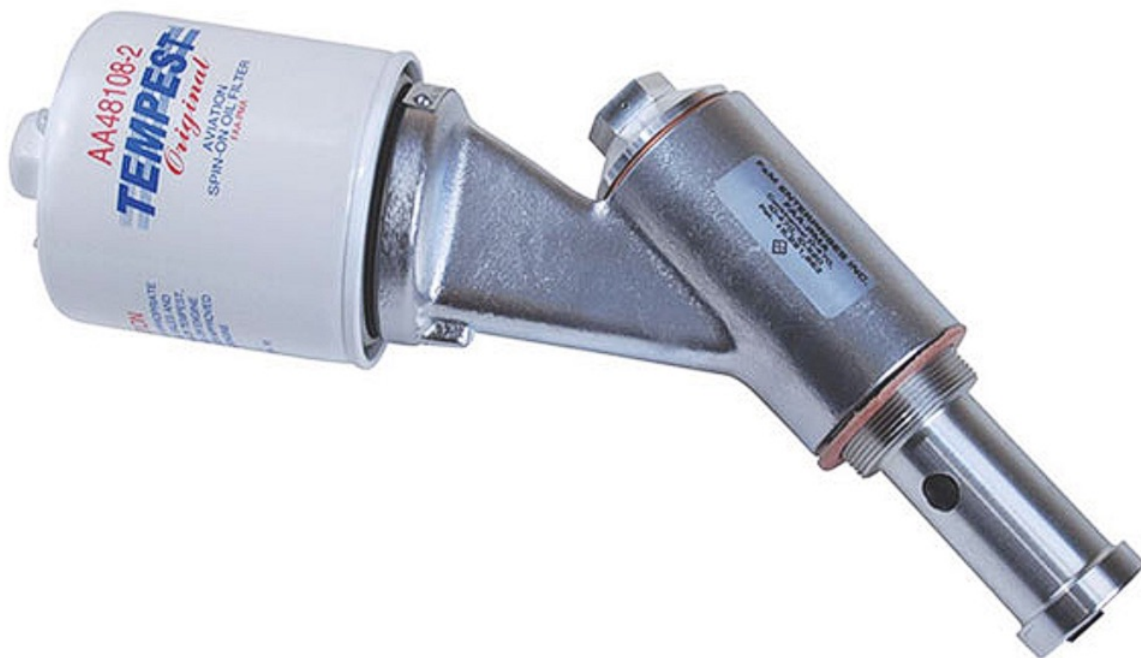
Subsequent inspection revealed that the STC'd oil filter adapter on the Skylane's Continental O-470 engine had vibrated loose, chewed up its gasket, and started letting engine oil leak overboard. Ultimately the oil level

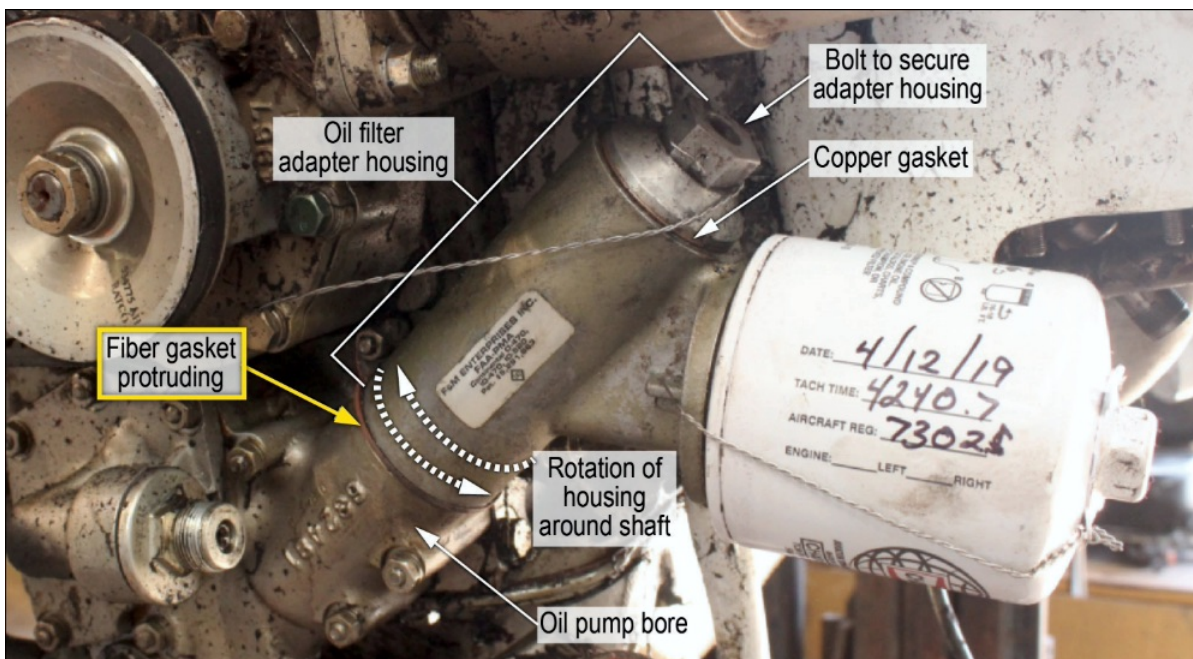
The National Transportation Safety Board (NTSB) is aware of at least 11 accidents and incidents that have occurred during the past 15 years caused by these F&M/Stratus/Tempest oil filters vibrating loose and chewing up their gaskets. Four of them involved fatalities or serious injuries.

It turns out that the NTSB has been bugging the FAA for 18 months to address this problem, but to date the FAA has been non-responsive. Finally, on November 30, 2020, the NTSB issued **a formal Safety Recommendation** asking the FAA to issue an Airworthiness Directive (AD) against these F&M/Stratus/Tempest oil filter adapters requiring repetitive inspections of

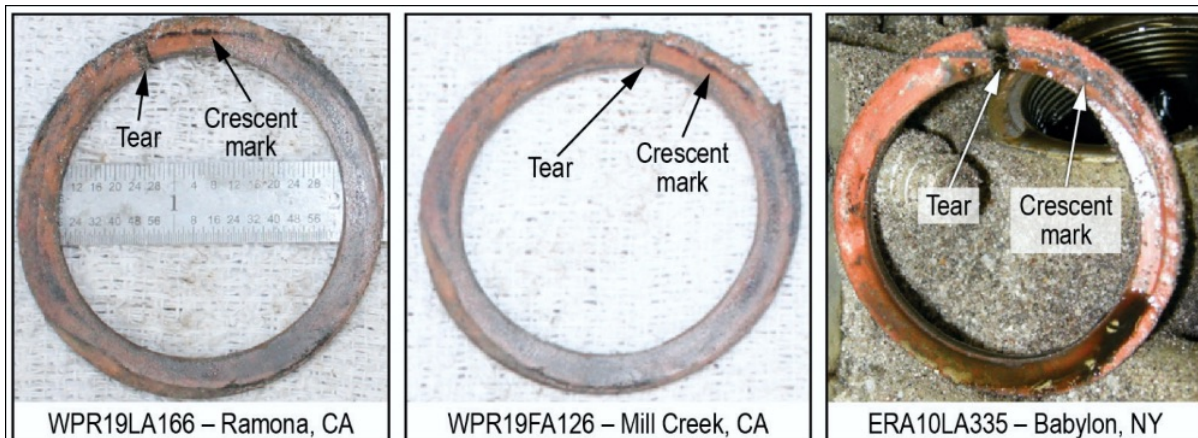
The NTSB doesn't say so, but we think the design of these oil filter adapters—both Cessna and F&M—is inherently problematic. The oil filter, when full of oil, constitutes a heavy weight mounted on a lever arm that is trying its

properly torqued retention nut (Cessna) or retention bolt (F&M). The problem is that the retention nut or bolt is securing a “soft joint” that has a gasket separating the parts being joined (adapter to oil pump housing). As the gasket deteriorates over time, preload is inevitably lost, allowing the adapter to twist when subject to engine vibration. This twisting causes further damage to the gasket, which causes further loss of preload, which causes increased twisting...and the assembly enters a death spiral that—unless noticed in time—inevitably results in loss of oil and possible loss of engine power.

Although frequent inspection—hopefully mandated by an AD—increases the chances of catching this problem before it becomes catastrophic, we think these adapters are fundamentally flawed. While we definitely recommend retrofitting an oil filter to any piston aircraft engine not so equipped, we would feel a lot more comfortable with a remote-mounted filter (e.g., the [Airwolf](#)) that has the filter firmly secured to the firewall and not subject to engine vibration.
