A Tale of Two Pipers (/maintenance- technical/item/1321-a-tale- of-two-pipers.html) //

Piper PA-28 and PA-32
Wing Spar NPRM 2018-CE-
049-AD ([/maintenance-
technical/item/1284-piper-
pa-28-and-pa-32-wing-spar-
nprm-2018-ce-049-ad.html](https://www.faa.gov/maintenance-technical/item/1284-piper-pa-28-and-pa-32-wing-spar-nprm-2018-ce-049-ad.html))

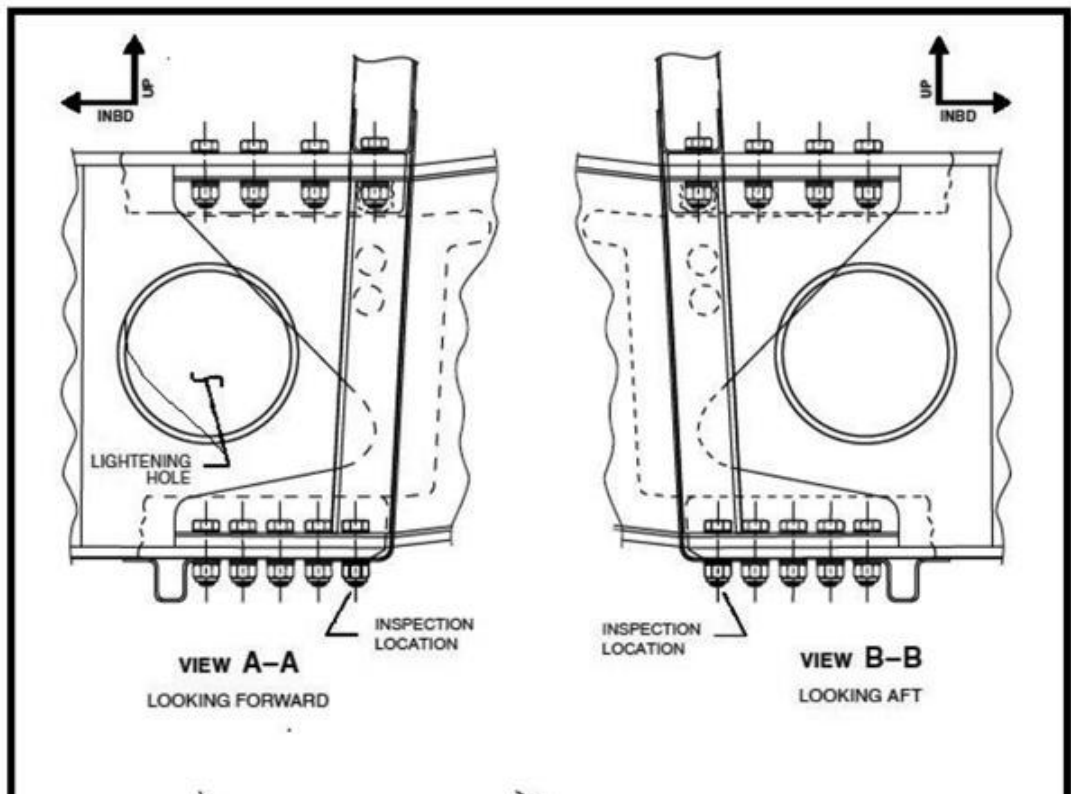
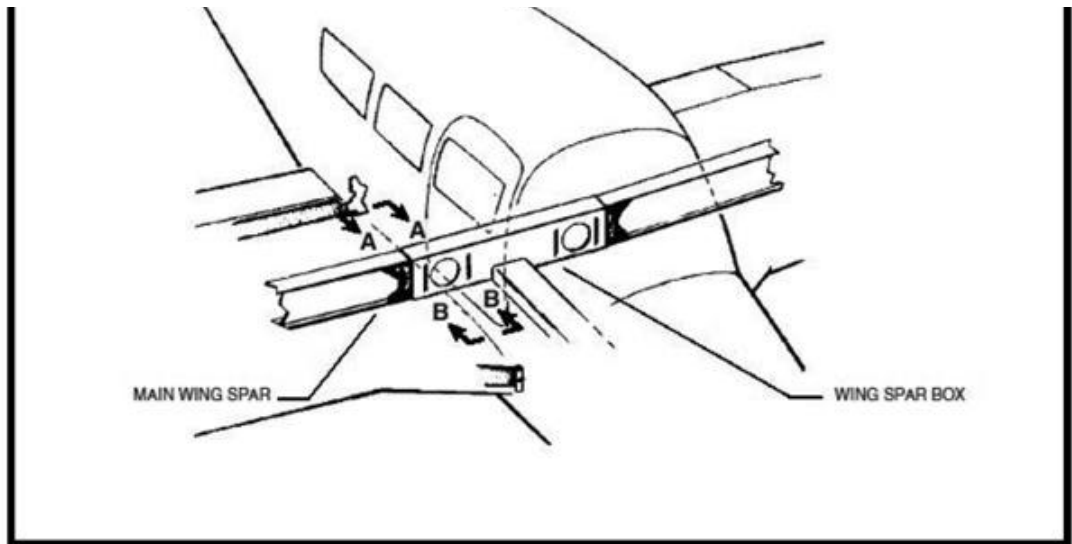
Figure 1. Main Spar Attach Bolt Locations (RH Side Shown)

(3) Use eddy current surface and bolt hole examinations to detect surface and shallow subsurface cracking and discontinuities on the left and right lower outboard spar bolt holes. Use SAE ARP4402, "Eddy Current Inspection of Open Fastener Holes in Aluminum Aircraft Structure," or another FAA-approved eddy current inspection method to do these inspections.

A crack or crack-like indication with an amplitude equal to or greater than 50 percent of the reference level signal must be rejected and documented. Such an amplitude reading indicates that the spar does not meet type design.

If cracks are found, the wing spar will need to be replaced. The AD estimates that that repair will take 32 work hours and estimates that, at a labor cost of \$85/hour the total cost will be \$2,720 in labor. The FAA projects the part cost at \$5,540, for a total cost of \$8,260.
