SERIOUS INCIDENT

Aircraft Type and Registration:	Airbus A330-243, G-TCCF
No & Type of Engines:	2 Rolls-Royce Trent 772B-60 turbofan engines
Year of Manufacture:	1998 (Serial no: 248)
Date & Time (UTC):	6 February 2019 at 1720 hrs
Location:	In flight over North Atlantic Ocean, west of the Republic of Ireland
Type of Flight:	Commercial Air Transport (Passenger)
Persons on Board:	Crew - 11 Passengers - 326
Injuries:	Crew - None Passengers - None
Nature of Damage:	VHF radio unit damaged
Commander's Licence:	Airline Transport Pilot's Licence
Commander's Age:	49 years
Commander's Flying Experience:	13,135 hours (of which 1,050 were on type) Last 90 days - 98 hours Last 28 days - 45 hours
Information Source:	Aircraft Accident Report Form submitted by the pilot and operator investigation

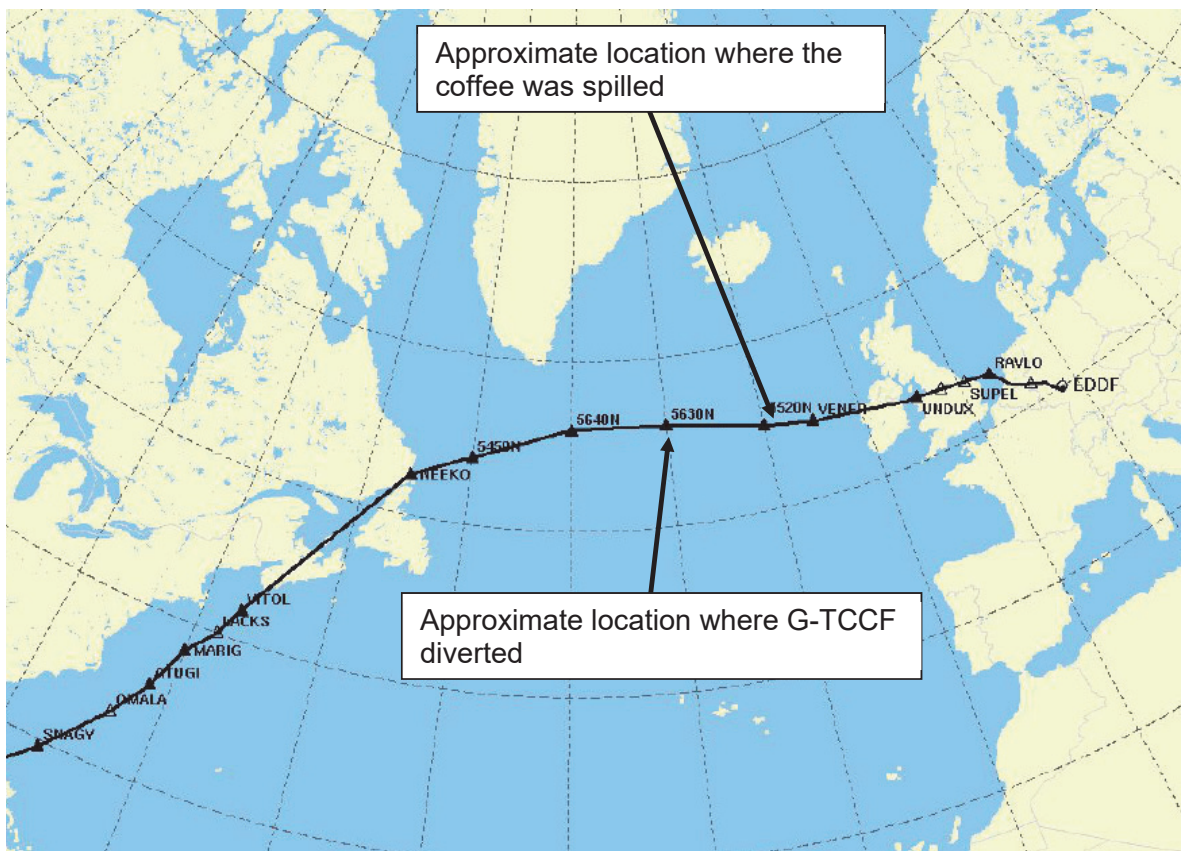
Figure 3

At approximately 1720 hrs, approaching N5600.0 W03000.0, the audio control panel on the co-pilot's side (ACP2) became hot enough to start melting one of its buttons, and failed. A small amount of smoke was observed coming from the ACP1. The commander decided to divert to Shannon, Republic of Ireland. During the diversion, the flight crew alternately used supplementary oxygen, with one pilot on oxygen at all times.

Planned route and approximate location where the commander decided to divert
