Final Report no. 2175 of the Swiss Accident Investigation Board SAIB

concerning the accident involving the
Piper PA-28-140 aircraft,
registration G-BBEF

on 14 October 2011

Petit-Beauregard, municipality of
Fontaines-sur-Grandson/VD

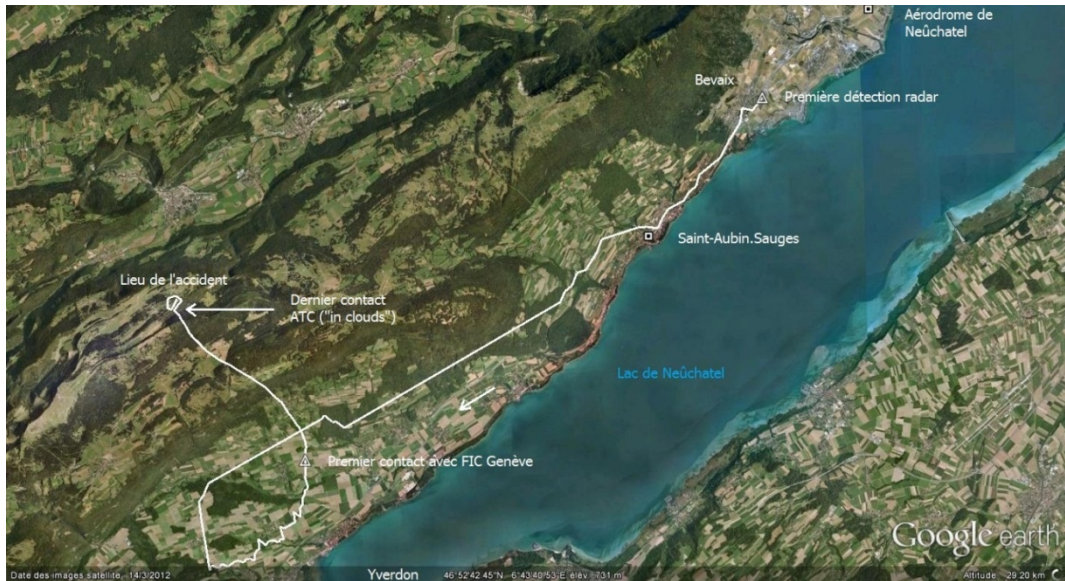
Fig. 1: 2-D representation of the aircraft's route.

At approximately 16:30, the wreckage of the Piper PA-28-140 was found at the edge of a wood on a ridge of the Jura, at the location known as "Petit Beauregard". The aircraft was destroyed and its two occupants were fatally injured.

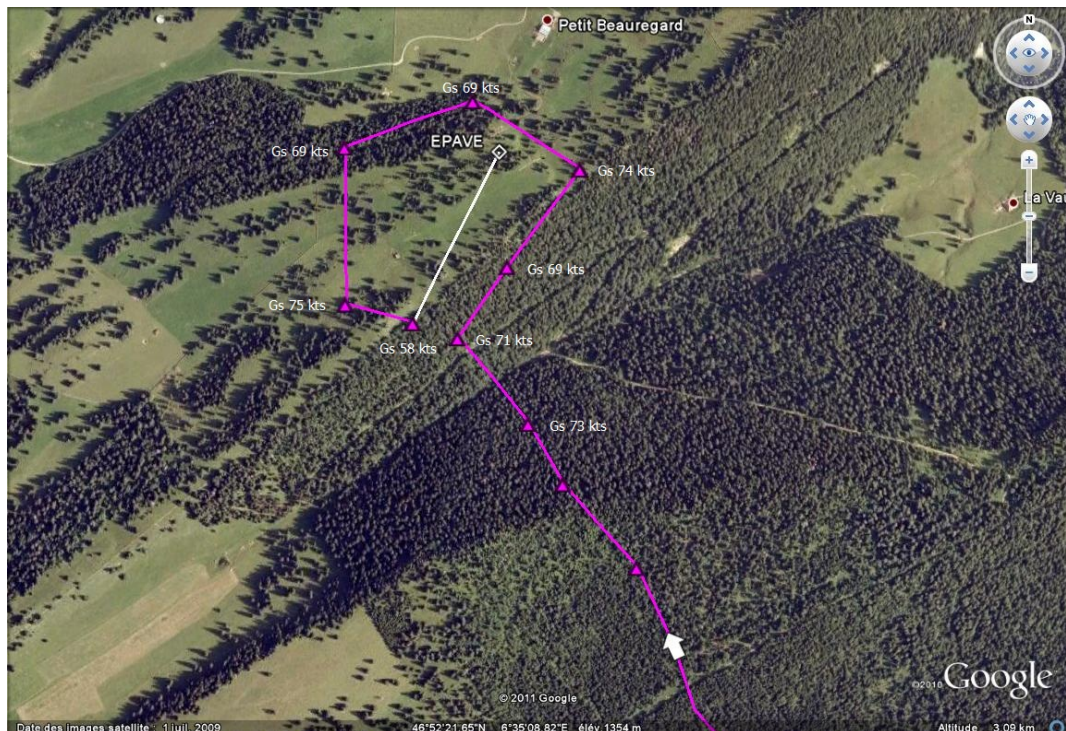
Fig. 8: Ground speeds reconstructed by the Grand-Ballon tracker

The ground speeds reconstructed by the Grand-Ballon radar tracker have an accuracy of 5-8 kt, but with a somewhat greater spread in the last seconds of recorded flight.
