## ACCIDENT

<b>Aircraft Type and Registration:</b>	Piper PA-28-140 Cherokee, G-AVRP	
<b>No &amp; Type of Engines:</b>	1 Lycoming O-320-E2A piston engine	
<b>Year of Manufacture:</b>	1967	
<b>Date &amp; Time (UTC):</b>	5 August 2007 at 1100 hrs	
<b>Location:</b>	0.5 nm south-west of Isle of Wight/Sandown Airport	
<b>Type of Flight:</b>	Private	
<b>Persons on Board:</b>	Crew - 1	Passengers - 3
<b>Injuries:</b>	Crew - 1 (Fatal)	Passengers - 3 (Fatal)
<b>Nature of Damage:</b>	Aircraft destroyed	
<b>Commander's Licence:</b>	Private Pilot's Licence	
<b>Commander's Age:</b>	48 years	
<b>Commander's Flying Experience:</b>	687 hours (of which 143 were on type) Last 90 days - 12 hours Last 28 days - 6 hours	
<b>Information Source:</b>	AAIB Field Investigation

## Synopsis

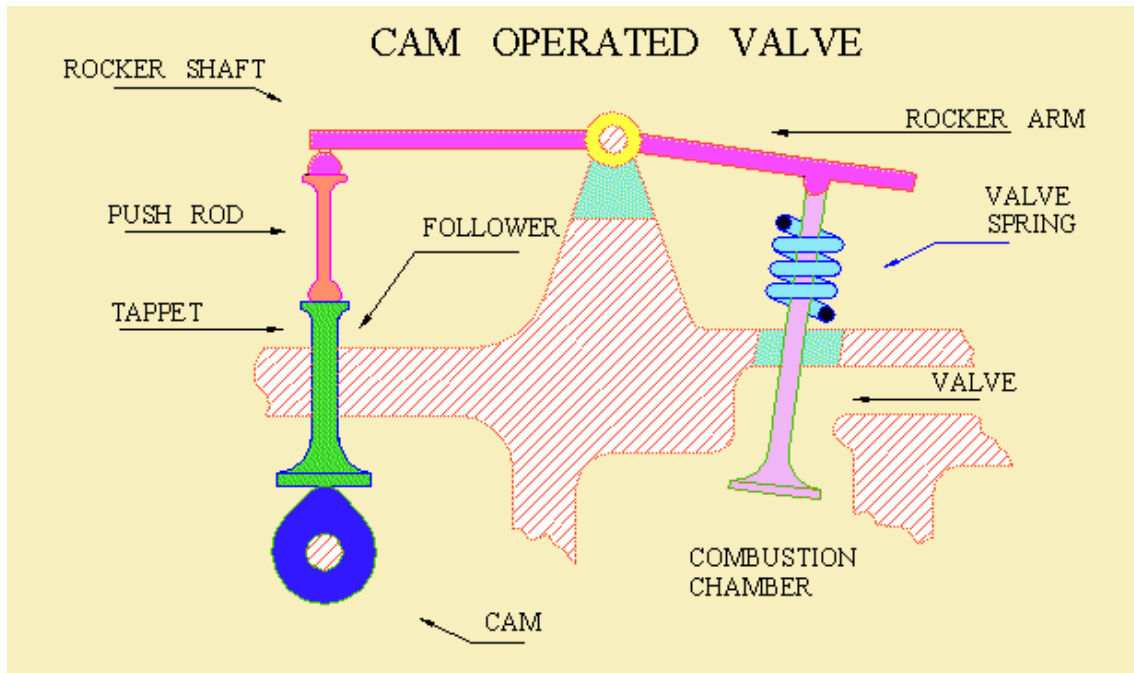
Sketch showing principle of valve operation

It is difficult to establish a typical timescale, in terms of engine operating hours, for cam lobes to wear through the case hardened layer, and at which point the wear rate would increase by an unpredictable amount. In addition, the engine manufacturer was unable to provide a figure of how much wear can occur before engine maximum power output is affected. The diagram overleaf illustrates how the cam wear affects valve operation.

The effect of the cam wear in this case was to reduce the cam follower range of movement by approximately 40%. This in turn would reduce the amount by which the inlet valves opened during the induction stroke, thus possibly resulting in a lower volume of fuel/air mixture and ultimately, reduced engine power output.

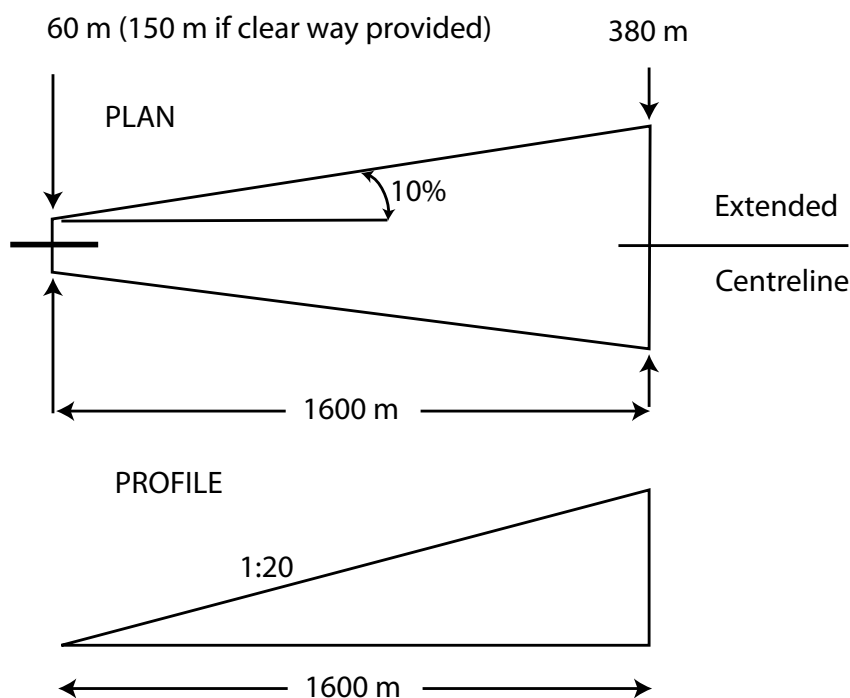
**Figure 3**

Runway 23 is designated as a code 1 runway for the purpose of determining the freedom from obstacles when landing and taking off. As such, its takeoff obstacle limitation climb surface has a slope of 5%, originating 30 metres beyond the end of the takeoff run and extending out to a distance of 1,600 metres, orientated on the extended centreline. The inner edge of this surface is 60 metres in width and the outer edge is 380 metres wide, with a linear increase in width of the surface between the two edges. See Figure 3.

Takeoff climb surface associated with a runway where the code number is 1

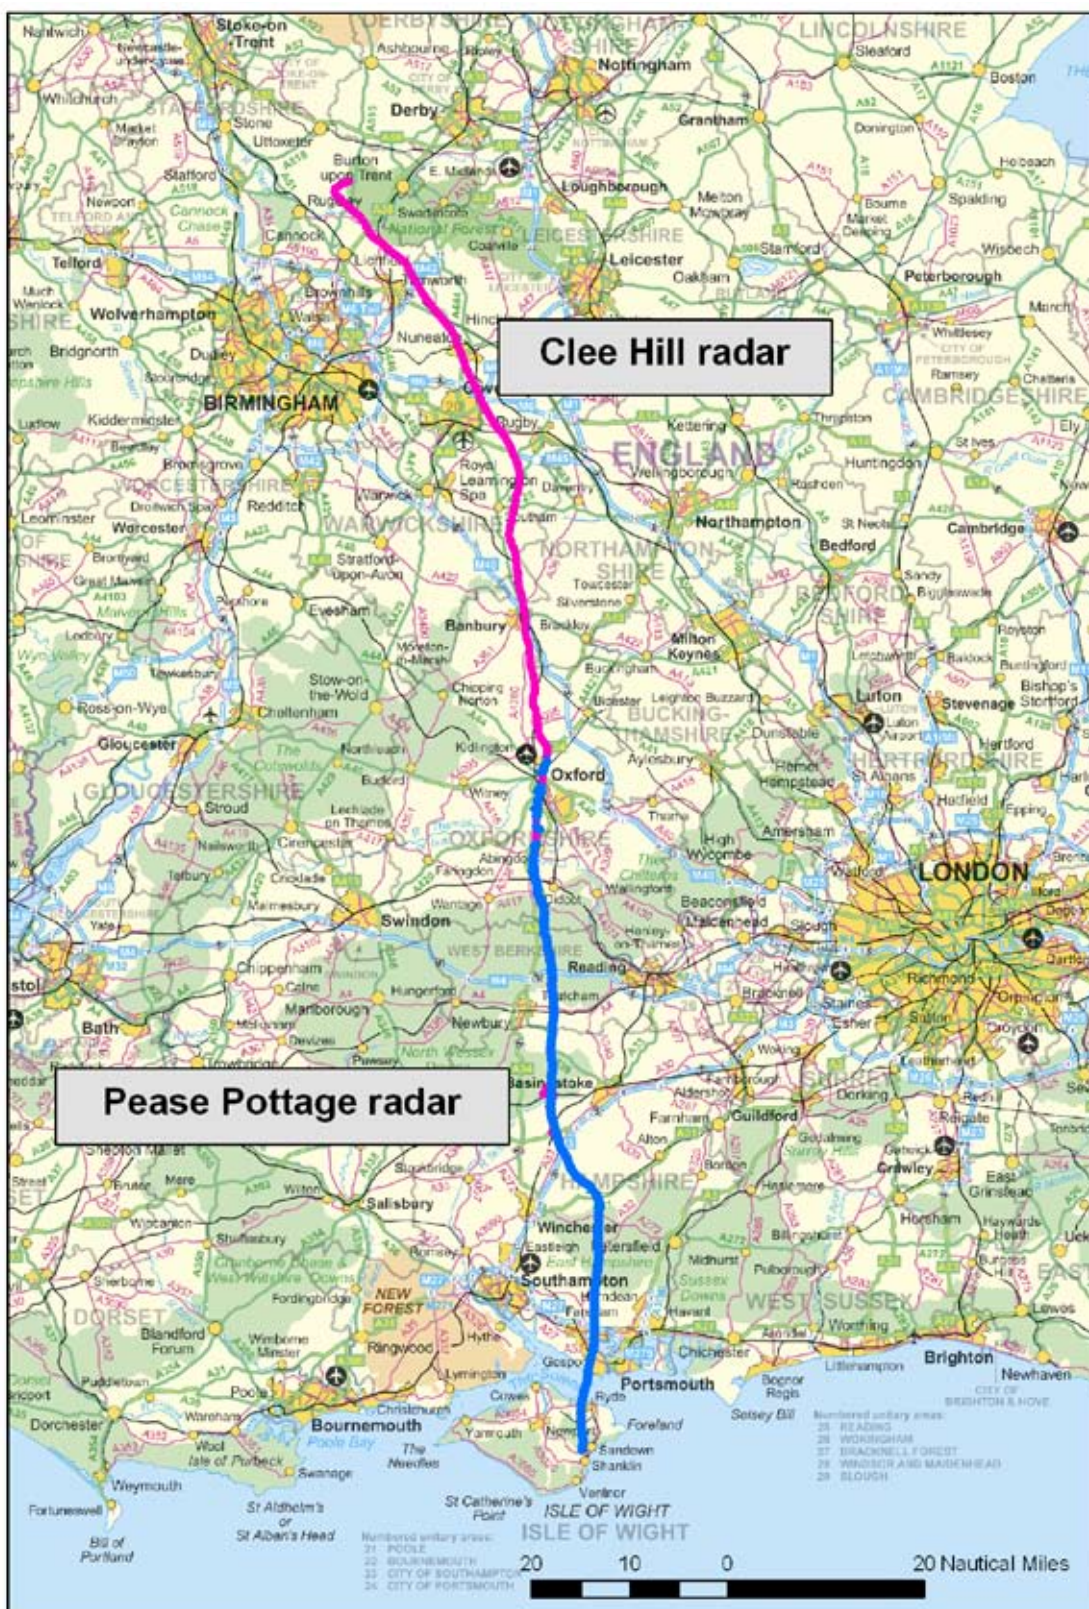
**Figure 5**  
G-AVRP's flight track from Tatenhill to Sandown Airport

Primary and secondary surveillance radar information from the radar heads located at Clee Hill and Pease Pottage was available for the aircraft's flight prior to the accident flight. Figure 5 shows this track, starting at 0748:23 hrs as G-AVRP climbed away from Tatenhill airfield, to the west, ending at 0939:40 hrs with the aircraft approaching Sandown Airport. No more radar data of G-AVRP was available.
