ACCIDENT

| Aircraft Type and Registration: | HK36 TC Super Dimona, G-FMKA | |
| Location: | Near Brimslade Farm, Wiltshire | |

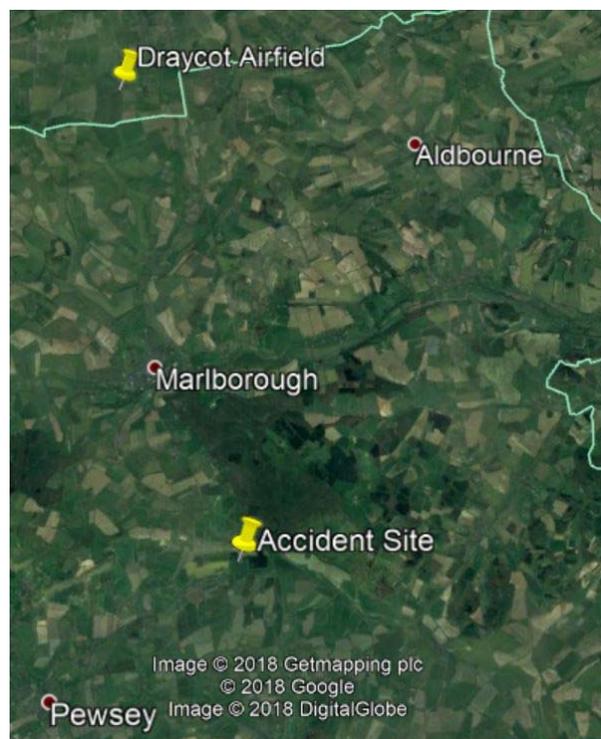
Figure 1
Accident geography

Another witness described the aircraft as “spinning around one wing and looked very nose-down” before his view was obscured by trees. The accident site was surrounded by tall trees on three sides and none of the witnesses saw the aircraft hit the ground. The accident site was located approximately 7 miles from Draycot (Figure 1).
