Air Accident Investigation Sector

- Final Report -

AAIS Case N° AIFN/0007/2019

Wake Turbulence Induced Loss of Control on Approach during Runway Lighting Calibration Flight

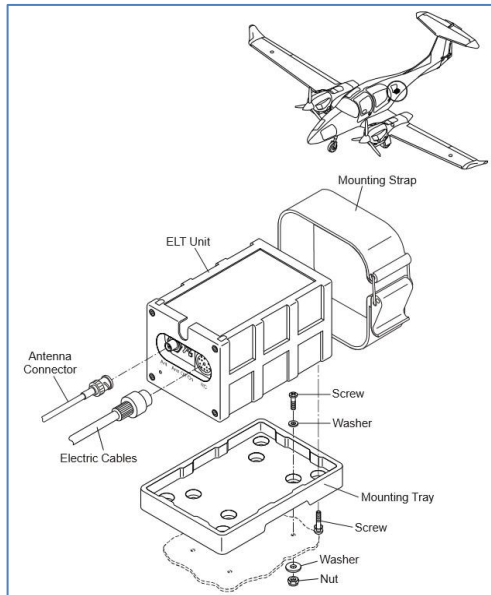
Figure 8a. ELT installation
[Source: Diamond Industries GmbH]

The Aircraft was fitted with a 406 MHz Kannad 406 AF emergency locator transmitter (ELT), which was installed in the aft fuselage beneath the aft baggage compartment. The ELT antenna was mounted on the upper surface of the fuselage, above the ELT installation (figure 8a).

The Investigation found that the ELT had been destroyed by the impact forces, and that the antenna and electrical cables were severed from the unit (figure 8b).

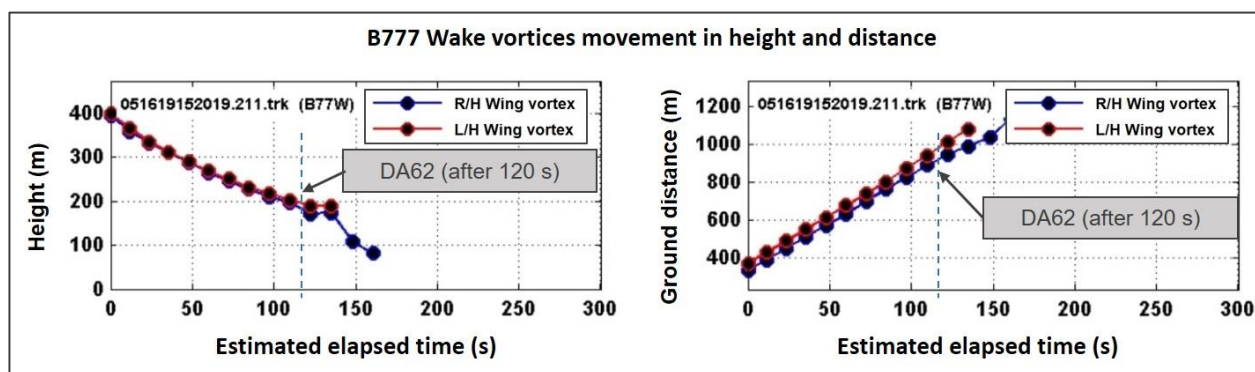
Figure 22. B777 generated vortices and drift at time of DA62 following [Source: dans]

The LIDAR data were reviewed for an approach that was carried out before the Accident approach. The DA62 was following a B777 and was 120 seconds behind. The LIDAR data indicated that the time separation was sufficient for the DA62 to follow without a wake turbulence encounter.

The B777 left and right wing wake vortices had descended to 202 m and 195 m at a distance of 937 m and 886 m respectively, from LIDAR station DXB2. With these distances, the DA62 would have been above the B777 vortices when it followed on the approach path to runway 30L (figure 223).

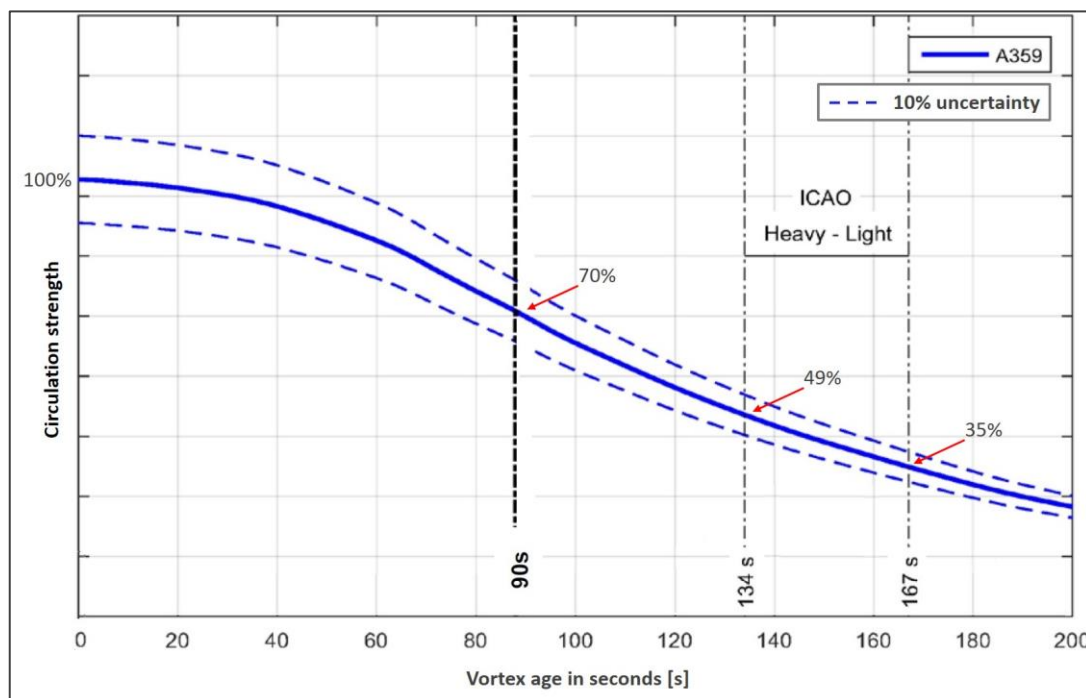
Figure 24. Heavy to Light aircraft separation as recommended by ICAO [Source: Airbus Industries]

The Airbus report concluded that “The estimated wake vortex turbulence circulation [strength], at the time of 2nd encounter ... is around 30% lower than the maximal circulation obtained at the time of wake generation by the preceding heavy aircraft...”

According to the Airbus report, and as illustrated in figure 24, the DA62 encountered a vortex circulation strength of approximately 70% of the maximal vortex strength generated by the
