ACCIDENT

Aircraft Type and Registration:	Aeroprakt A32 Vixxen, G-ENVV	
No & Type of Engines:	1 Rotax 912ULS piston engine	
Year of Manufacture:	2019 (Serial no: LAA 411-15611)	
Date & Time (UTC):	19 July 2022 at 1920 hrs	
Location:	Newtownards Airfield, County Down	
Type of Flight:	Private	
Persons on Board:	Crew - 2	Passengers - None
Injuries:	Crew - 2 (Fatal)	Passengers - N/A
Nature of Damage:	Extensive	
Commander's Licence:	See pilot information section	
Commander's Age:	See pilot information section	
Commander's Flying Experience:	See pilot information section	
Information Source:	AAIB Field Investigation

Synopsis

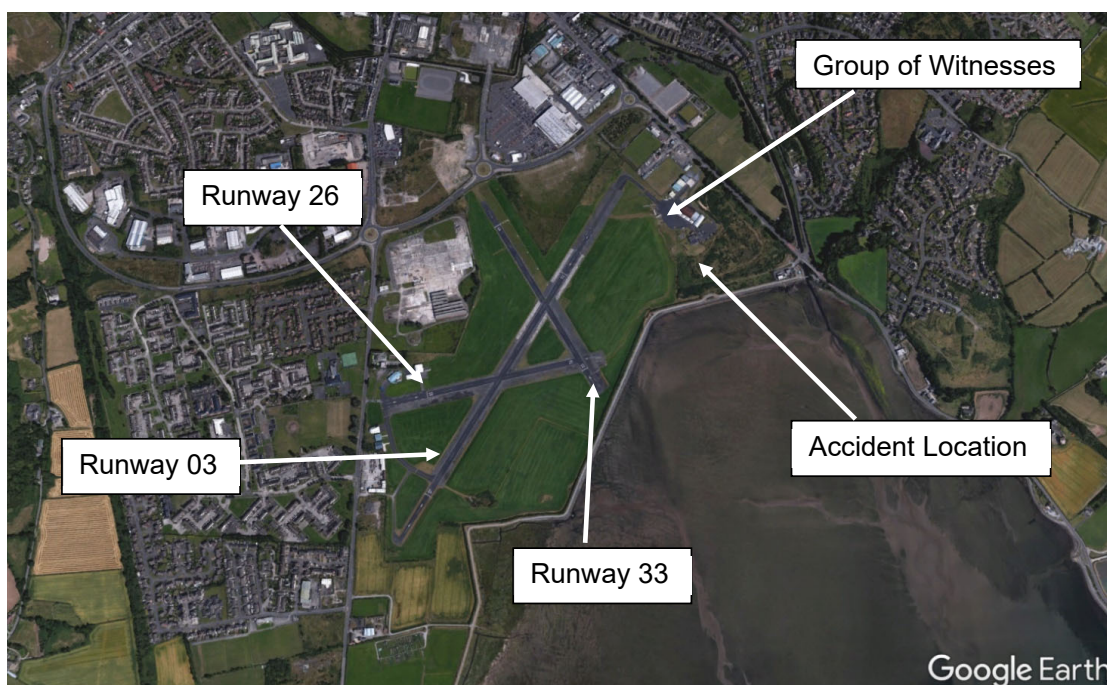
Figure 1

Newtownards Airport showing the accident and witness locations

Several people, who were at the airport preparing for an open day due to take place the following weekend, saw parts of the accident flight. When the accident occurred, they were stood by a vintage bus on the main apron (Figure 1). Many other people in the local area witnessed parts of the flight.
