Subject: Piper Aircraft, Inc. Comments to the "Interim" Notice of Proposed Rulemaking AD, Docket No. FAA-2018-1046; Product Identifier 2018-CE-049-AD

### **Introduction**

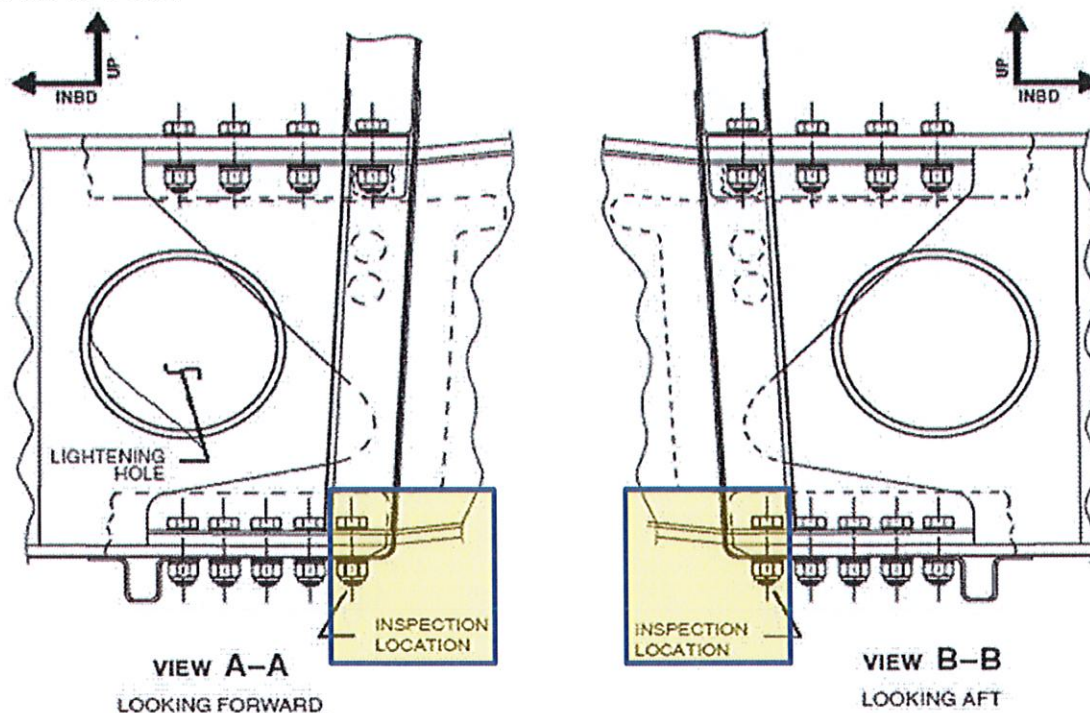
Figure 1: Location Inspection Area

The tasks required in order to perform the fastener removal for the inspection pose additional unnecessary risks which may create a feature (notch, gouge, thread mark, etc.) that is likely to cause a safety or airworthiness hazard. The hazard is tied to the removal of the outboard lower wing to fuselage spar attachment bolts. The directed activity is not a part of regular maintenance activities and requires the mechanic to maneuver in the confined area around the wing spar in order to gain access to both sides of the proposed inspection bolts and associated holes as shown below in the figure taken from the NPRM AD's text:

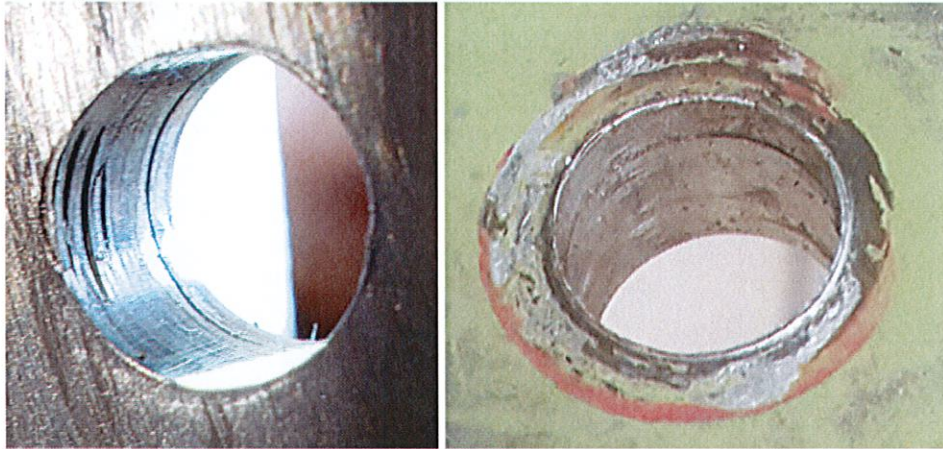
Figure 2: Example of Inspection Damaged Spar Bolt Holes

Piper Aircraft, Inc. customer service has already received reports of spar fastener holes that were damaged during the removal of the bolts. One such report stated that these bolts were removed in order to perform voluntary inspections of the fastener holes and consequently sustained thread marks and other damage which then needed to be repaired.
