Annual Safety Review 2023

30 years of investigating Serious Incidents – the AAIB’s perspective

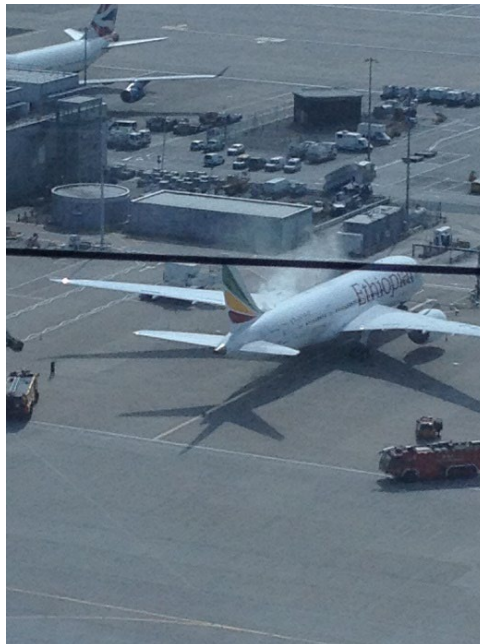
Figure 1

ET-AOP on a remote stand at Heathrow during the incident

In July 2013 a ground fire started in a parked and unoccupied Boeing 787-8 at London Heathrow Airport (Figure 1). The circumstances surrounding the occurrence did not fall within the definitions of an Accident or Serious Incident as defined in ICAO Annex 13, however, the Chief Inspector, exercised his powers under the Civil Aviation (Investigation of Air Accidents and Incidents) Regulations 1996, initiated an investigation, treating the occurrence as a Serious Incident and invoking the protocols of ICAO Annex 13 with regard to the participation of other interested States. An investigation was commenced immediately and a team of AAIB Inspectors was deployed.

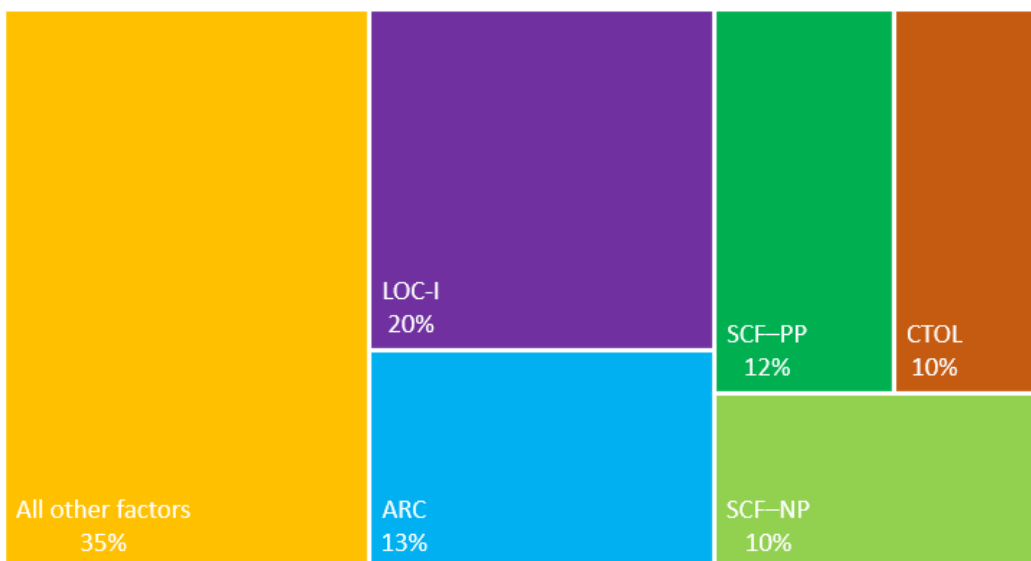
Top factors for all investigations reported on by the AAIB in 2023

As in previous years, the overall predominant main factor in aircraft Accidents and Serious Incidents is loss of control in flight (LOC-I).

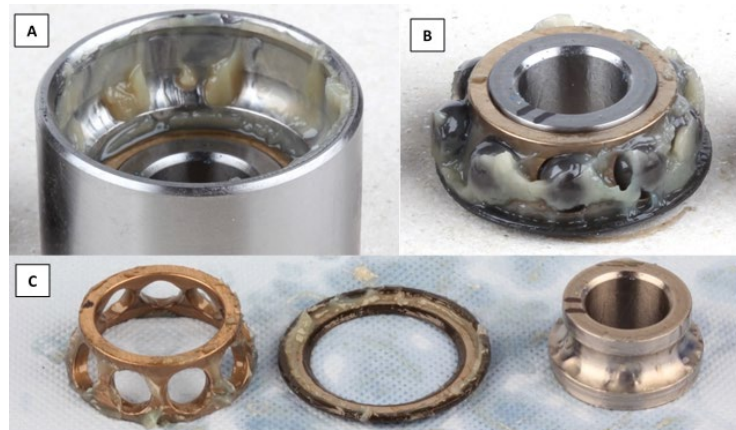
Bearing in new condition - (A) Housing and outer race, (B) inner race, cage and balls assembled, (C) cage, seal and inner race disassembled

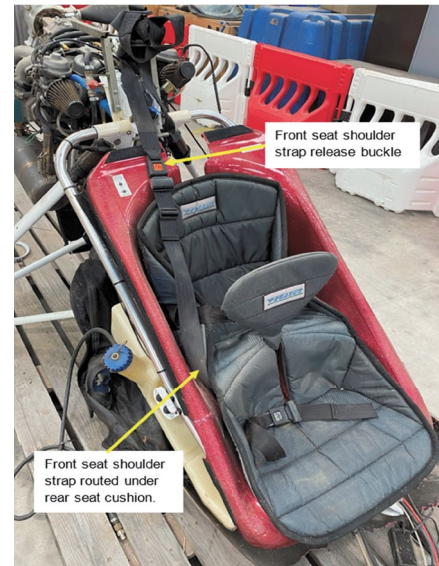
It is likely that the pilot started the engine with the hand throttle open and did not free the base bar, reduce the rpm or stop the engine before the aircraft became airborne. The pilot might have survived if he had been wearing his shoulder (diagonal) harness and his helmet had been designed to protect him from rotational head injuries.

Front seat diagonal shoulder strap positioned as found at the accident site

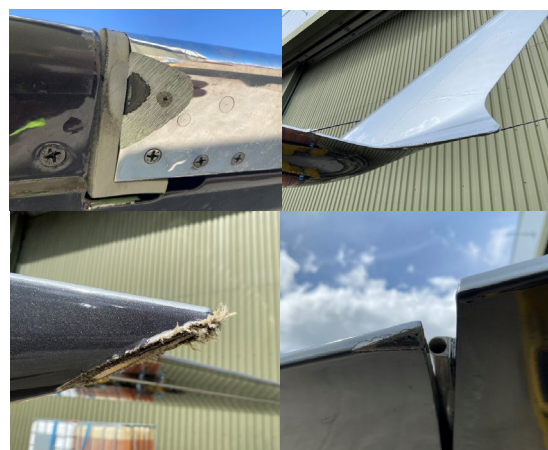
On approach to Runway 25 at London Luton Airport in gusty conditions, the right wing of LX-NST made contact with the runway causing damage to the wingtip, flap fairing, aileron and slat. The runway contact occurred during a baulked landing in which the pitch and roll combination was sufficient for the right wing to touch the runway for approximately 18 m.

Damage to LX-NST. Clockwise from top left – slat, winglet, aileron, flap fairing

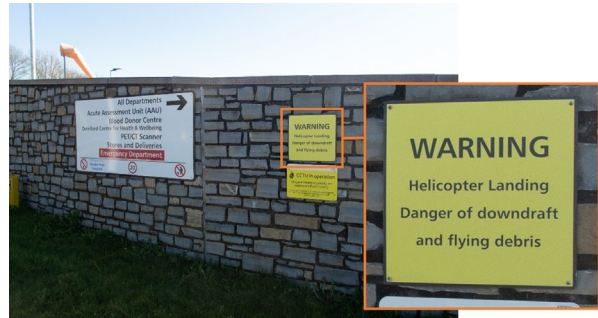
Warning sign on the perimeter of the HLS

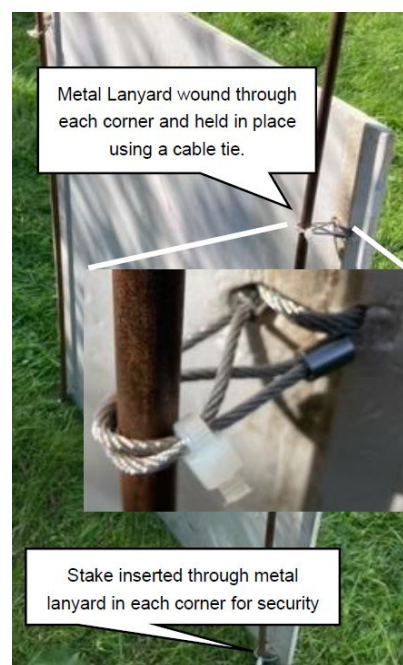
- The operator took immediate action on the day to increase the distance between the landing helicopter and the passenger area.
- The operator issued a flying staff instruction that required the sign to be secured with two cable ties on each corner and ordered metal lanyards to secure the sign in future.
- The flying staff instruction also required the ground team leader to check the safety of the site before the first flight of the day and before each start of the helicopter engine.

New method of securing the sign (Image used with permission)

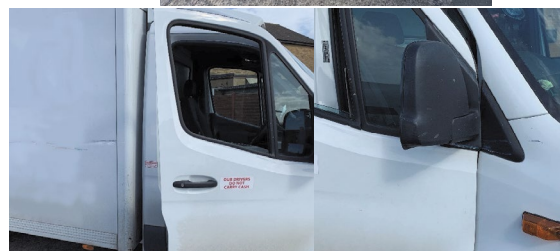
Damage to the aircraft wingtip (top) and to the vehicle panel side panel (left) and below the wing mirror (right). (Images used with permission)

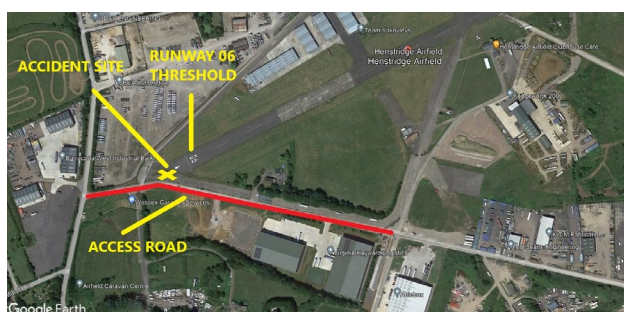
Henstridge Airfield and accident site

The aircraft was on a standard 3° approach path when it struck the lorry.

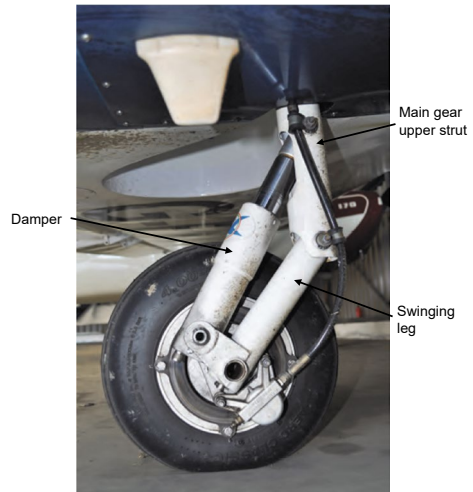
- As a result of this investigation the LAA are reviewing the design and manufacturing aspects of the Alpi Pioneer 300 landing gear, including whether on-going maintenance action is required.

Alpi Pioneer left main landing gear

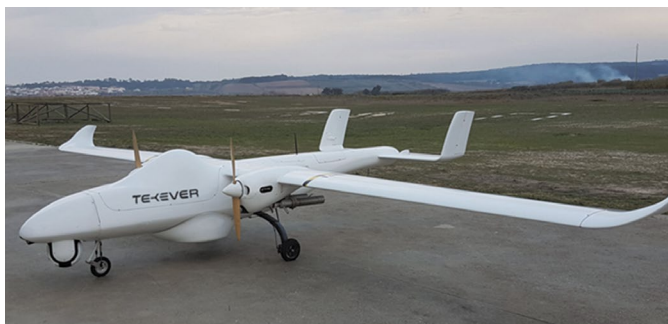
The unmanned aircraft encountered a loss of the communications link due to a fault in the Satcom antenna, such that it was not under the direct control of the remote pilot for a period of several minutes. In accordance with contingency procedures, the aircraft entered a holding pattern and the communications link was subsequently re-established. The remainder of the flight proceeded without incident.

Tekever AR5 Evolution

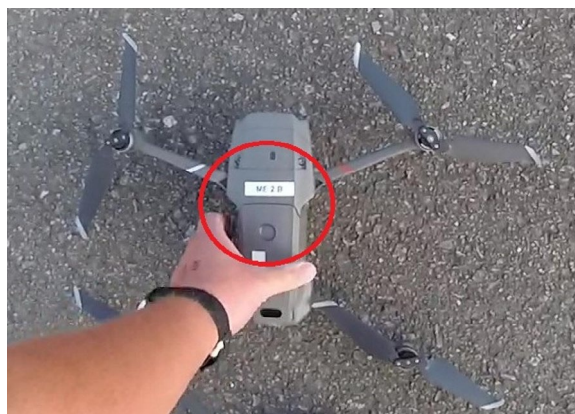
The UAS was being used in a police operation over an abandoned building near a public car park and train station. During hover over the building the aircraft's motors stopped and the aircraft fell vertically with no prior warning to the remote pilot. The aircraft struck the roof of the building and the battery separated. Recorded data indicated that the battery probably disconnected in flight. This could have been caused by the battery not having been fully latched prior to takeoff, or the latching mechanism or battery being worn from repeated use resulting in an in flight disconnection.

Image from the pilot's bodycam prior to takeoff
